Loss of control and collision with water involving Cessna 210 VH-EFB

160 km south-west of Darwin, Northern Territory | 1 April 2013

ATSB Transport Safety Report

Aviation Occurrence Investigation AO-2013-063 Final – 7 November 2013 Cover photo: Occupant of aircraft in same area as VH-EFB at the time of the occurrence.

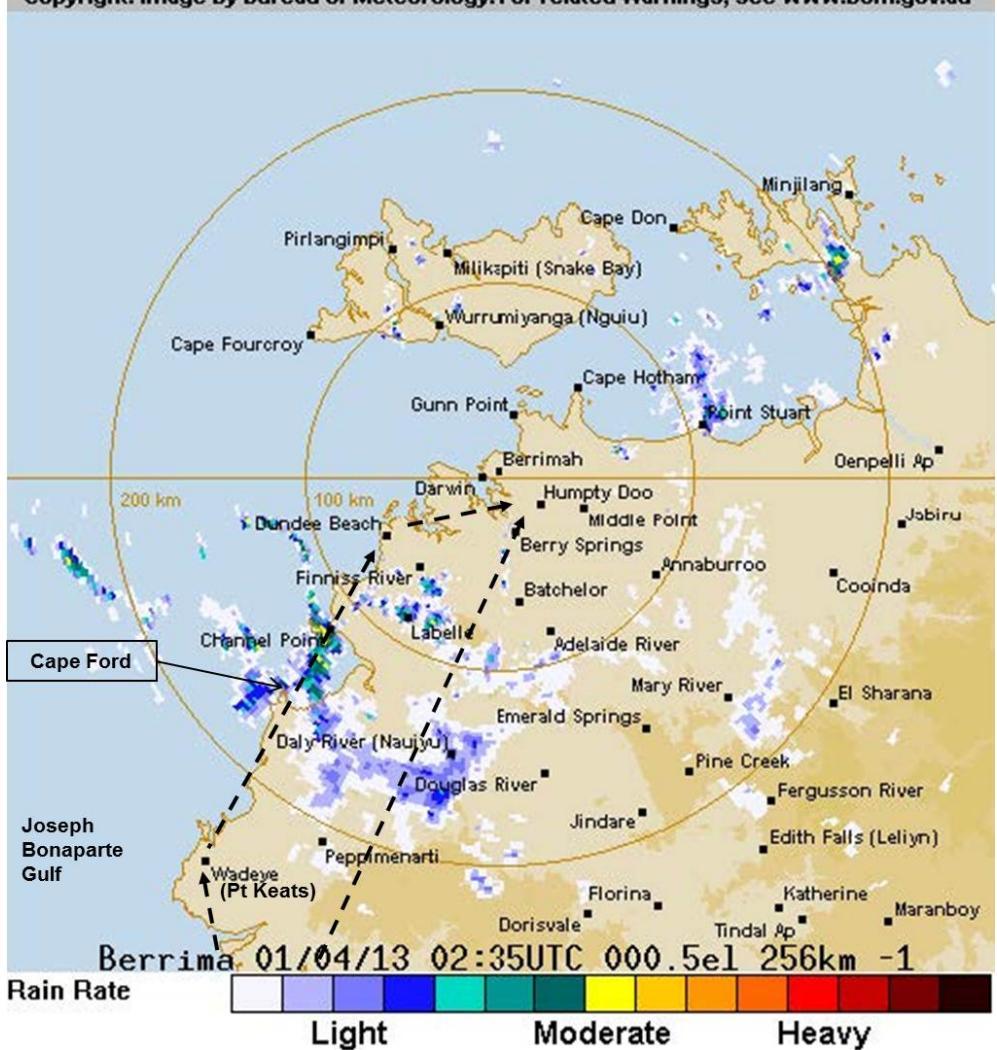
Figure 1: Weather radar image as of 1205 (nominal coastal track and direct track overlaid) Copyright: Image by Bureau of Meteorology. For related Warnings, see www.born.gov.au

The Bureau of Meteorology advised that on the day of the accident a low pressure system was located in Joseph Bonaparte Gulf, west of Wadeye. On the eastern flank of the system, converging low level winds and a moist unstable atmosphere contributed to persistent thunderstorms in the Cape Ford/Anson Bay area, north of Wadeye. This activity is evident in the weather radar images at 1205 in Figure 1, and later in Figures 2 and 3.

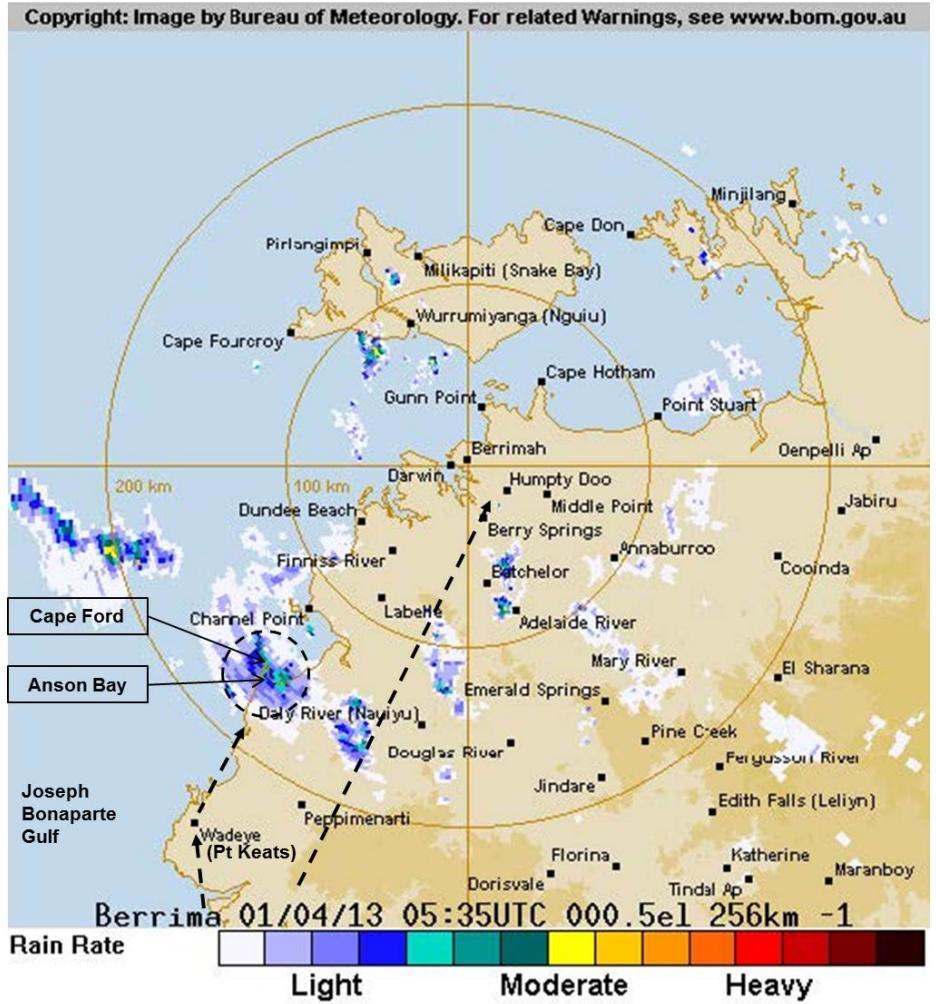
Weather radar detects rainfall and where rain is identified renders the area in colour proportional to intensity. It should be noted that the greater the distance from the radar, the higher the minimum height at which the radar can detect weather. This means that the rainfall showing up in the Cape Ford/Anson Bay area is at a height of least 10,000 ft and therefore may not represent any rainfall emanating from lower cloud.

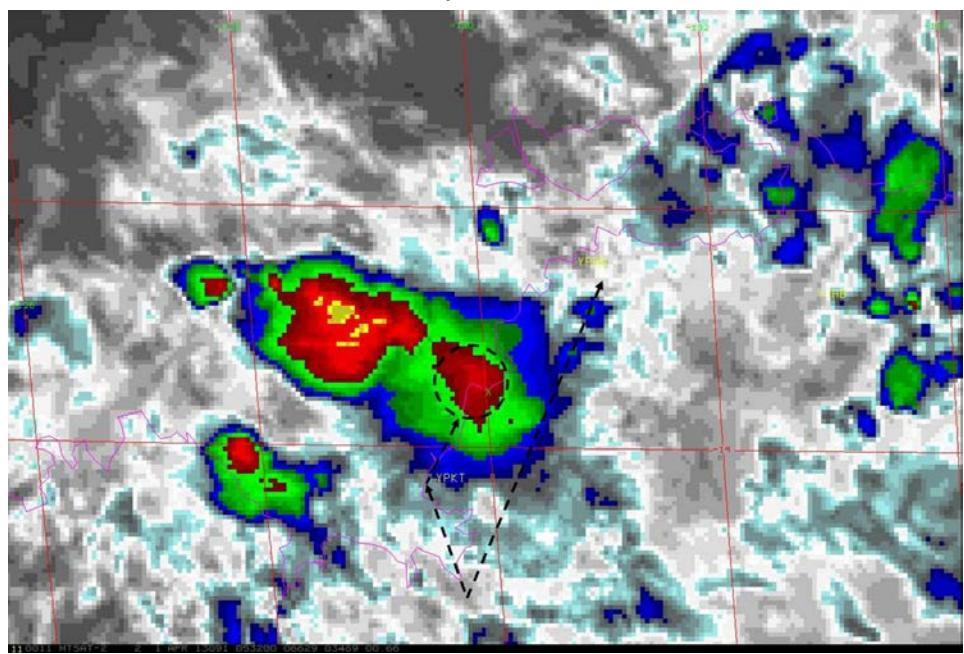
Figure 3: False-colour infrared satellite image at 1500, about the time of the accident (nominal coastal track and direct track overlaid by ATSB with the likely accident site area circled)

A false-colour infrared satellite image (Figure 3) is an enhancement of the basic greyscale infrared satellite image and provides information on the temperature of the underlying surface or cloud. Post-image processing for this type of image applies colour ranges to the cold end of the temperature scale, to highlight the deep atmospheric convection typically associated with thunderstorms.

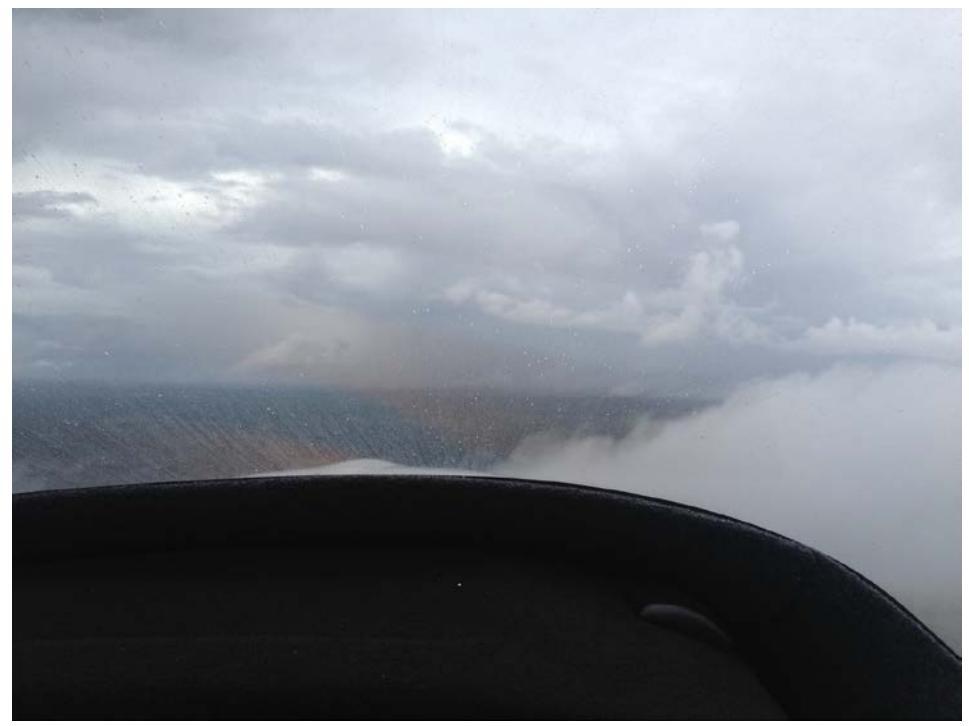
Figure 4: View from an aircraft in the group as the pilot navigated between storms about 40 km south-east of Cape Ford

The other pilots in the group flying from Bullo River to Emkaytee reported cloud and rain in areas that correlated to the radar and satellite imagery. Some of the aircraft occupants photographed the cloud formations and rain associated with the storms in the vicinity of Cape Ford (Figures 4 and 5).

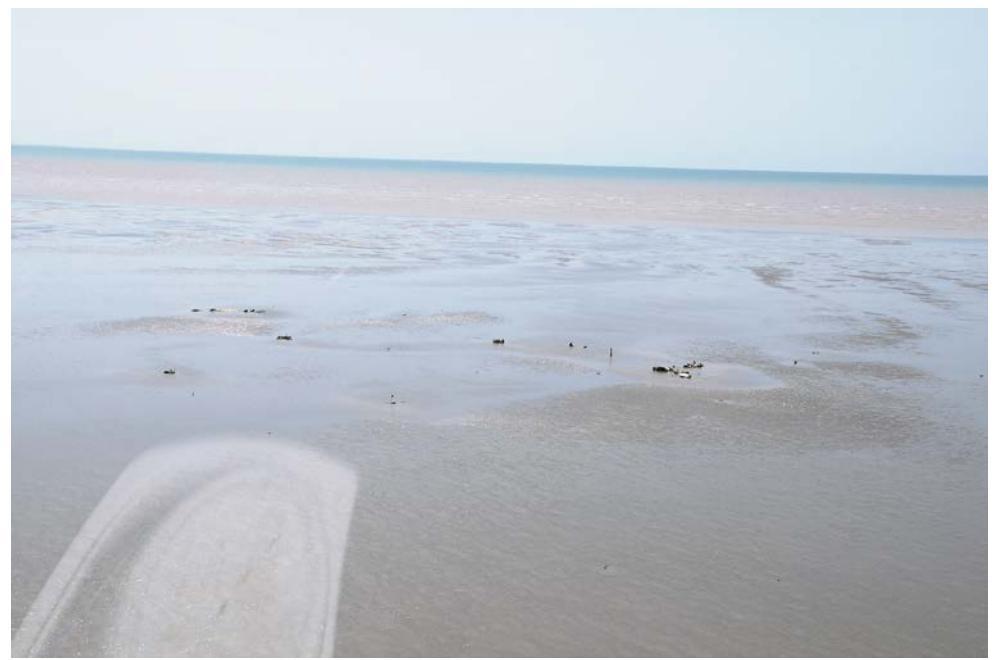
Figure 6: Aircraft wreckage in October 2013

The wreckage found in October 2013 was spread over a few hundred metres (Figure 6). The airframe was extensively fragmented with elements of the wings, fuselage, and seats identified. The engine and propeller, separated from the rest of the wreckage, were damaged but largely complete. As a result of the fragmentation, submersion, and tidal action, there was little additional information available.

It is evident from the fragmentation and distortion of the items recovered from the aircraft that there was a high degree of force involved in the collision with the water. Without knowing any specific details, that type of impact is almost certainly related to an inadvertent descent into the water. Such a descent invariably results from pilot unawareness of an aircraft's trajectory towards the water or pilot inability to alter that trajectory.
