Collision between a truck and passenger train 8205

Pettavel Road Level Crossing, Mount Moriac, Vic | 7 September 2013

ATSB Transport Safety Report Rail Occurrence Investigation RO-2013-024 Final – 11 February 2014 This investigation was conducted under the *Transport Safety Investigation Act 2003* by the Chief Investigator, Transport Safety (Victoria) on behalf of the Australian Transport Safety Bureau in accordance with the Collaboration Agreement entered into on 18 January 2013.

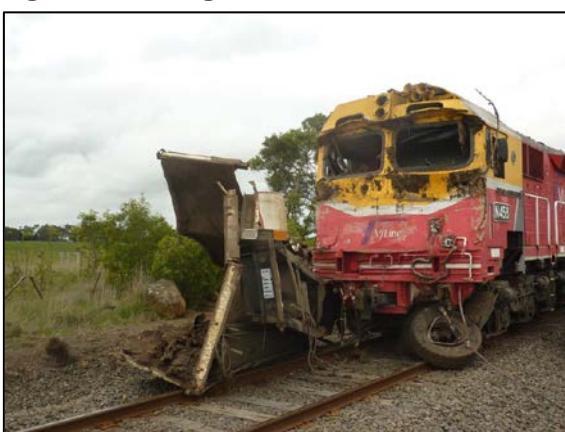
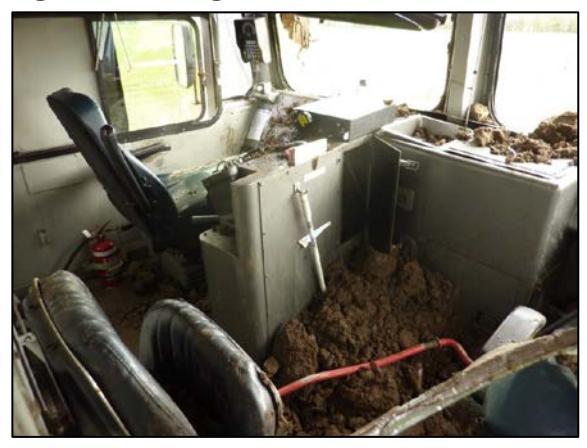
Figure 3 - Damage to locomotive cab

The collision destroyed the road vehicle trailer, and caused significant damage to the locomotive (Figures 2 and 3) and approximately 75 m of track infrastructure.

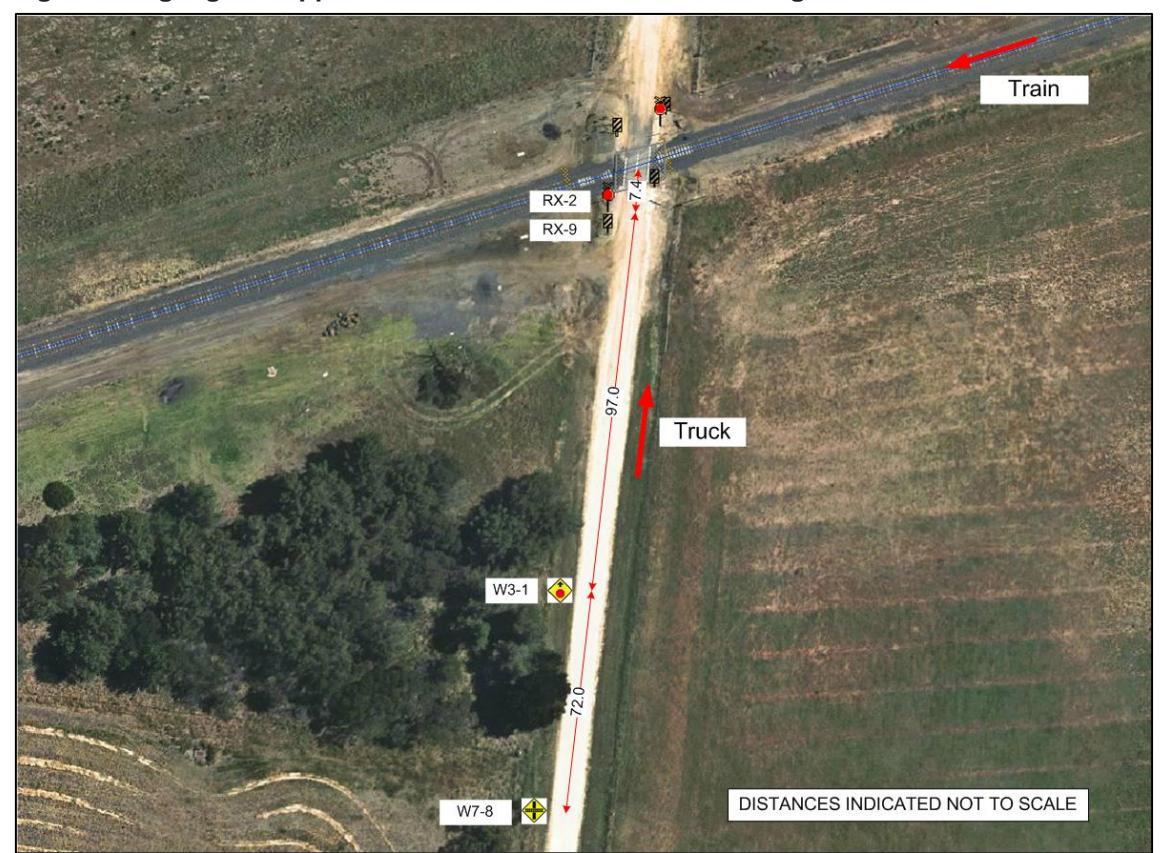
Figure 5: Signage on approach to Pettavel Road level crossing from the south

Pettavel Road is an unsealed road with a speed limit of 100 km/h. Traffic controls installed on the approach from the south of the Pettavel Road level crossing (Figures 5 and 6) included a *Railway Crossing Ahead (W7-8)* sign located 174 m before the crossing and a *Stop Sign Ahead (W3-1)* sign as the second warning sign, located about 102 m in advance of the crossing. The location of the *Stop Sign Ahead (W3-1)* was not in compliance with the *AS 1742.7-2007* standard, which required its location to be between 180 and 250 m from the Stop sign. A *Railway Crossing Stop*

Assembly (RX-2) and Railway Crossing Width Marker Assembly (RX-9) were also located in advance of the crossing.

Surf Coast Shire Council has relocated the signage to comply with the requirements of the *Australian Standard AS 1742.7-2007, Manual of uniform traffic control devices, Part 7: Railway crossings.*

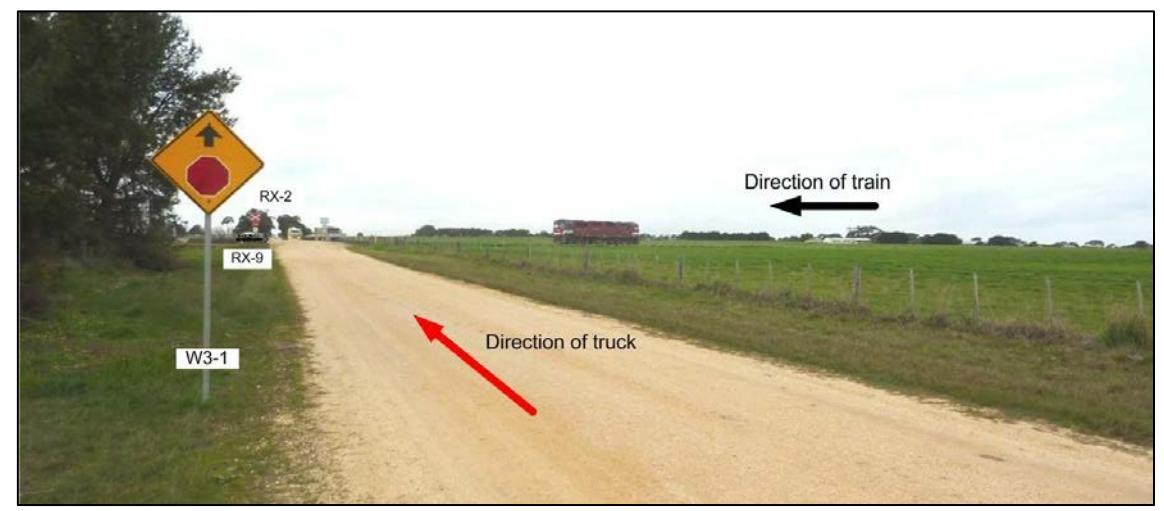
Figure 6: Pettavel Road level crossing (approach from the south)

When approaching the level crossing from the south, there is clear sighting of trains to the east on the approach to the crossing and at the Stop sign (Figure 6 and 9).

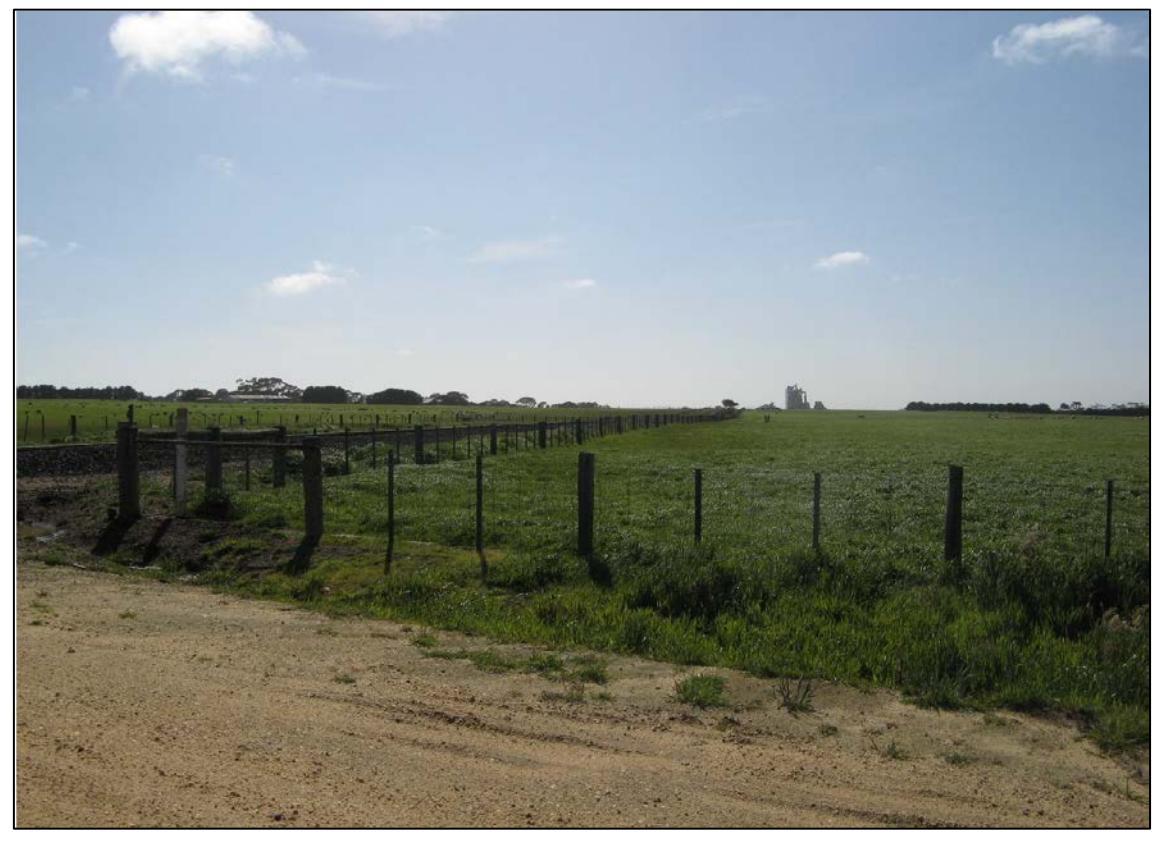
From the Stop sign south of the Pettavel Road level crossing, and looking east, clear sighting is available well beyond 552 m (Figure 9) and therefore exceeded the minimum sighting requirements specified in the *AS 1742.7-2007*.

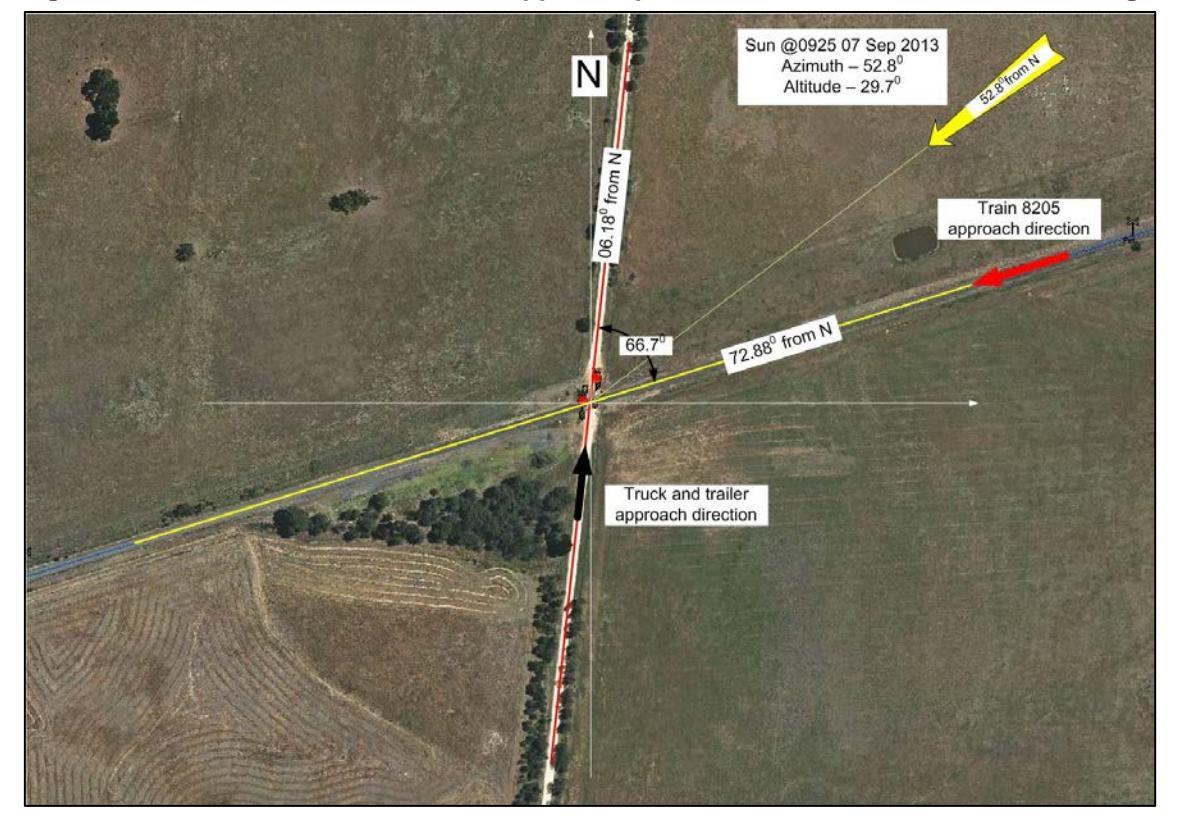
Figure 10: Overview of truck and train approach path to the Pettavel Road level crossing

The directional alignment of Pettavel Road is approximately 6° east of north and forms an angle of 66.7° with the rail tracks (Figure 10). *AS 1742.7-2007* specifies maximum sighting angles to the left and right measured at the Stop sign to ensure that an approaching train can be sighted without excessive head movement by a vehicle driver or sight obstructed by parts of the vehicle itself. An assessment of the Pettavel Road level crossing's geometry revealed that the viewing angle to the east from the Stop sign south of the crossing (truck approach direction) was within the angle specified by the standard.

The incident occurred at about 0925, and at that time the sun's azimuth³ was 52.8° at an altitude⁴ of 29.7° (Figure 10). The weather was fine with clear visibility at the time of the incident. On-site observation established that sighting of the train was unlikely to have been affected by sun glare.
