Loss of control involving a Eurocopter EC-120B, VH-VMT

16 km N of Ballina/Byron Gateway Airport, New South Wales, 8 December 2013

ATSB Transport Safety Report Aviation Occurrence Investigation AO-2013-217 Final – 25 February 2014 Released in accordance with section 25 of the Transport Safety Investigation Act 2003

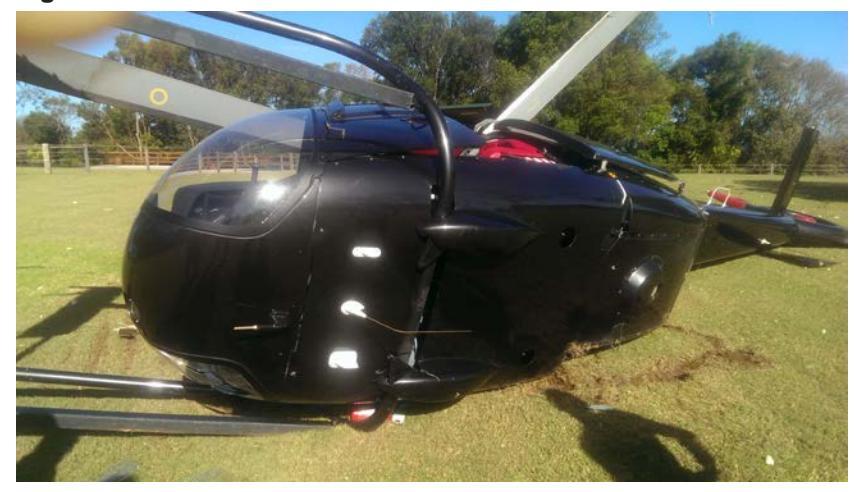
Figure 1: VH-VMT

When about 3 ft above ground level, the pilot reported that he entered the hover² with an airspeed of less than 10 kt and with full engine power selected. Immediately after, the helicopter began to yaw to the left. The pilot applied right anti-torque pedal to counteract the yaw and reduced the engine power to idle. The helicopter continued to yaw left and the pilot applied full right anti-torque pedal, but was unable to arrest the rotation. The helicopter rotated left about 90° before the left skid lowered and contacted the ground. It continued to rotate and rolled onto its right side. The helicopter was substantially damaged (Figure 1) and the pilot and passengers were able to evacuate uninjured.

The pilot believed that a combination of main rotor downwash and a wind gust contributed to a loss of tail rotor effectiveness (LTE).
