# Aircraft proximity event between a Cessna 172, VH-RQZ and an Agusta AW139, VH-ESZ

Archerfield Airport, Queensland, 26 August 2013

ATSB Transport Safety Report Aviation Occurrence Investigation AO-2013-134 Final – 10 December 2013 Released in accordance with section 25 of the Transport Safety Investigation Act 2003

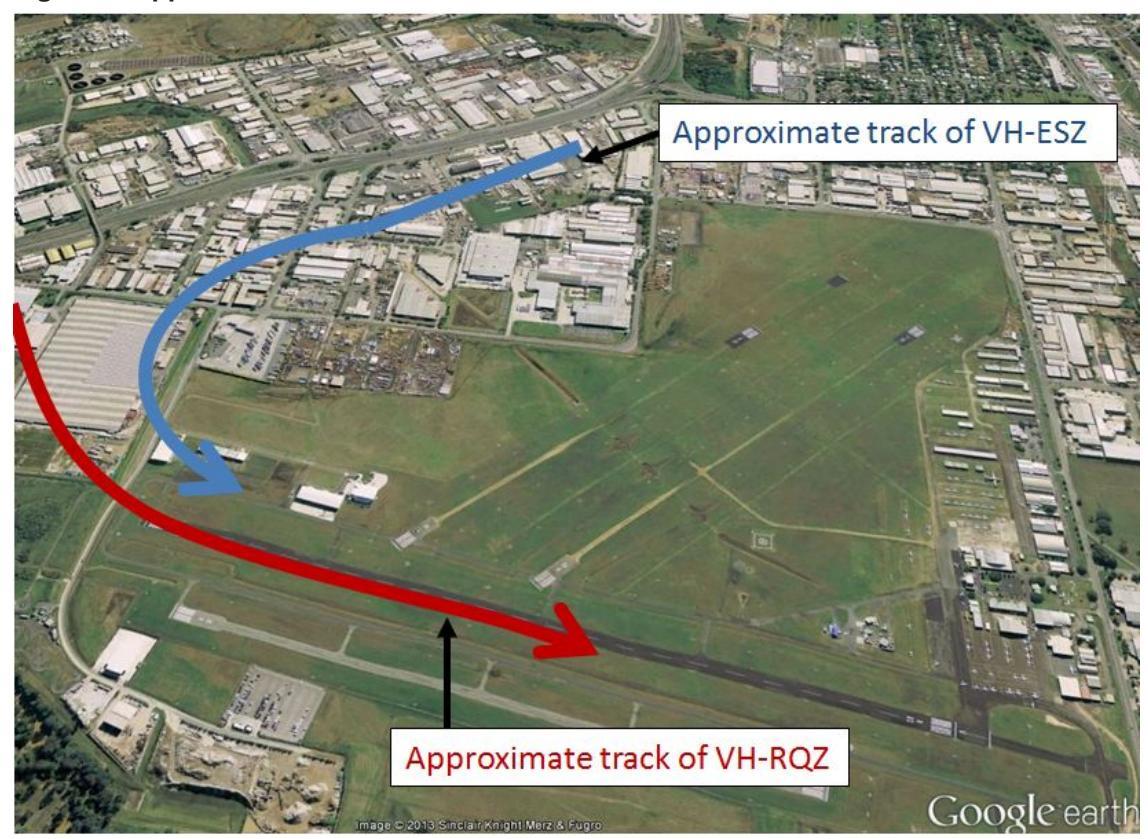
Figure 1: Approximate aircraft tracks

When RQZ was on final approach to runway 10, the instructor sighted ESZ on a close base in his 10 o'clock<sup>5</sup> position, about 1 NM (1850 m) away. The instructor of RQZ then broadcast asking the pilot of ESZ whether he had RQZ ('the aircraft on final') sighted, but did not hear any response. The instructor of RQZ reported that they were then about 300-500 m away from ESZ and about 50 ft below. The instructor took control of the aircraft and initiated a go-around. He manoeuvred the aircraft about 50 m to the right of the runway centreline to ensure separation with ESZ.

When at about 300 ft above ground level (AGL), the pilot of ESZ scanned for aircraft prior to turning onto final. He then sighted RQZ in his 4 o'clock position, about 100 ft below and 100 m behind ESZ and reported that RQZ appeared to have commenced a turn. The instructor of RQZ then broadcast that they were going around. The pilot of ESZ tightened the turn onto final and elected to land on the taxiway parallel to runway 10 (Figure 1). He had not received a TCAS alert on any aircraft other than the IFR aircraft, which was on downwind. The pilot of RQZ reported that they had their transponder turned on and it was operational at the time.
