Total power loss involving a Piper PA-28-140, VH-RVJ

Kilcoy (ALA), Queensland, 22 September 2013

ATSB Transport Safety Report Aviation Occurrence Investigation AO-2013-164 Final – 10 December 2013 Released in accordance with section 25 of the Transport Safety Investigation Act 2003

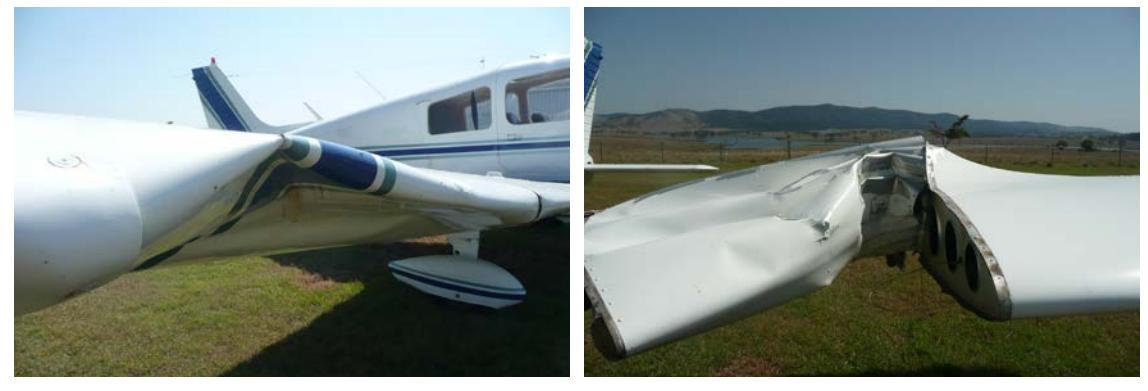
The aircraft left the end of the runway and collided with a fence, with the left wing striking a strainer post, then continued through a paddock and a ditch before coming to rest after colliding with a second fence.

The aircraft sustained substantial damage (Figure 1) but the pilot and passenger did not receive any injuries.

Figure 1: Damage to VH-RVJ
