Losses of separation assurance involving Airbus A330-243, PK-GPO and Airbus A330-341, PK-GPA

near ATMAP (IFR reporting point), Western Australia | 31 March 2012

ATSB Transport Safety Report

Aviation Occurrence Investigation AO-2012-047 Final – 28 February 2014 Released in accordance with section 25 of the Transport Safety Investigation Act 2003

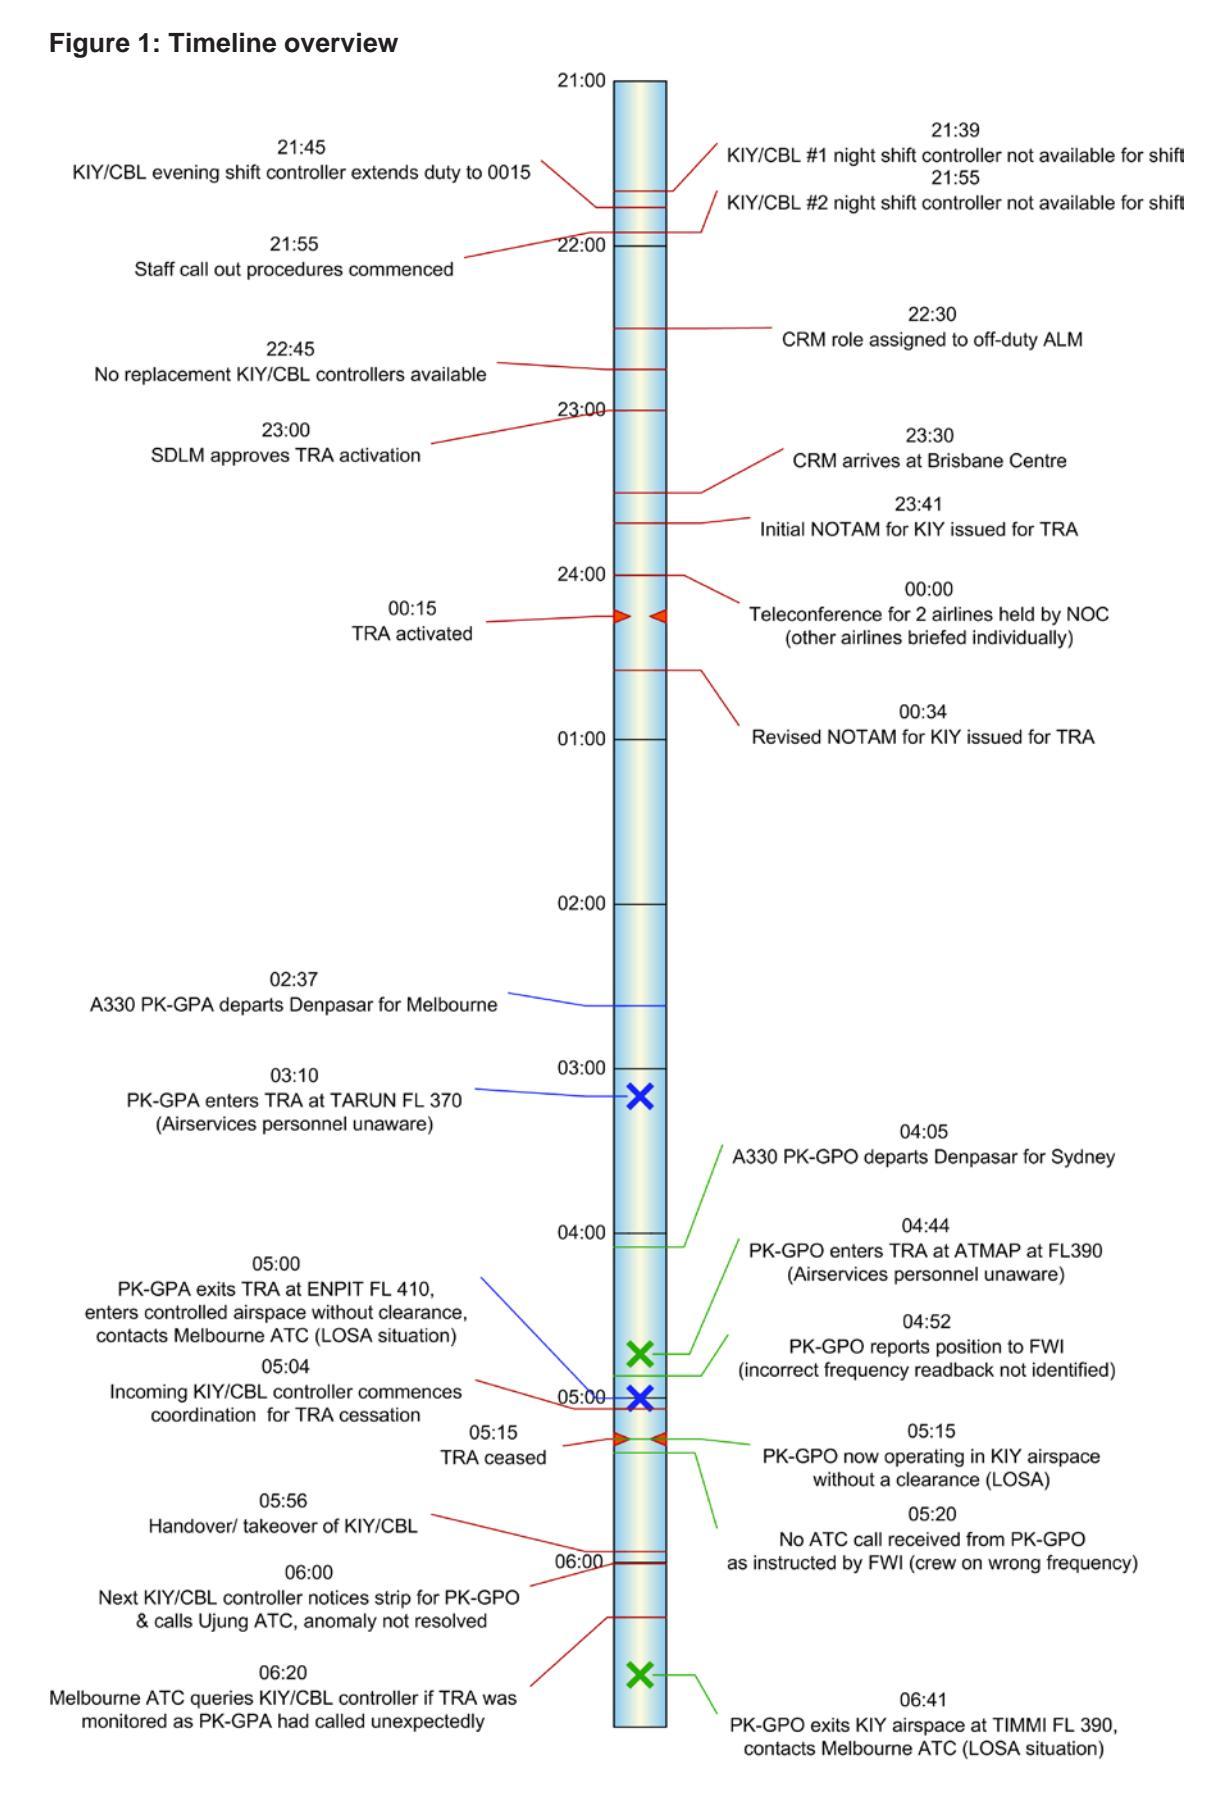
Note: Red lines indicate ATC activities, blue lines indicate PK-GPA activities and green lines indicate PK-GPO activities.

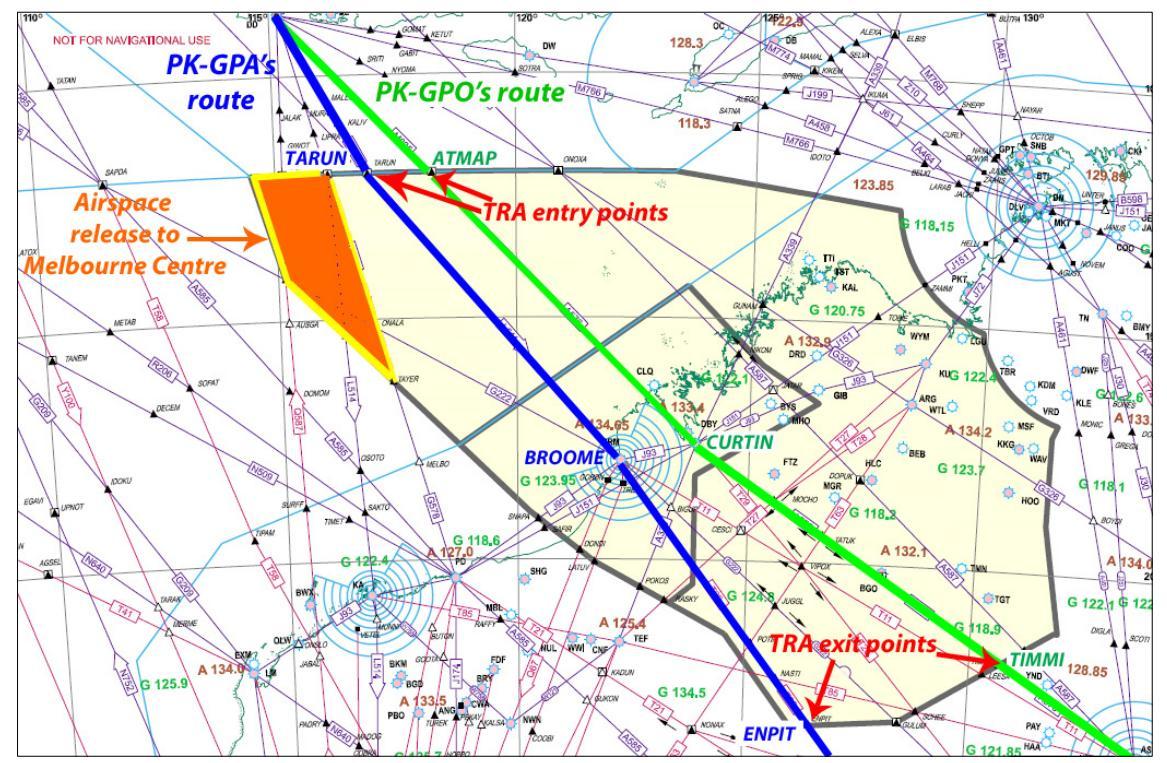
Figure 5: Temporary Restricted Area airspace with aircraft routes

During the TRA activation period, Melbourne Centre agreed to assume a portion of the KIY airspace, on and west of air route G578, which reduced the size of the TRA from the standard KIY/CBL airspace dimensions. The flight planned routes of PK-GPA and PK-GPO required the aircraft to transit through the TRA (Figure 5).

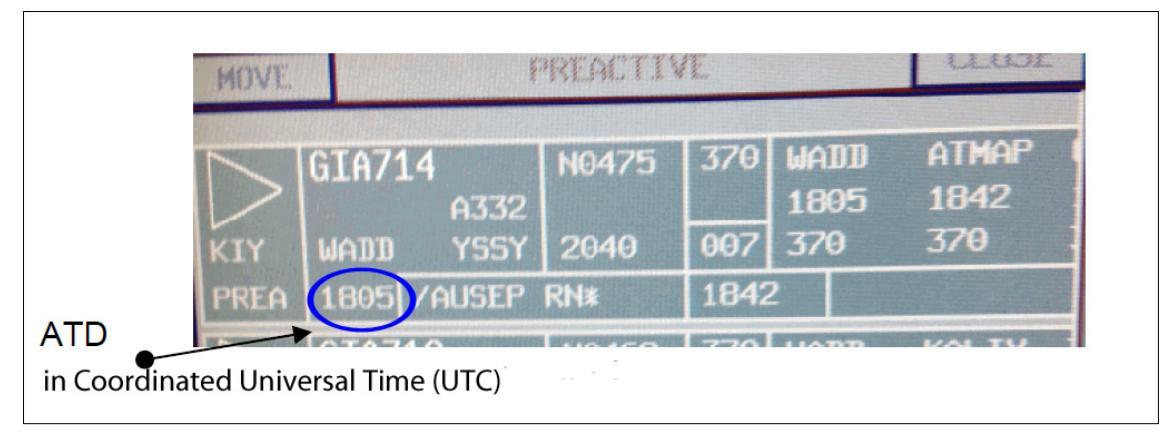
Figure 6: Flight progress strip showing actual time of departures (ATD)

The Local Instructions for the Tops Group detailed the required controller interactions with FDRs. For the FDR of an aircraft inbound to Australia, the controller was required to visually scan the TAAATS preactive strip window for aircraft that had departed and check whether an ATD was displayed in the preactive strip (Figure 6). For aircraft with an ATD, the controller was required to manually interact with the FDR to move it to a 'coordinated' state so that the aircraft's flight plan track was displayed on their air situation display. That track would be shown as a square symbol with a label displaying information including the aircraft's call sign and planned flight level. Once in a coordinated state, the aircraft's position could be updated by radar or ADS-B (if available), by an 'Airep' submitted by Flightwatch, or manually by the controller based on a position report from the flight crew or another controller. For an aircraft subject to radar or ADS-B surveillance (but not for aircraft subject to procedural separation), a symbol representing the aircraft's position, uncorrelated with its relative FDR, would still be displayed even if the FDR was not coordinated.

The CRM remained at or near the KIY/CBL console during the TRA activation period. However, they were not aware of the requirement to manually coordinate the FDR. The controller who resumed ATS on the KIY/CBL sectors at 0515 did not notice the ATD displayed in the flight progress strip for PK-GPO. As previously noted, the controller who took over the sectors at 0556 did notice the ATD and manually coordinated the aircraft's FDR, but then processed the FDR back to a preactive state, after initial discussions with Ujung ATC.
