Total power loss involving a Piper PA-28-161, VH-CCQ

9 km N of Cunnamulla aerodrome, Queensland, 1 October 2013

ATSB Transport Safety Report Aviation Occurrence Investigation AO-2013-168 Final – 19 March 2014 Released in accordance with section 25 of the Transport Safety Investigation Act 2003

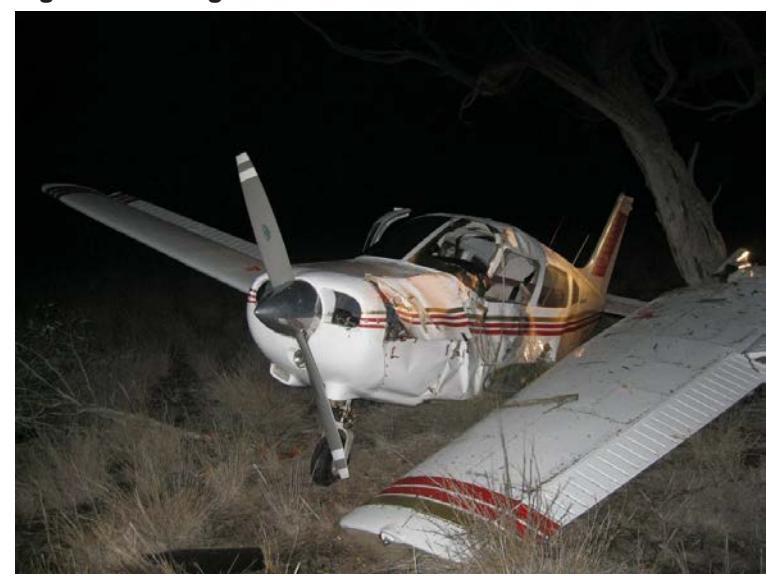
Figure 1: Damage to VH-CCQ

The aircraft landed in a paddock at about 1920, bounced once and, during the subsequent landing roll, the pilot shut down the engine. The aircraft subsequently collided with a tree, detaching the left wing. The pilot reported that he had detected a fuel smell and heard the sound of liquid running. The pilot and passenger exited the aircraft and moved away from the aircraft in case of fire. After about 20 minutes, with no fire eventuating, the pilot returned to the aircraft and located a telephone with which he called emergency services.

The aircraft was substantially damaged (Figure 1), the pilot sustained serious injuries and the passenger sustained minor injuries.

An engineering report provided to the ATSB stated that during an inspection of the engine conducted after the accident, the carburettor float bowl was found to be empty.
