Australian Government Australian Transport Safety Bureau

Hard landing involving a Rolladen-Schneider Flugzeugbau LS7-WL, VH-XJJ

20 km SE of Benalla aerodrome, Victoria

ATSB Transport Safety Report Aviation Occurrence Investigation AO-2013-224 Final – 19 March 2014 Released in accordance with section 25 of the Transport Safety Investigation Act 2003

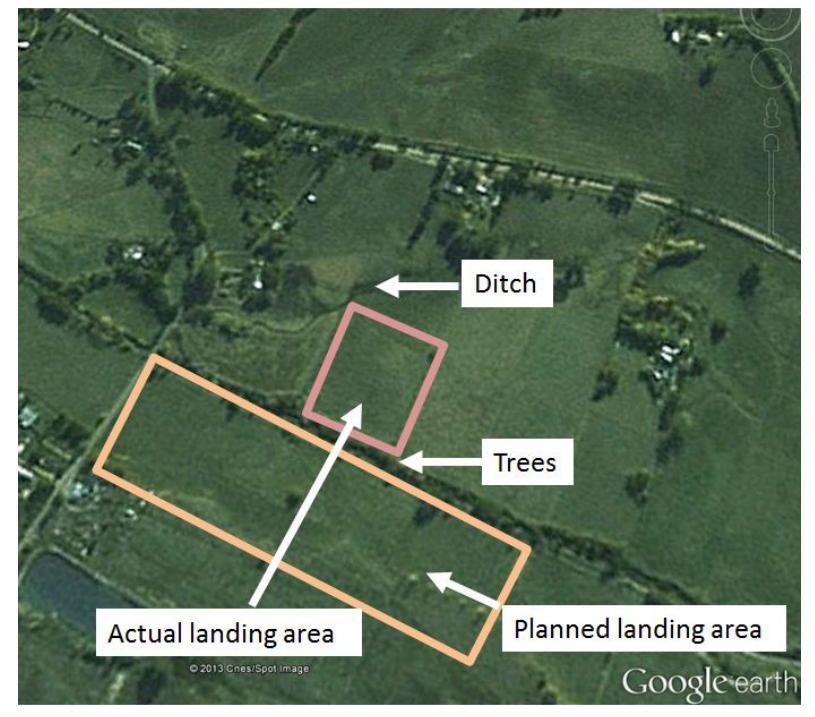
Figure 1: Landing area

The alternative field was perpendicular to the planned landing area and the glider would be landing towards the north-east (Figure 1). There was a row of trees on the approach end of the field and a ditch at the far end. The pilot conducted an approach to the field and the glider passed over the trees at about 50 ft AGL. The pilot then attempted to reduce altitude and airspeed by conducting shallow turns and flying diagonally across the field. The glider landed heavily in the north-eastern corner of the field. The pilot sustained a serious injury due to the hard landing and the glider was substantially damaged.
