Take off event involving a De Havilland DH-82 Tiger Moth VH-RAY

19 km NNE Coffs Harbour, New South Wales, 23 September 2013

ATSB Transport Safety Report Aviation Occurrence Investigation AO-2013-190 Final – 27 March 2014 Released in accordance with section 25 of the Transport Safety Investigation Act 2003

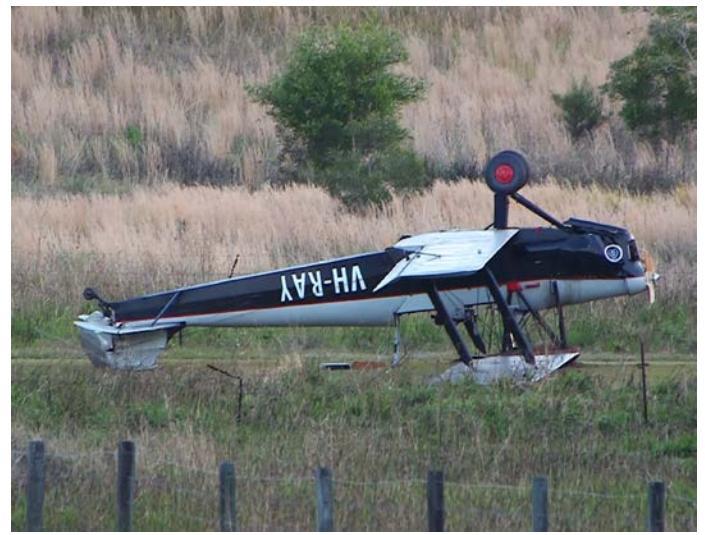
Figure 1: VH-RAY

The pilot taxied to the end of the runway and applied the brakes to conduct engine run up checks, then released the brakes and lined up on the runway heading and applied full power for take-off. The aircraft accelerated down the runway. As the airspeed increased the tail rose to the take-off position, at about 200 meters down the runway and at about 30 knots indicated air speed the nose of the aircraft dropped very rapidly and the aircraft flipped onto its back.

The aircraft was modified in 1997, installing main wheel brakes in accordance with an engineering order. Following the accident, the aircraft was inspected by the maintenance organisation and it was determined that the left main landing gear brake drum had evidence of corrosion and the brake operating rod was found stiff to operate. When the brakes were applied and released the left brake did not release fully. After the brake was cleaned and lubricated the brake operated normally. The maintenance organisation suspects that the left brake was partially engaged on take-off. They also determined that the aircraft was last flown on 12 February 2013 and the aircraft was normally stored in a high corrosion environment.
