Ground fire involving a Robinson R44, VH-TZE

32 km N of Daly Waters, Northern Territory, 15 October 2013

ATSB Transport Safety Report Aviation Short Investigations

AO-2013-192 Final – 8 April 2014 Released in accordance with section 25 of the Transport Safety Investigation Act 2003

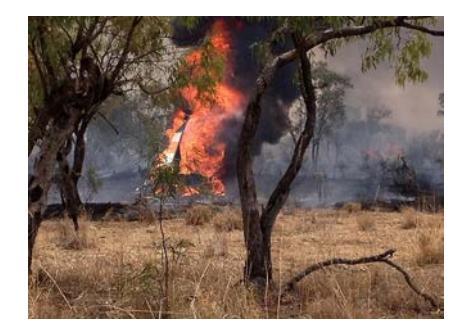
VH-TZE- Intensity of the fire

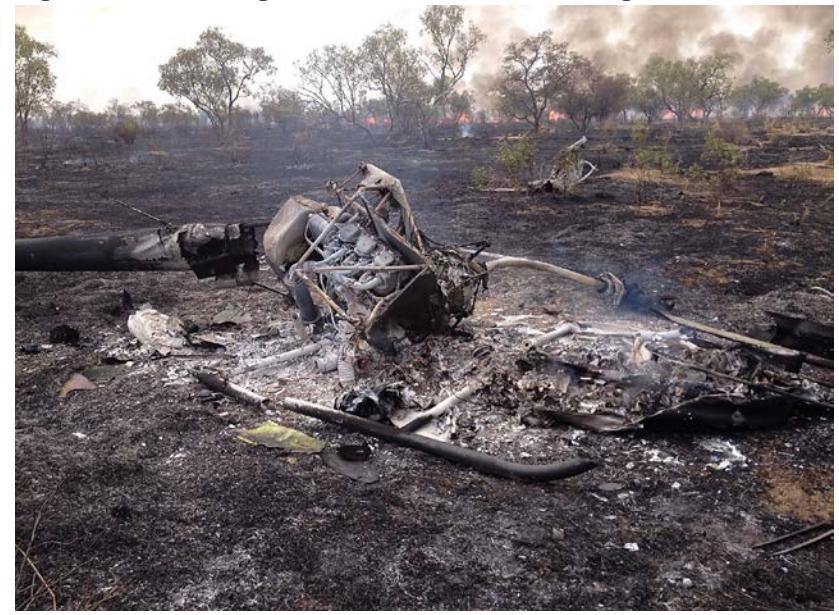
Figure 1: Fire damage to VH-TZE and surrounding bush

An uncommanded change in engine noise prompted the pilot to increase engine power a small amount in order to improve engine performance. While doing this, he checked the gauges and noticed that the engine revolutions per minute (RPM) had dropped significantly and the rotor RPM was decaying toward zero. He then saw the technician waving his arms in an attempt to gain his attention. The pilot looked toward the rear of the helicopter and saw a fire underneath, which was spreading into the engine bay. The pilot exited the helicopter and notified the landholders via phone so they could construct fire breaks to contain the ensuing grass fire. The helicopter was not equipped with a portable fire extinguisher. The occupants were uninjured; however, the helicopter was destroyed by the fire (Figure 1).

TZE had a serial number of 1333, indicating that the helicopter had been fitted with aluminium exhaust collector and tailpipe shields during the manufacturing process. A review of the post-accident photographs³ was unable to identify the presence of these shields in the wreckage; however, it was possible that they had melted in the ensuing fire. The associated stainless steel brackets and clamps were also not observed.

The photographs also indicated that the muffler shroud, a stainless steel shroud that fitted over the muffler to heat the air flow for the cabin heater system⁴ and assisted with cooling the muffler and engine compartment, was not visible. The absence of a muffler shroud would reduce engine compartment cooling and expose a larger surface area of heated metal, thereby increasing the risk of a grass fire during off-airport landings. The reason for the muffler shroud not being evident in the photographs could not be determined.
