# Collision with terrain involving Cessna 206, VH-WAV

156 km SSE of Croydon, Qld | 15 September 2013

ATSB Transport Safety Report Aviation Occurrence Investigation AO-2013-151 Final – 14 May 2014 Released in accordance with section 25 of the Transport Safety Investigation Act 2003

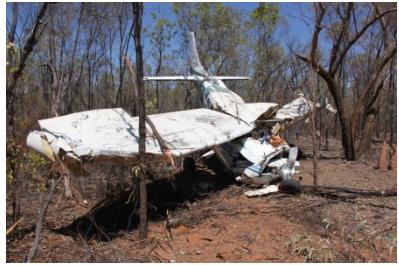
#### Accident site

The distance available from where the pilot increased power for take-off was much shorter than the distance advised in the aircraft's pilot operating handbook under the prevailing conditions.

There was no apparent reason for the pilot to attempt a take-off from that location when a more suitable location was nearby. It is most likely that the pilot misjudged the distance available, the prevailing conditions and their effect on the aircraft's performance, or had a false recollection of the relative layout of the two roads and thought that there was more take-off room available beyond the curve. However, it is also possible that the pilot's judgement of the available distance, or his decision-making capability, was affected by a serious medical condition and/or prescribed medications that had not been reported to the Civil Aviation Safety Authority (CASA) until after the pilot's previous medical certificate had expired.

In addition, the ATSB found that the pilot's seat had broken from its mounts, probably as the result of heavy, unsecured cargo striking it during the accident sequence. This could have had a detrimental effect on the survivability of the accident.

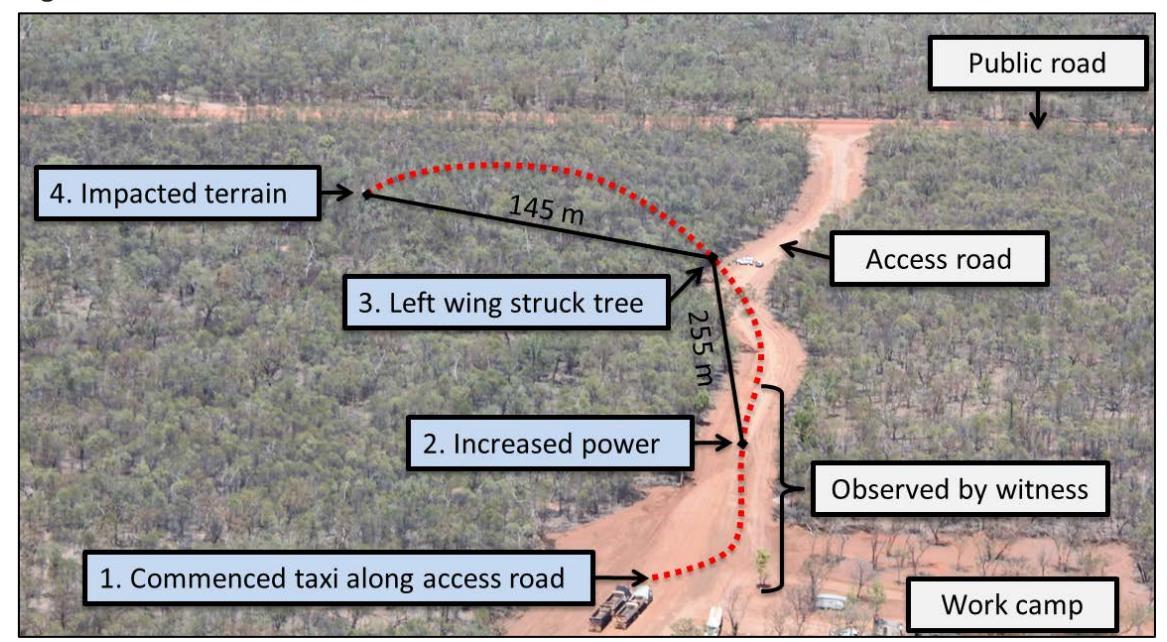
#### Figure 1: Accident site overview

The pilot landed on a straight, unsealed public road about 650 m from the work camp at about 1200 and taxied to the camp using an unsealed private access road (Figure 1). The pilot parked on the access road and both occupants disembarked.

About 155 m from the reported commencement of the take-off, the access road curved about 20° to the left (Figure 1 and Figure 4). About 75 m beyond that point the road curved 25° to the right, then left 15° to intercept the public road.

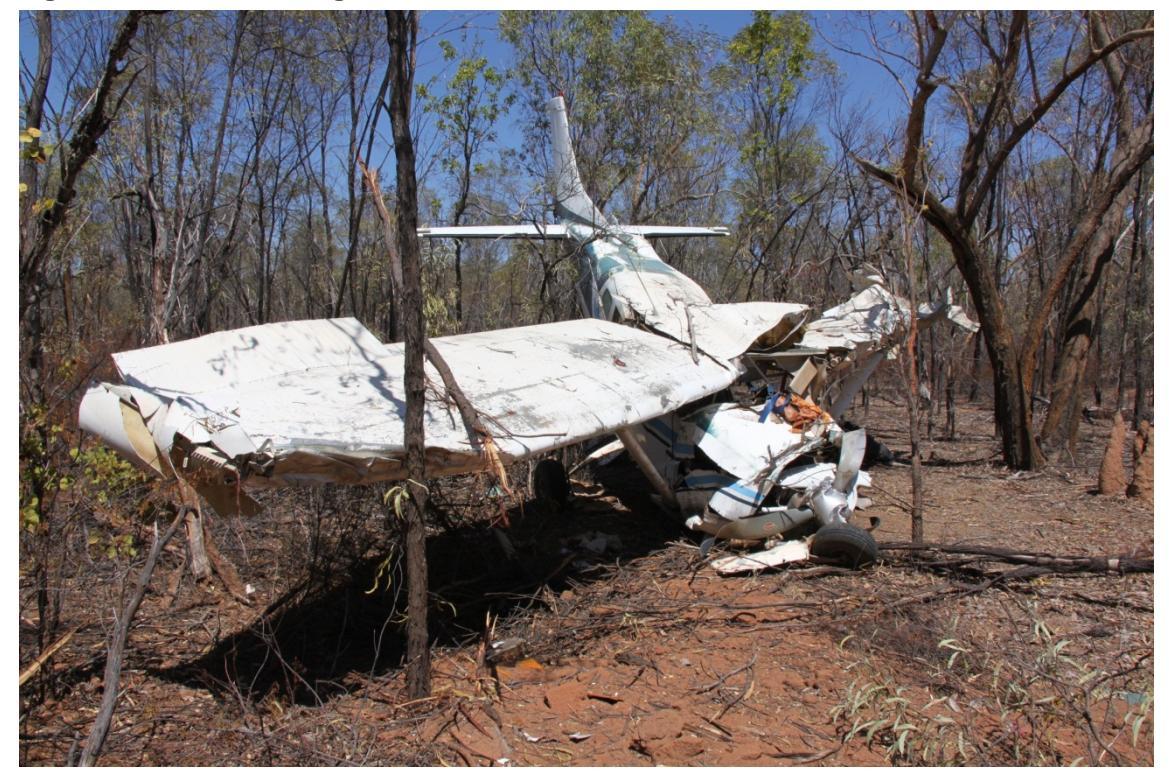
### Figure 2: Aircraft wreckage

Later examination showed that the aircraft's left wing struck a tree at a height of about 30 ft. The wingtip and aileron separated before the aircraft impacted terrain, fatally injuring the pilot and passenger. The aircraft was destroyed (Figure 2). The accident occurred at about 1516.

All of the aircraft's major components were located at the accident site and there was no evidence of pre-impact damage or defects. About 0.75 m of the aircraft's left wingtip and part of the left aileron separated from the aircraft immediately after contacting the tree. The left wingtip leading edge exhibited a compaction mark of a similar size to a large branch that had broken off the tree.

Ground marks and damage to the aircraft indicated that it impacted terrain in a very steep, left-wing low and nose-down attitude. The aircraft came to rest about 10 m from the initial ground impact point.

The propeller exhibited bending consistent with it being driven under significant power at the time of impact. Engine, propeller and flight control continuity was established. It was not possible to determine the flap position at the time of impact.

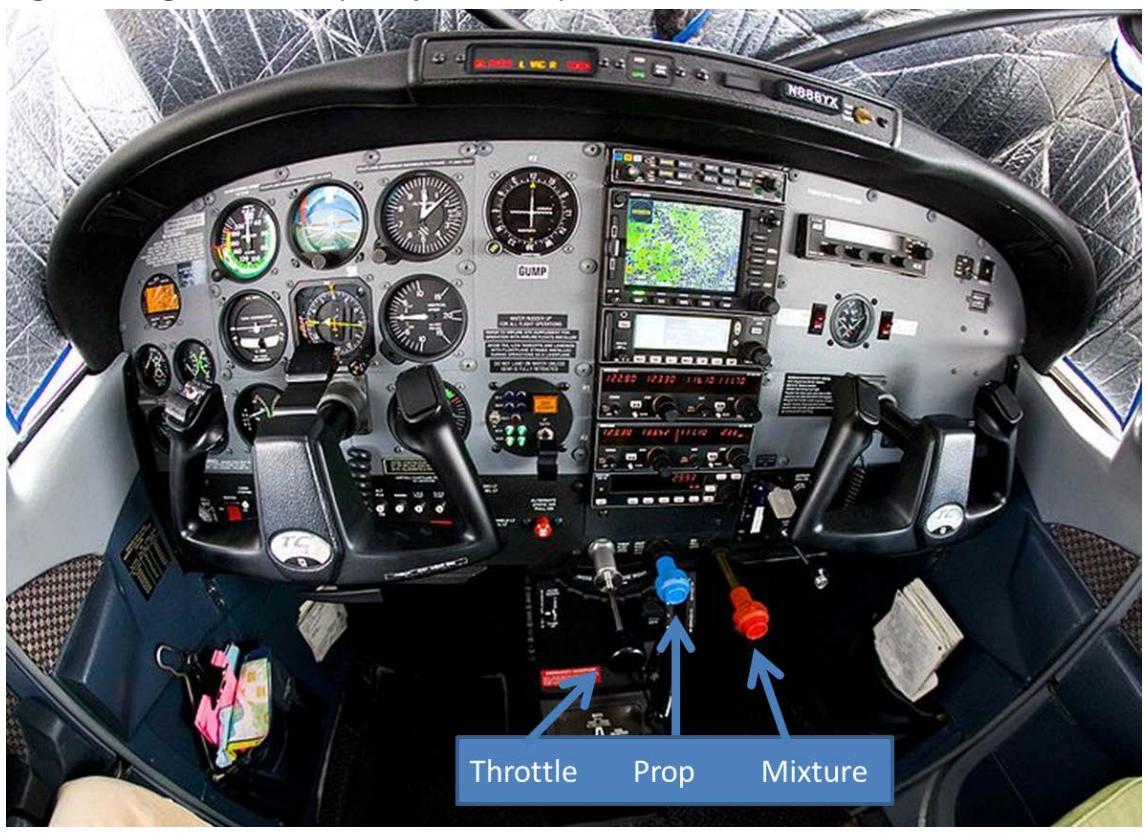
Figure 3: Engine controls (exemplar aircraft)

Engine throttle (power), propeller pitch, and fuel mixture were each controlled by push-pull sliding shafts mounted on the lower edge of the instrument panel (Figure 3). At take-off, the three control knobs are normally pushed fully forward (that is, corresponding to the full throttle, fine pitch, and full rich<sup>5</sup> positions respectively).

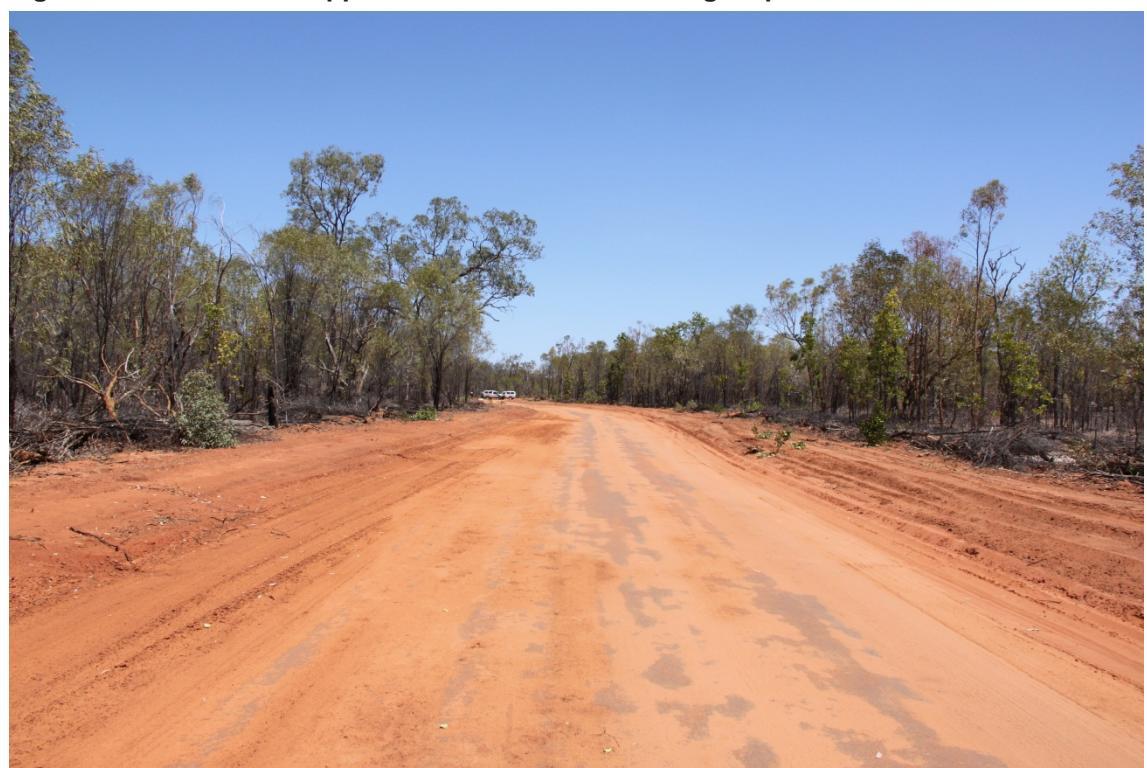
Figure 4: View from the approximate location where engine power was increased

The area around the roads and camp was covered in trees that were generally about 25-30 ft high (Figure 4). The public road was about 20 m wide, with a hard clay surface. The access road to the work camp was about 13 m wide, comprising an 8 m wide strip of hard clay with light loose sand along the centre with soft sand at the edges, and had minimal slope.

The take-off was conducted on a relatively short and narrow section of road, which curved about 155 m from the reported commencement of the take-off, and was surrounded by trees. The distance available for take-off was much shorter than the distance advised by the aircraft's pilot operating handbook under the prevailing conditions. Suggested take-off and landing area considerations, as set out in Civil Aviation Advisory Publication (CAAP) 92-1(1) *Guidelines for Aeroplane Landing Areas* were also not met, including the runway width and the dimensions of the 'approach and take-off area'. In combination, these factors increased the risk associated with the take-off.
