Canopy-related landing accident involving Lancair Legacy, VH-ALP

Geraldton Airport, Western Australia | 18 September 2013

Aviation Occurrence Investigation AO-2013-158 Final – 15 May 2014 Source: Cover photo supplied by Geraldton Airport

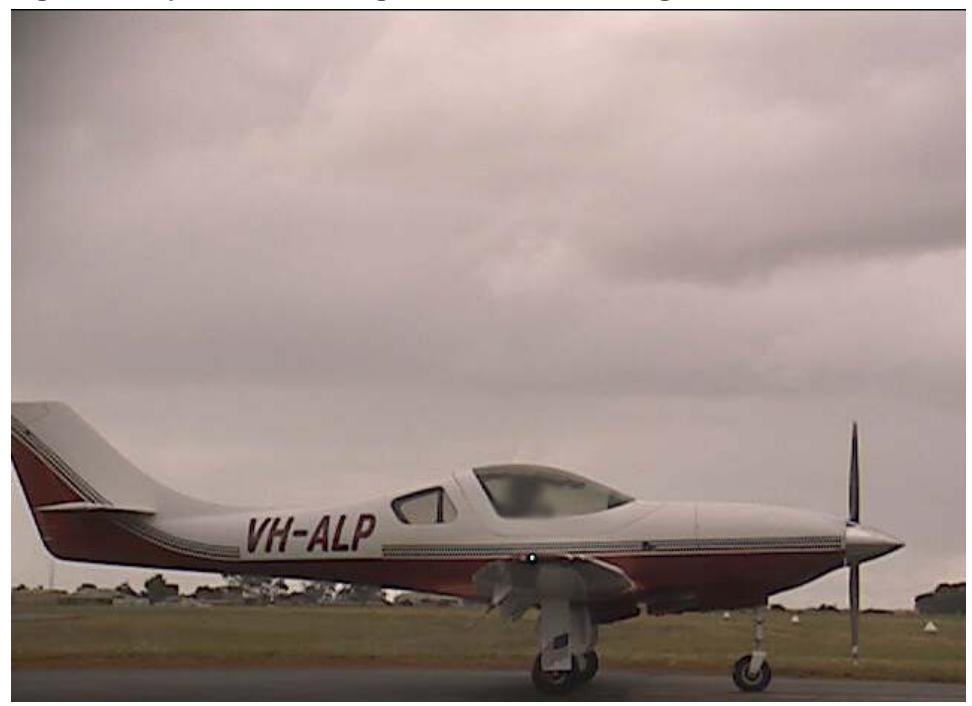
Figure 1: Airport camera image of the aircraft during taxi

The pilot began the take-off roll with substantial engine power and the aircraft was observed to accelerate normally to about halfway along the runway. At this point, smoke from the main wheels indicated that the brakes were applied momentarily, and at about the same time the forward-hinged canopy opened about 15 to 30 cm. No change to engine power was evident and the take-off roll continued.

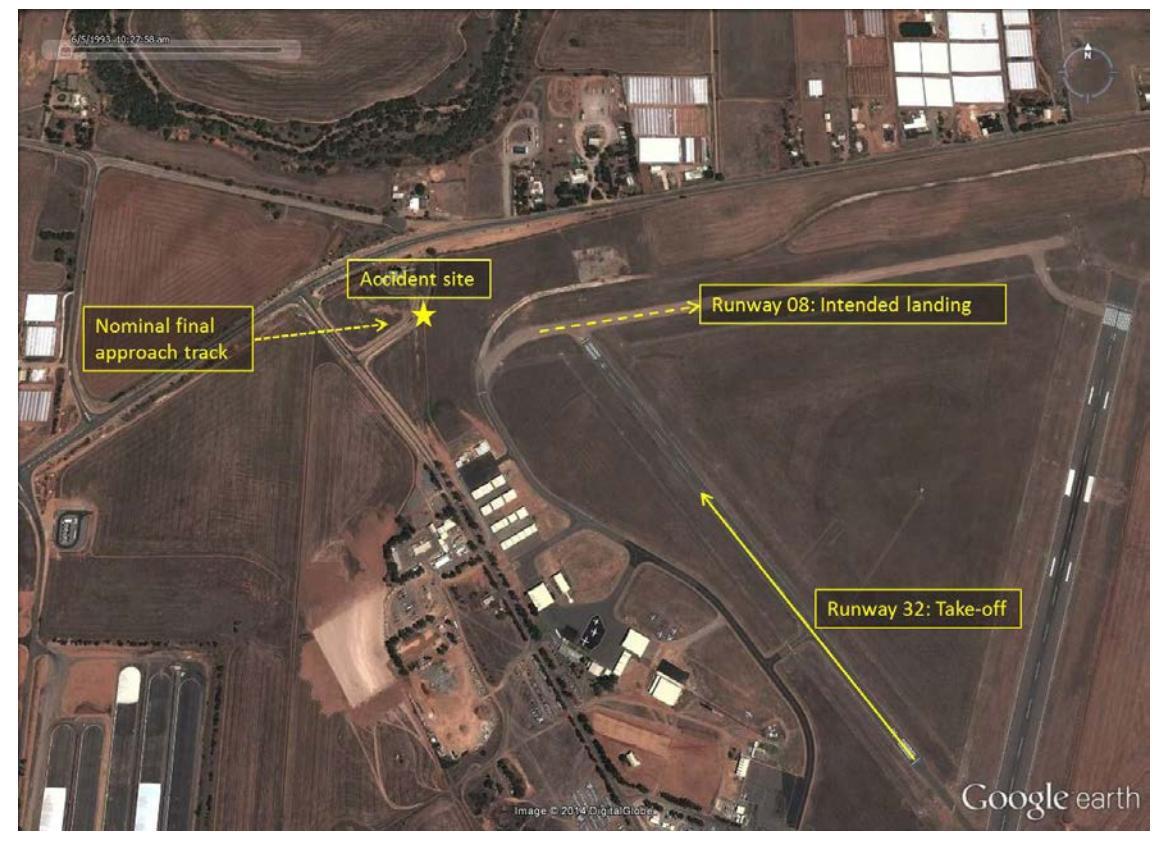
Figure 2: Geraldton Airport

The pilot appeared to be manoeuvring for a landing on runway 08 but the aircraft undershot the approach and the wheels hit a road kerb short of the airport perimeter (Figure 2). The aircraft then collided with the perimeter fence and became entangled as it overturned. Shortly after, an intense fire engulfed the aircraft.

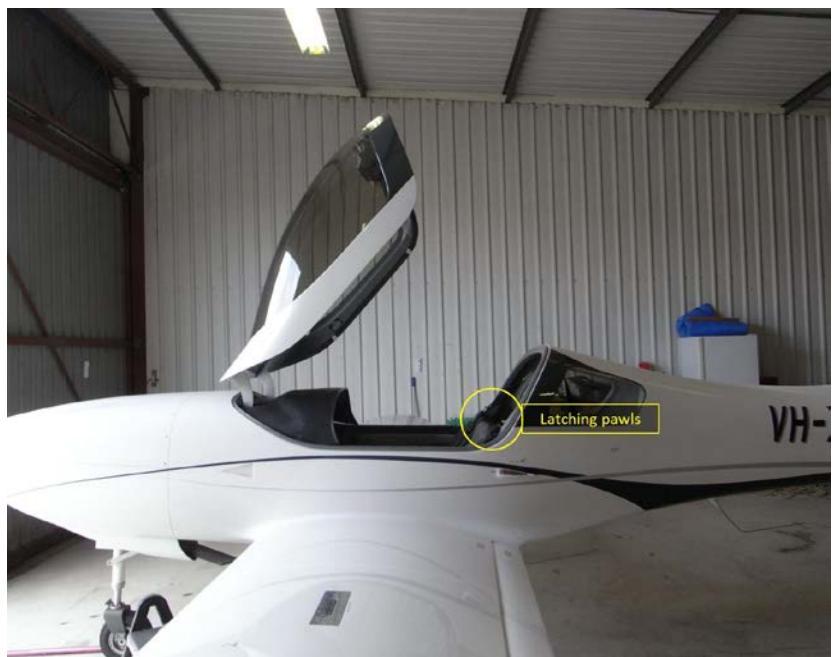
Figure 3: Exemplar Lancair Legacy with fully open canopy – latching pawls in circled area

At the front of the canopy, two hinges connected the canopy to the fuselage and allowed rotation through an arc of 50° from the down position (Figure 3). Gas struts connected to the hinges provided mechanical assistance to open the canopy but due to the geometry of the design had no effect when the canopy was down.

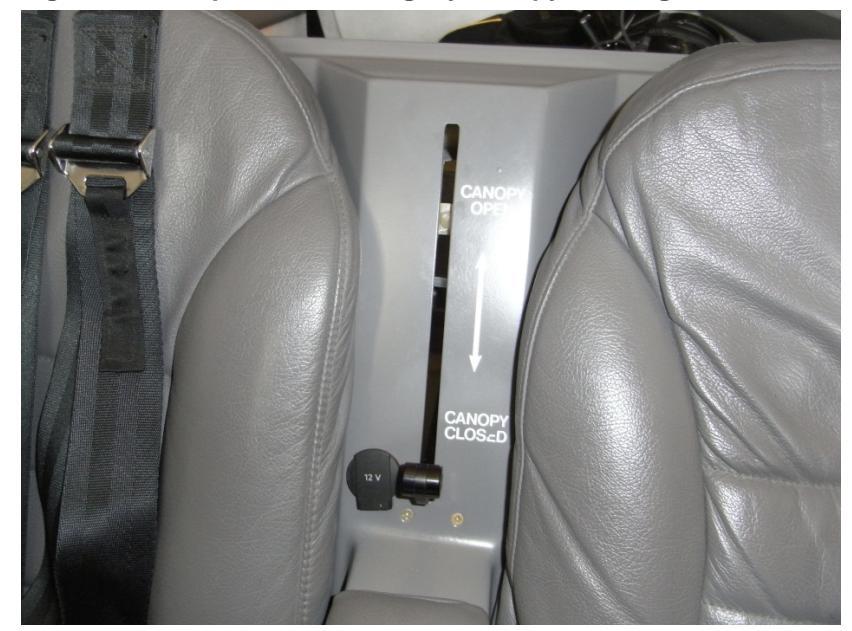
Figure 4: Exemplar Lancair Legacy canopy latching handle in closed (latched) position

With the canopy sitting in the down position, the pilot was able to mechanically latch it by operating a handle located between the seat backs (Figure 4). When the handle was in the upper OPEN position the latching pawls mounted in the fuselage were retracted. When the handle was moved to the lower CLOSED position, the mechanism extended the pawls forward to engage with the canopy frame. In that latched position, the actuating mechanism was designed to be positively over-centre and resisted any movement. This action was supplemented by a spring that provided resistance to movement of the canopy handle from the closed or open position, whichever was selected.

The ATSB examined an intact Lancair Legacy as an exemplar and found that the canopy latching mechanism of that aircraft was rigged according to the kit manufacturer's instructions. When the canopy handle was placed in the OPEN or CLOSED position it was spring-loaded to maintain the selected position. Some force was required to move the handle up from the closed position.

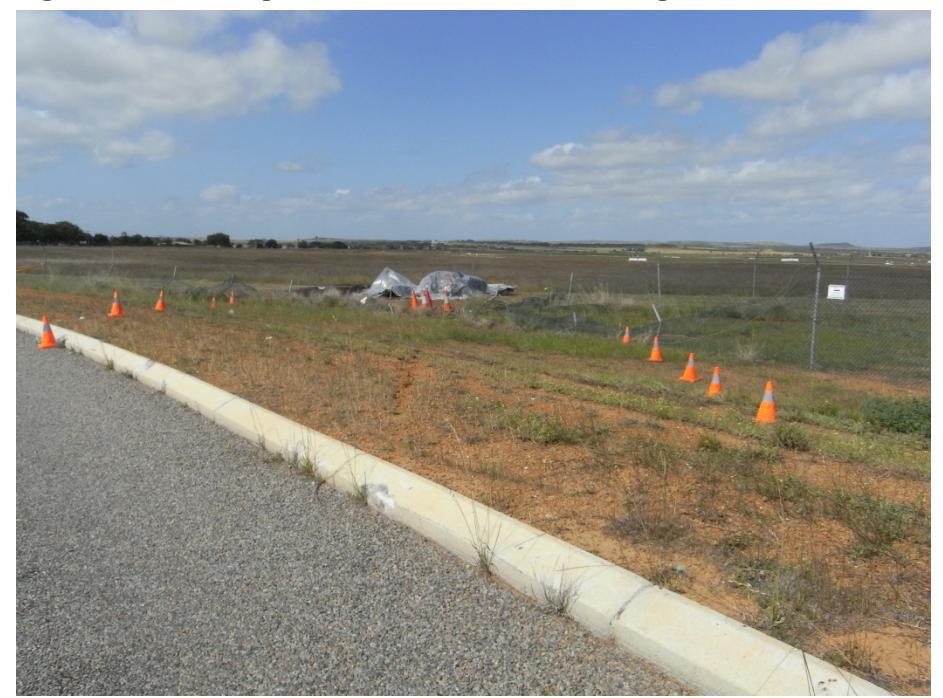
Figure 5: View along accident trail towards wreckage

The aircraft touched down across the road on an easterly heading, about 10 m outside the airport perimeter fence and 200 m from the threshold of runway 08 (Figure 5). The aircraft then collided with the perimeter fence and overturned. Fire broke out during the accident sequence and consumed most of the aircraft.

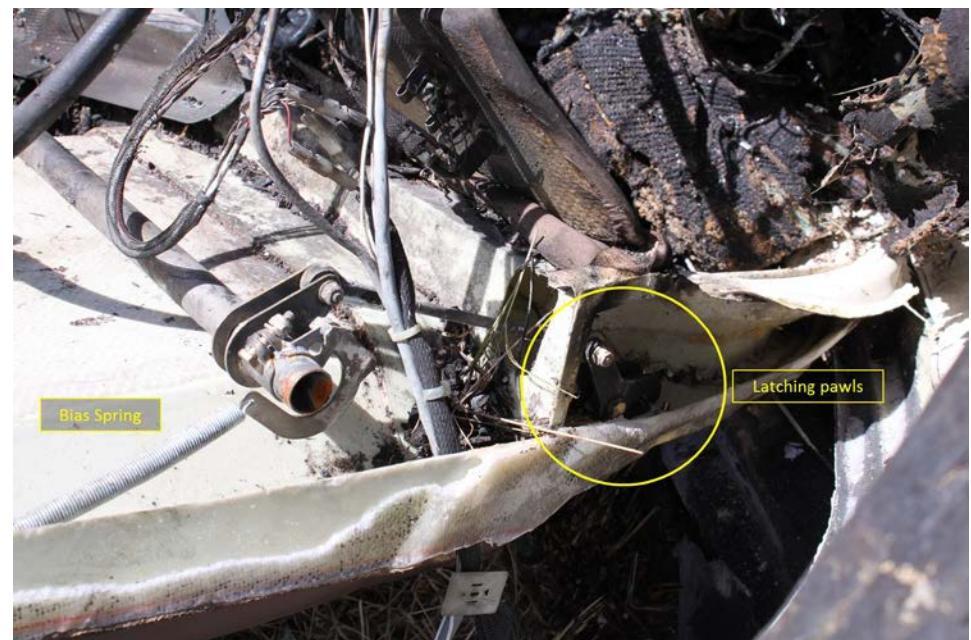
Figure 6: Canopy latching mechanism on pilot's side of aircraft, showing latching pawls and bias spring

In the fuselage behind the seats the structure had disintegrated and disrupted the arrangement of the canopy latching mechanism. That precluded the derivation of any useful information about the canopy handle position and mechanism rigging. The latching mechanism was examined and found to have all of the rods connected with bias spring still attached (Figure 6). Some of the pawls were distorted by intense heat but were otherwise complete.

The ineffective latching required for the canopy opening could have been the result of a latching mechanism malfunction (undetected by the pilot) or simply non-engagement of the mechanism. Although the latching mechanism and supporting structure was disrupted in the accident, the unbroken mechanical continuity, in-situ bias spring, and undamaged condition of the pawls (except fire-related) were evidence of pre-accident functionality.

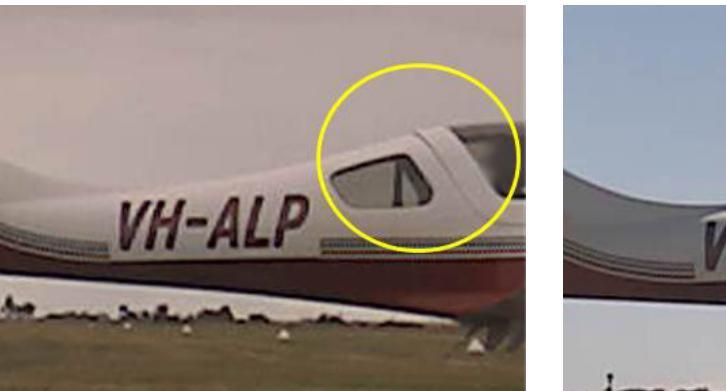
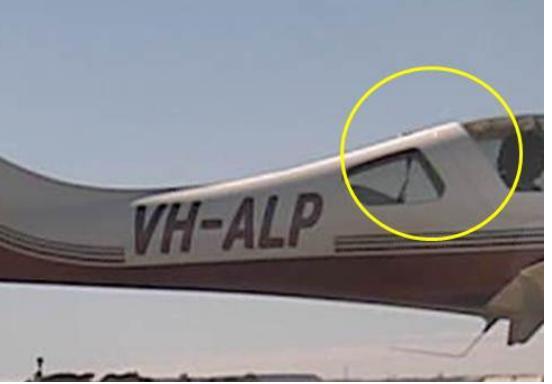
Figure 7: Contrasting canopy positions Taxiing pre-accident

If the aircraft had a functioning canopy latching system it follows that the operating handle was in the open position when the canopy opened. Based on the photos showing the aircraft taxiing before the accident and compared with a previous flight (Figure 7), the canopy was down but not latched during the taxi and in the circumstances was likely not latched before take-off. Given the unlikelihood of the pilot manipulating the canopy handle during the take-off roll, the pilot must have conducted the take-off with the canopy down but inadvertently unlatched. Then late in the take-off roll, under the influence of lift generated by the airflow as the aircraft accelerated, the canopy suddenly popped open.

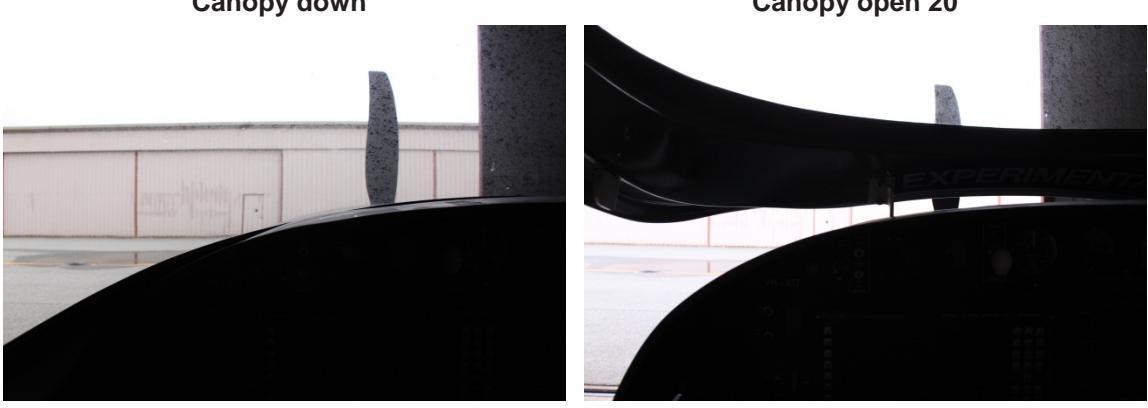
Figure 8: Exemplar Lancair Legacy – representative views from pilot's seat Canopy down Canopy open 20°

Whatever the control and performance issues, the open canopy would have been obstructing the pilot's forward visibility. The ATSB placed the canopy of the exemplar Legacy in different positions and found that the most obstructive position was the 20°-open position (Figure 8). While the exact position of the canopy during the approach could not be determined, witness accounts were

generally consistent in estimating the angle as 30°. This might have been closer to 20° given the rake on the forward part of the canopy might have created a visual illusion that over-accentuated the opening angle.
