Loss of control involving a Robinson R44, VH-YYS

near Mareeba aerodrome, Queensland, 2 March 2014

ATSB Transport Safety Report Aviation Occurrence Investigation AO-2014-038 Final – 26 May 2014 Released in accordance with section 25 of the Transport Safety Investigation Act 2003

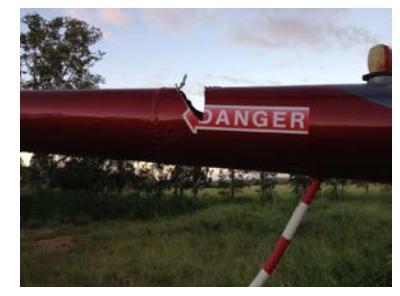
The helicopter lifted off and the pilot reported all engine indications were normal and the blades appeared to be tracking normally. During the translation from hover to forward flight, the helicopter yawed to the left. The pilot raised collective¹ and rolled the throttle on and the helicopter then spun quickly about 90 degrees to the right. The pilot heard an Damage to VH-YYS

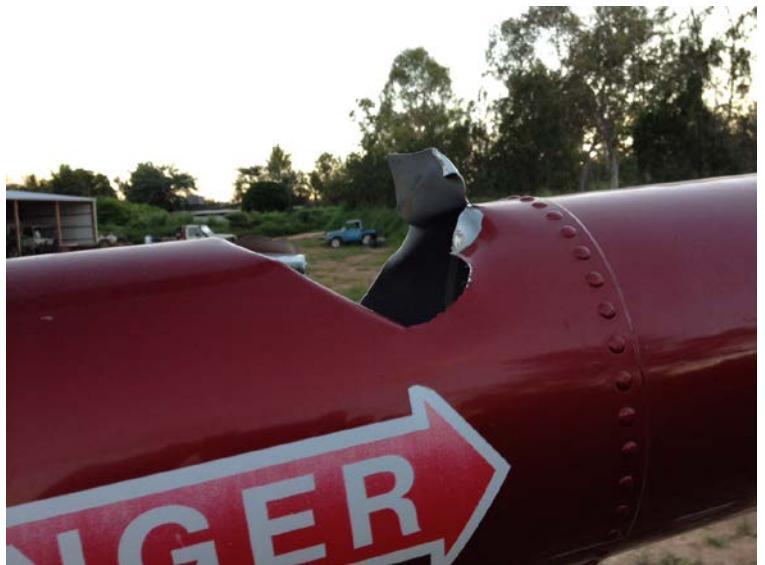
Figure 1: Damage to VH-YYS

The pilot eased the collective into the ground and as the helicopter touched down, it started to roll to the left. He moved the cyclic right, reduced the throttle and the helicopter rocked from side to side and then settled. During the event, the rotor blades contacted the tail boom resulting in substantial damage (Figure 1).

A post-accident engineering inspection did not find any defects other than those resulting from the incident.
