Loss of control involving Grob G-115, VH-BFW

Merredin Aerodrome, Western Australia, 4 February, 2014

ATSB Transport Safety Report

Aviation Short Investigation AO-2014-020 Final Released in accordance with section 25 of the Transport Safety Investigation Act 2003

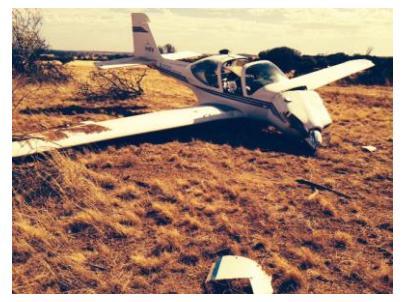
VH-BFW at accident site

The student exited the aircraft and walked to the main building. The duty platform instructor activated the crash alarm. An instructor who was flying in the circuit landed and attended the scene. He switched off the magnetos and master switch in the damaged aircraft. Staff and emergency services attended soon after. The student was not injured, but the aircraft sustained substantial damage.

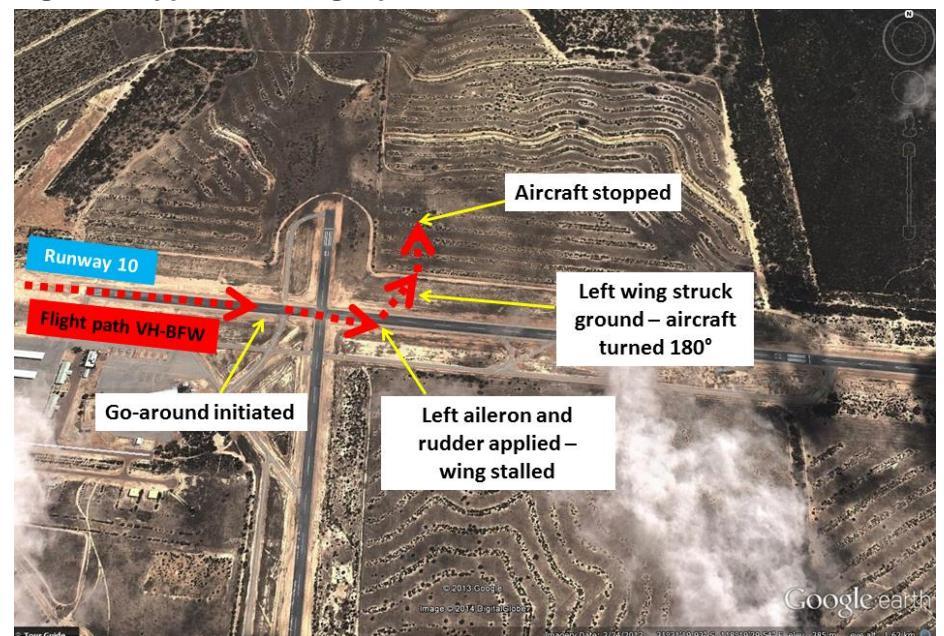
Figure 1: Approximate flight path of VH-BFW

The stall warning started to sound, the aircraft began to sink and the left wing dropped. In an attempt to arrest the sink, the student applied back pressure to the elevator control, and may have applied some aileron and rudder in an attempt to counter the wing drop. With the reduced airspeed, the crosswind moved the aircraft further to the left of the runway. With the stall warning still sounding, the left wing struck the ground and the aircraft spun around pointing south. It then bounced back into the air maintaining its high nose attitude. It struck the ground again and came to rest about 144 metres north of runway10/28 still facing south (Figure 1).
