# Operational non-compliance involving an Airbus A320, VH-VGU

Near Melbourne, Victoria, 01 January 2014

ATSB Transport Safety Report Aviation Occurrence Investigation AO-2014-003 Final – 6 August 2014 Released in accordance with section 25 of the Transport Safety Investigation Act 2003

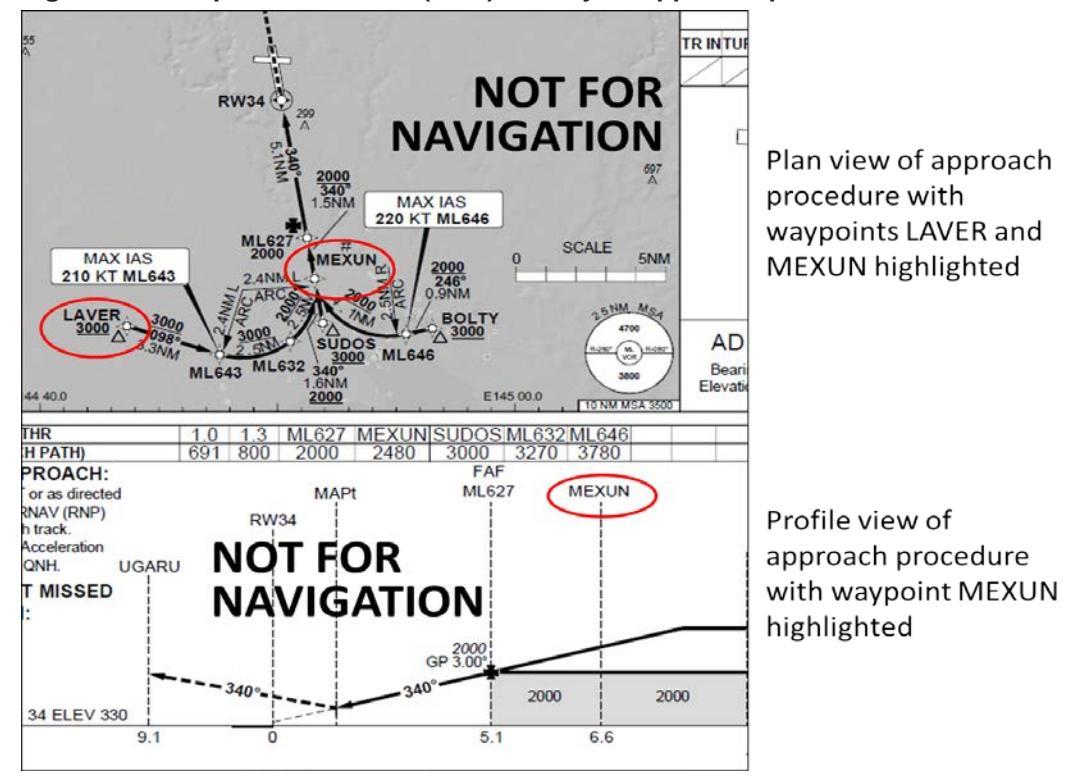
### Figure 1: Excerpt from RNAV-P (RNP) runway 34 approach procedure<sup>2</sup>

The STAR was cancelled by ATC before the aircraft reached LAVER to allow ATC to sequence VH-VGU with other aircraft arriving into Melbourne. Descent continued in a southerly direction under radar vectors. The descent was stepped to 4,000 ft, followed soon after by a speed reduction and advice that the crew could expect radar vectors to join the RNAV-P (RNP) procedure at waypoint MEXUN (Figure 1). The approach procedure identified MEXUN as the latest point at which an aircraft could join the procedure.

<sup>&</sup>lt;sup>2</sup> Figure 1 is an excerpt from the Airservices Australia RNAV – P (RNP) runway 34 approach chart. The crew involved in this incident were using a chart provided by Jeppesen, but relevant details are identical.

<sup>&</sup>lt;sup>4</sup> The approach procedure includes a table (Figure 1) that provides recommended altitudes at specific distances from the runway threshold and approach waypoints, to provide guidance with respect to a constant descent path. An aircraft flying a constant 'on profile' descent would normally pass over MEXUN at 2,480 ft as the table indicates, but that altitude does not represent a minimum safe altitude or altitude constraint.

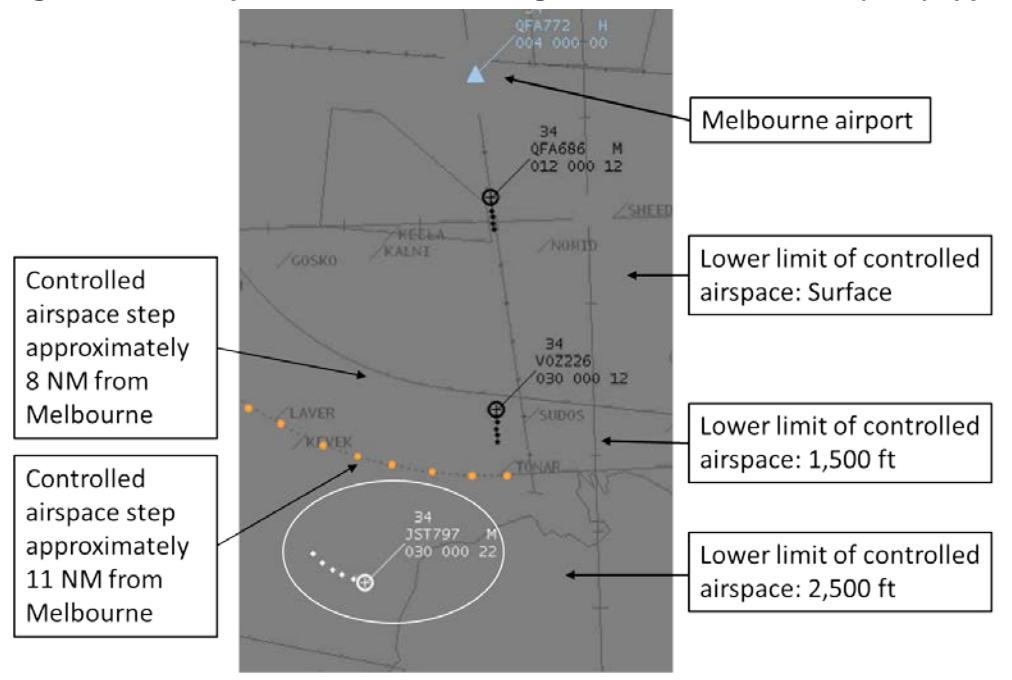
Figure 2: Aircraft position soon after being cleared for the RNAV-P (RNP) approach

The crew read back the clearance to track direct to MEXUN, which was followed almost immediately by an ATC clearance to conduct the RNAV-P (RNP) approach to runway 34. ATC did not issue further descent instructions with that clearance. The position of the aircraft at 3,000 ft, soon after being cleared for the RNAV-P (RNP) approach, is depicted on an ATC radar image at Figure 2. When cleared to track direct to MEXUN, the crew entered MEXUN as the next waypoint on the flight management guidance system (FMGS) flight plan. When cleared for the approach, the crew armed final approach mode<sup>3</sup> which engaged almost immediately.

Tracking direct to MEXUN with final approach mode engaged, the aircraft continued descent from 3,000 ft. The auto-flight system was descending the aircraft in final approach mode towards 2,000 ft which was the next altitude constraint or 'hard altitude' identified in the FMGS navigation database (corresponding to waypoint ML627 – the approach procedure final approach fix).<sup>4</sup> The crew were aware that the final approach mode had engaged and descent was continuing, but were not initially aware that continued descent would take the aircraft outside controlled airspace.

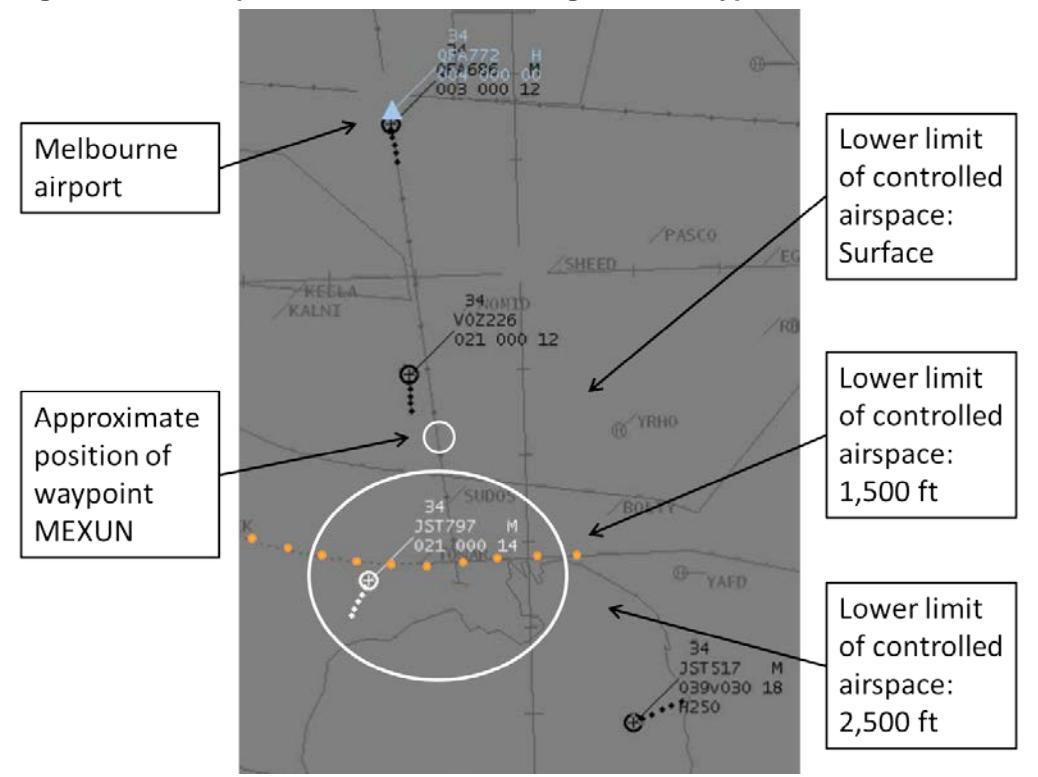
Figure 3: Aircraft position at 2,100 ft tracking toward waypoint MEXUN

Soon after, as the aircraft passed about 2,400 ft, ATC cautioned the crew to the effect that they were nearing the lowest safe altitude in their immediate area, and then updated that information as the aircraft continued toward MEXUN. Responding to the advice from ATC, the crew stopped the descent at 2,100 ft and continued towards MEXUN at that altitude. The point at which descent was stopped at 2,100 ft is depicted on an ATC radar image at Figure 3.

When the aircraft left 3,000 ft on descent, it entered the 500 ft buffer between the aircraft and the lower limit of controlled airspace,<sup>5</sup> then when it passed 2,500 ft, the aircraft left controlled airspace. Controlled airspace was re-entered as the aircraft reached the airspace with a lower limit 1,500 ft, 11 NM south of Melbourne. The elapsed time from the point the aircraft left 3,000 ft to the point it re-entered controlled airspace was about 1 minute and 15 seconds. The aircraft was outside controlled airspace for about 45 seconds. There was no conflict with other known air traffic and the approach continued normally from 2,100 ft following intercept of the intended descent profile.

In response to this incident, the aircraft operator has reminded flight crew of the importance of assessing the nature of ATC instructions before continuing descent. The operator has also reminded flight crew of the importance of maintaining airspace awareness.
