ATSB TRANSPORT SAFETY REPORT

Aviation Occurrence Investigation AO-2008-005 Final

Engine failure 15 km west of Townsville Airport, Qld 14 January 2008 VH-PSQ Cessna Aircraft Company 208

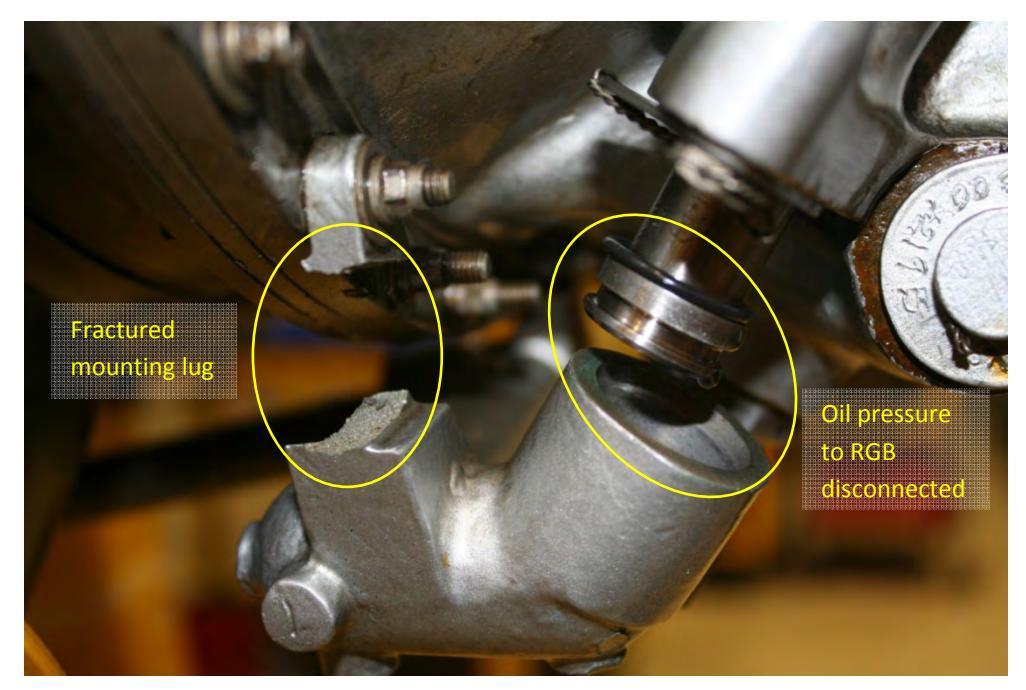
Figure 1: Fractured mounting lug and RGB oil tube disconnect

The forward oil pressure transfer elbow was fractured and separated at one of its two mounting lugs, allowing the oil tube to disconnect from its normal position (Figure 1). The fracture to the elbow showed no evidence of prior cracking or of any pre-existing defects.

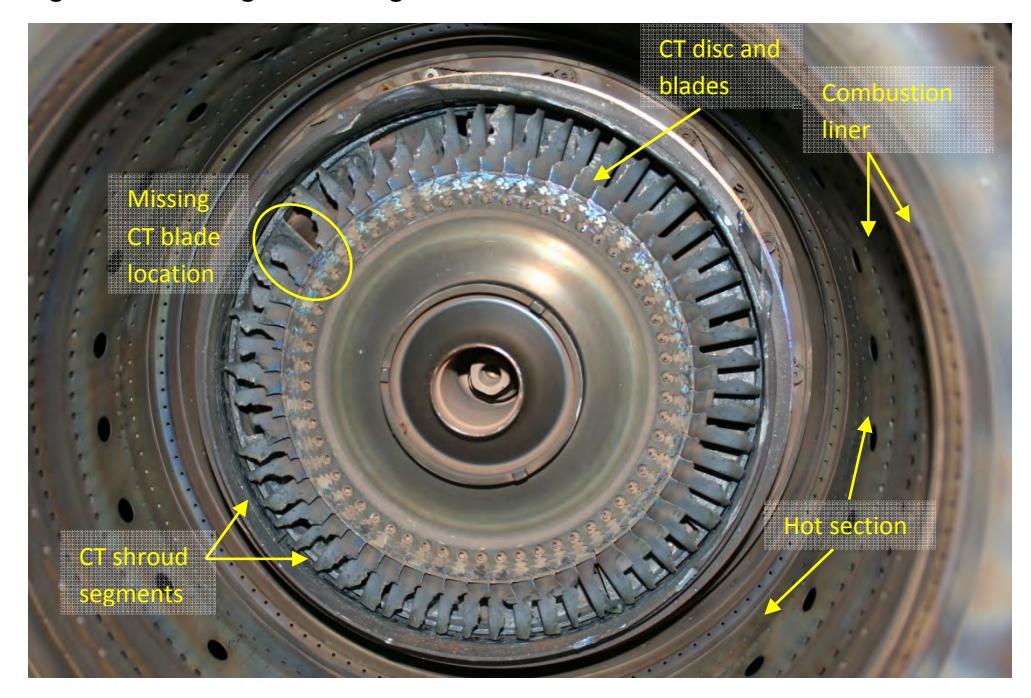
All but one of the CT blades were fractured through the outermost half of the airfoil section span (Figure 2). The nature of the fracture of those blades was consistent with hard-object impacts during the rotation of the disc. The outer circumference of the disc and rear faces of the blade roots showed heavy rotational scoring.

Figure 2: Missing and damaged CT blades and disc

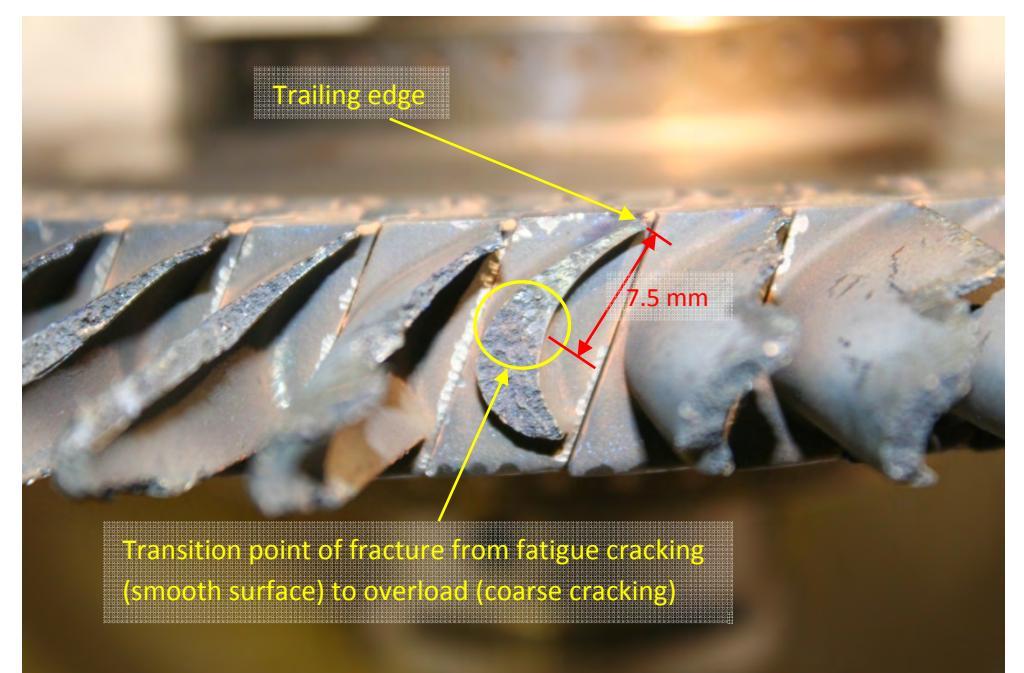
A single CT blade was fractured closer to its root than the other blades (see Appendix A, Figure 18), around 1.5 mm above the blade platform (Figure 3) and was unable to be located. The fracture surfaces for that missing blade presented evidence of fatigue cracking extending forward for around 7.5 mm from the trailing edge, before transitioning into the coarser overload fracture that was typical of the other blades in the set. Additional examination of that blade was conducted under the scanning electron microscope. That examination confirmed the presence of fatigue crack progression markings, generally extending in a trailing-edge to leading-edge direction.

Figure 3: Missing CT blade fracture surface, displaying fatigue crack transition to an overload failure

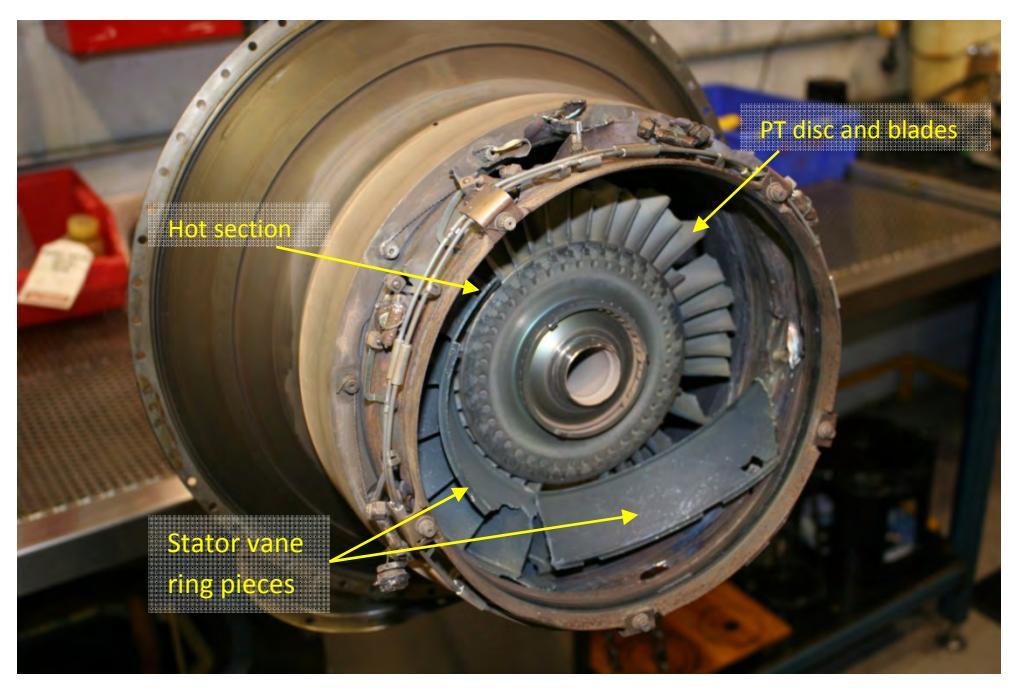
The PT stator vane ring was broken up extensively during the engine failure (Figure 5). While the fracture surfaces presented varying levels of oxidation and tinting, all such effects were moderately light and at a level consistent with having developed during the engine failure sequence.

Figure 5: Broken PT stator vane ring

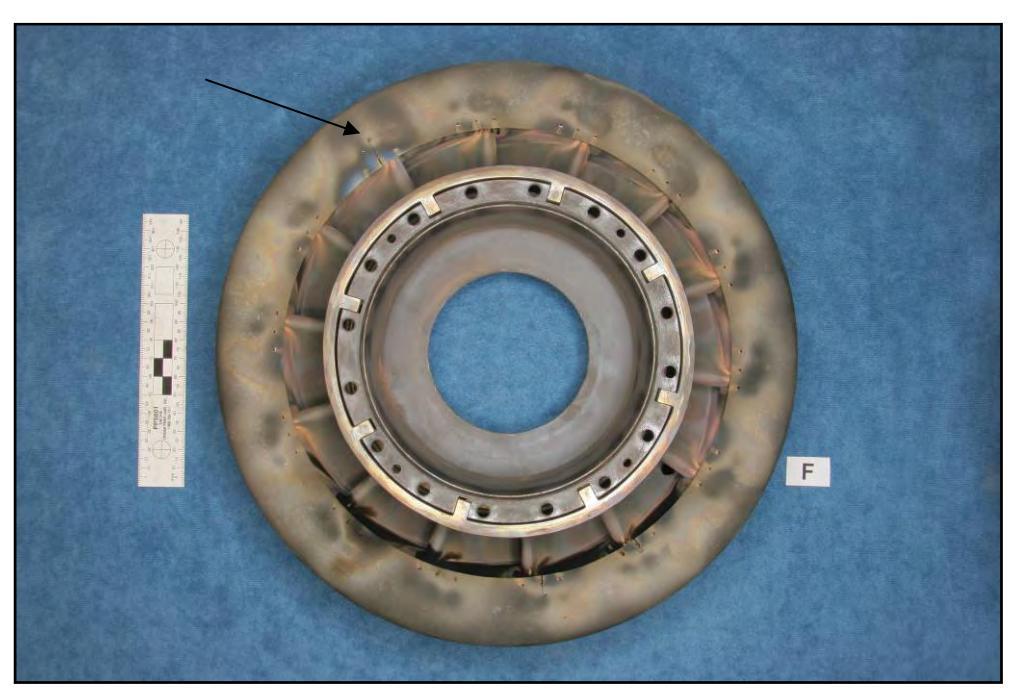
Figure 2. Small exit duct and nozzle guide vane assembly. Largest of the duct cracks arrowed

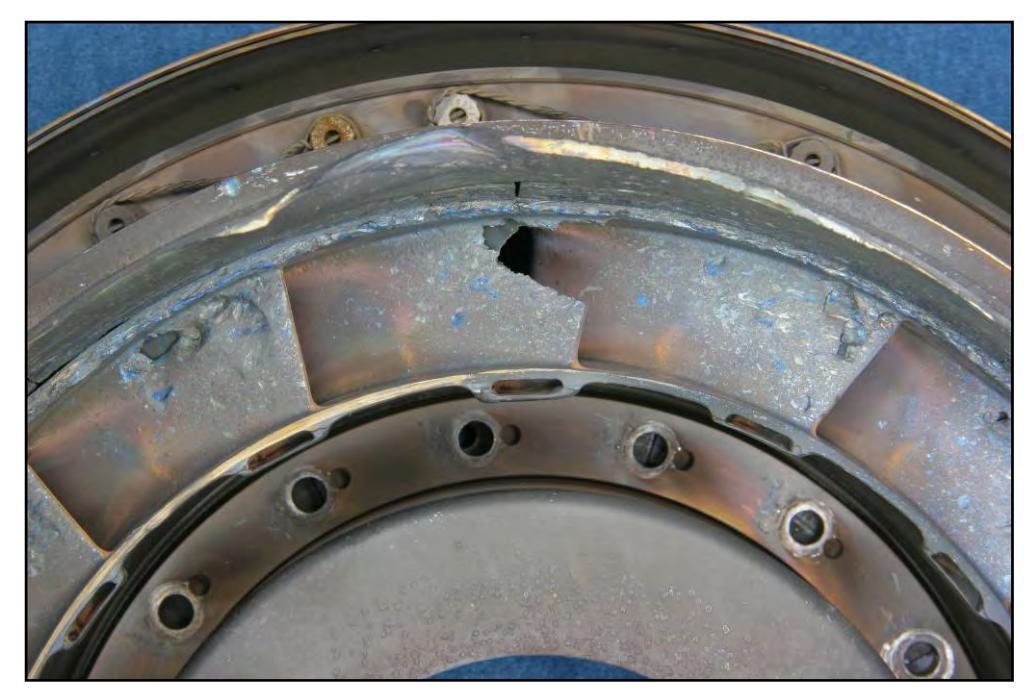
Figure 3. Impact damage to trailing edges of nozzle guide vanes

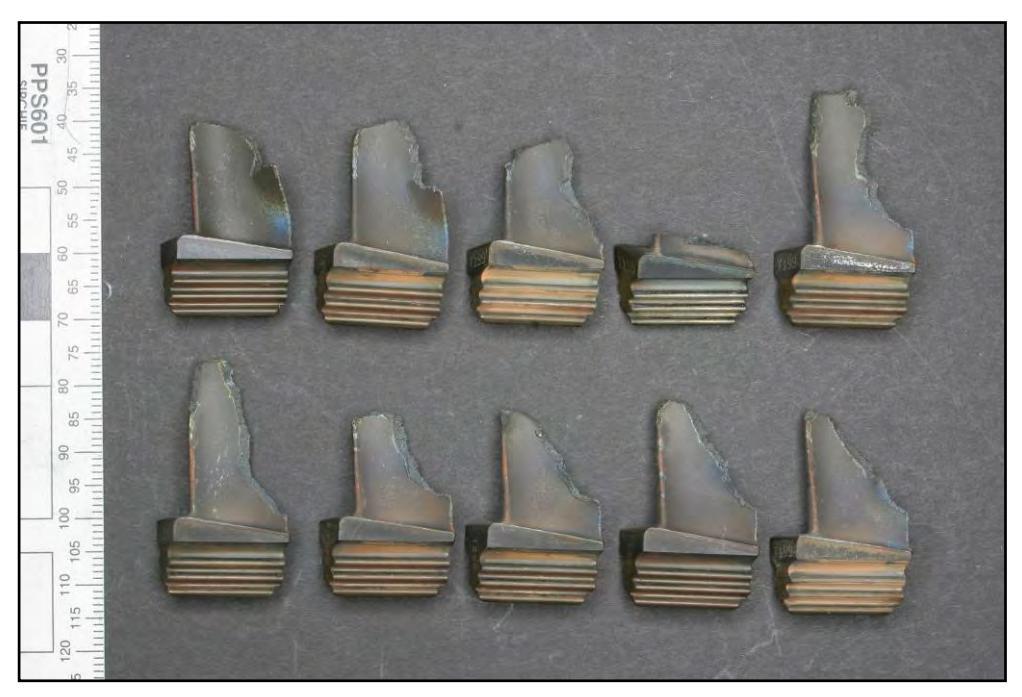
Figure 6. CT blade trailing edges and root end faces – metallisation and scoring

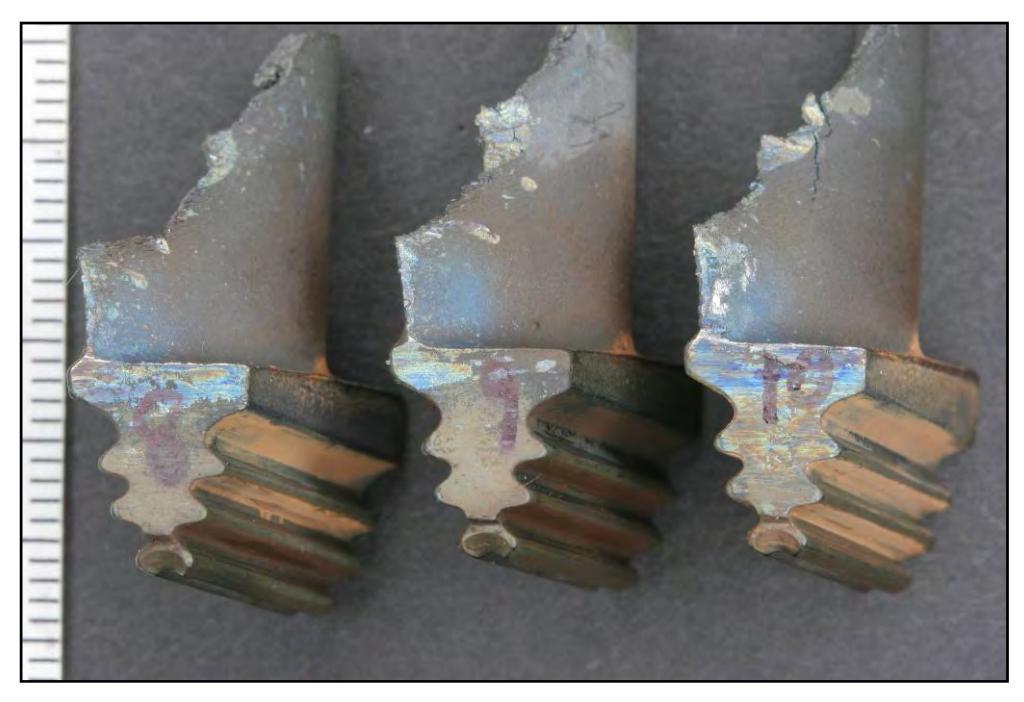
A single CT blade had fractured further toward the root than the other blades around 1.5 mm above the root transition (Figure 5). The fracture surface presented distinct mixed-mode characteristics, with a flat, comparatively smooth area extending transversely forward for around 7.5 mm from the trailing edge, before transitioning into the uneven, coarser fracture that was typical of the other blades of the set (Figure 7). The blade was retained for further metallurgical examination.

Figure 7. Anomalous CT blade fracture surface

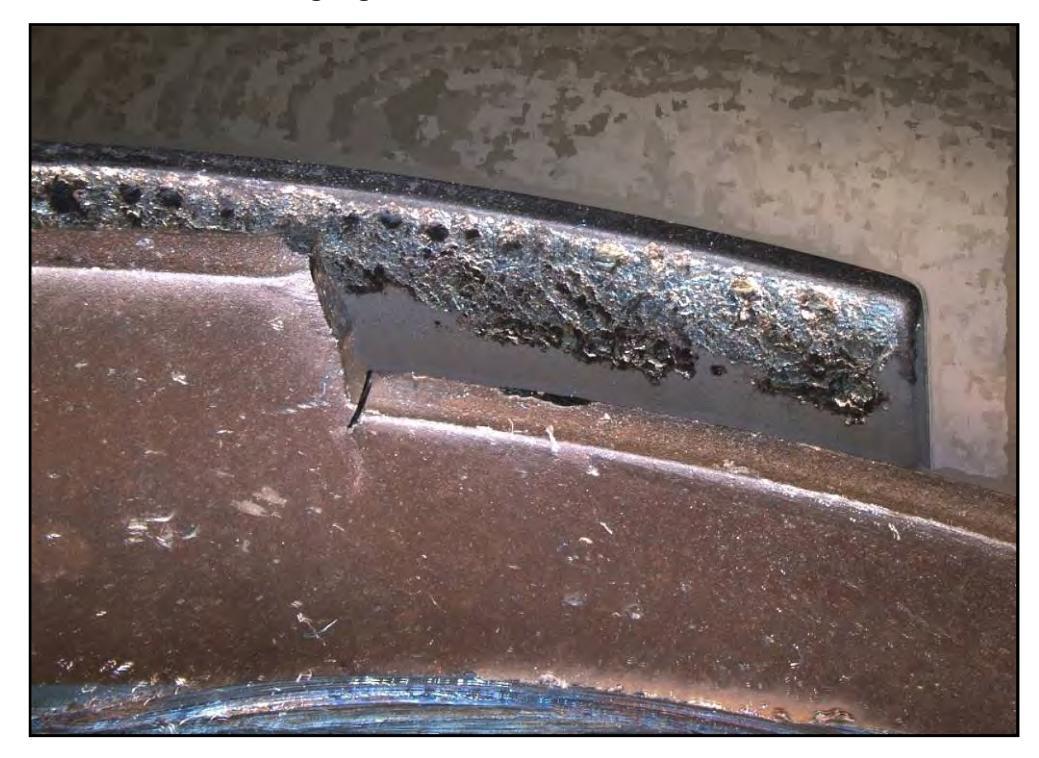
The central raised bosses on both sides of the baffle assembly showed crushing, scoring and deformation that attested to the baffle moving laterally out of position between the compressor and power turbine discs. The rivets retaining the bosses and baffle plates were all present and secure.

Figure 10. Fretting damage on baffle retaining tabs and cracking at locating lug corner

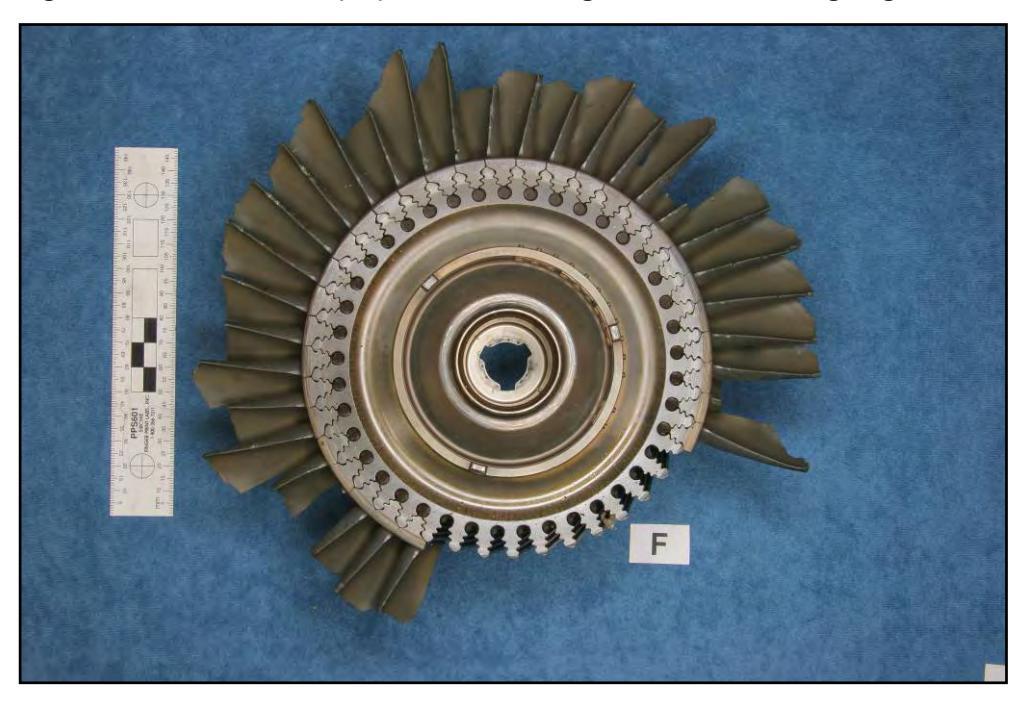
The engine power turbine (PT) disc (Figures 11, 12) carried 41 solid-section removable blades, affixed with a fir-tree arrangement as-per the CT disc. The blades had sustained a varying degree of mechanical damage – the majority having fractured transversely or diagonally backward through the outer airfoil section. Several blades however, had fractured at or near to the root transition, although the uniform dendritic fracture morphology was similar to the other blades and typical of forced fracture under conditions of impact-induced overstress (Figure 13). The trailing edges of all PT blades showed little visual evidence of service-related cracking or other progressive degradation mechanism.

Figure 11. Power turbine (PT) disc and damaged blades – leading edge view

Figure 12. PT blades with varying levels of aerofoil damage

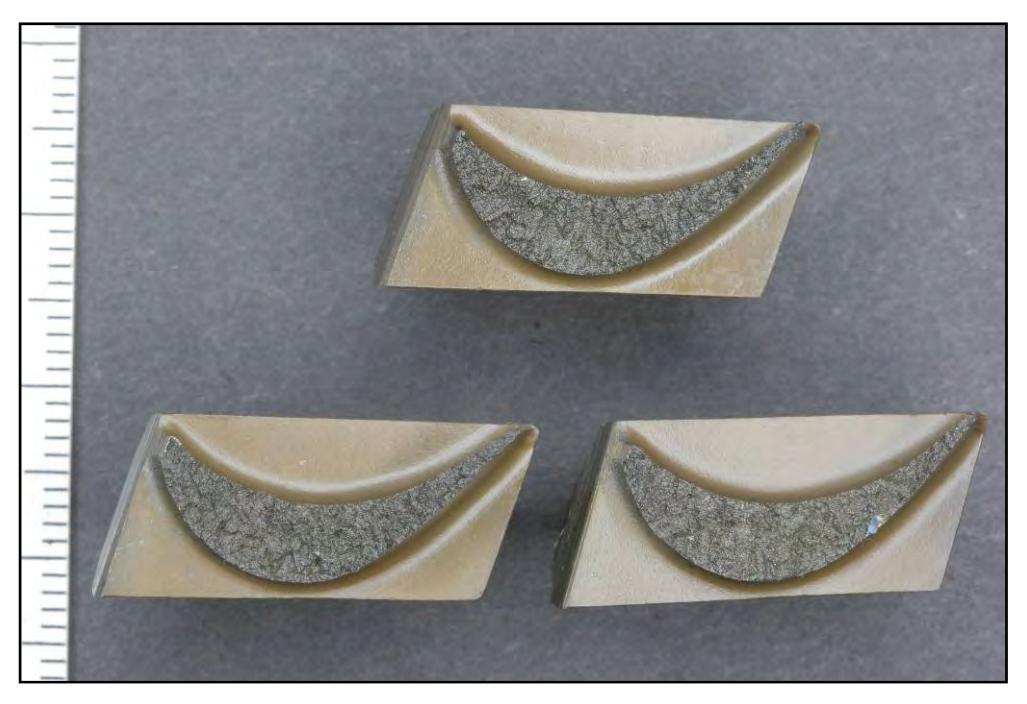
Figure 13. Typical PT blade fracture surface appearance – overstress rupture

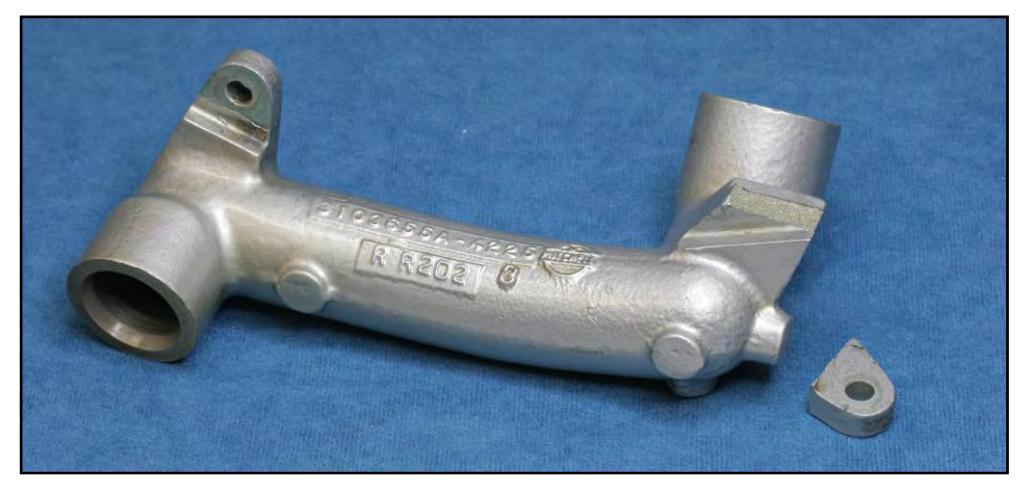
The part number 3103655 oil tube had sustained the fracture of one of the two mounting lugs that retain the tube in position (Figure 14). The fracture showed little associated ductility and had occurred through the machined change in the section associated with the transition to the tubular section. Macroscopically, the fracture showed no evidence of prior cracking or pre-existing defects (Figure 15), with microscopic scrutiny showing no features associated with fatigue cracking or other progressive, service-related failure mechanisms. Under the scanning electron microscope, the fracture morphology was typical quasi-cleavage, with small areas of ductile microvoid coalescence.

Figure 14. External oil tube lug failure.

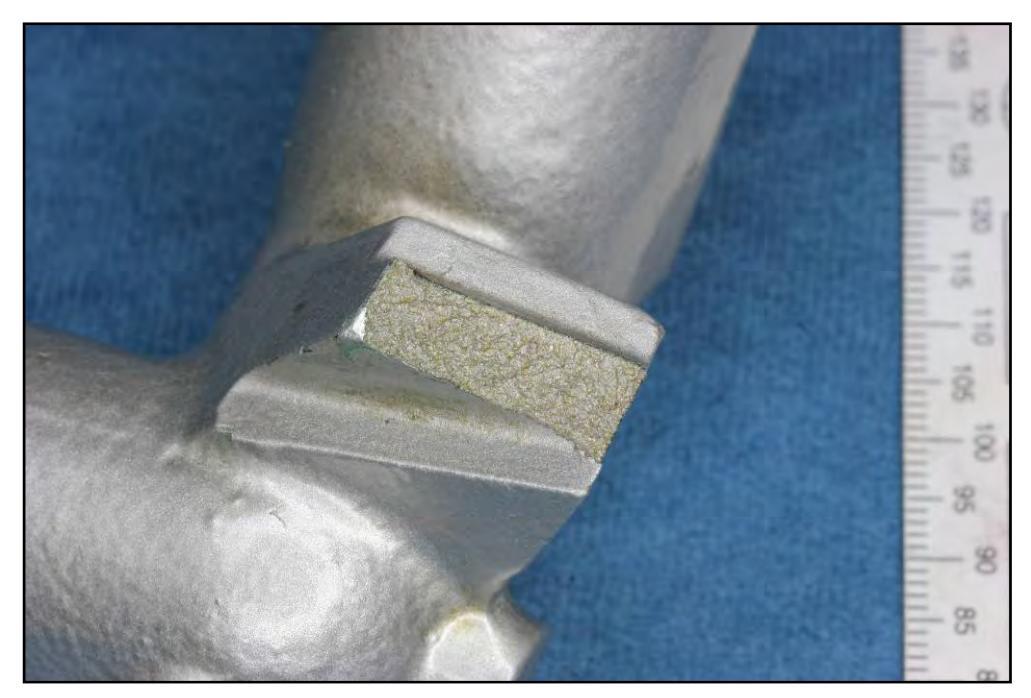
Figure 15. Lug fracture surface – typical of overstress rupture

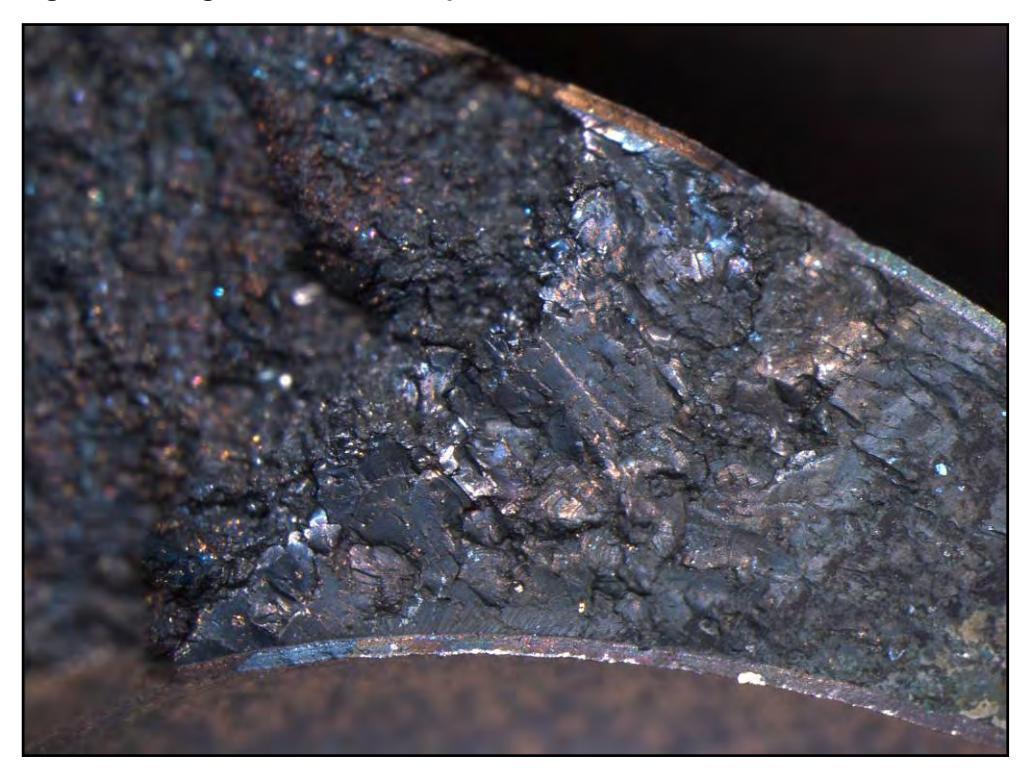
The area of comparatively flat, transverse fracture extended chord-wise for approximately 7.5 mm from the blade trailing edge and was located approximately 1.5 mm above the root platform surface. Although moderately oxidised and stained/discoloured towards the trailing edge, the central areas of the fracture presented an angular form when examined microscopically, with curved facet transitions and concentric crack progression markings (Figure 16). The transition to coarse, dendritic fracture occurred abruptly at the mid-chord position, and the remainder of the fracture to the leading edge was uniform and characteristic of overstress rupture.

Figure 16. Fatigue – overstress rupture transition – CT blade

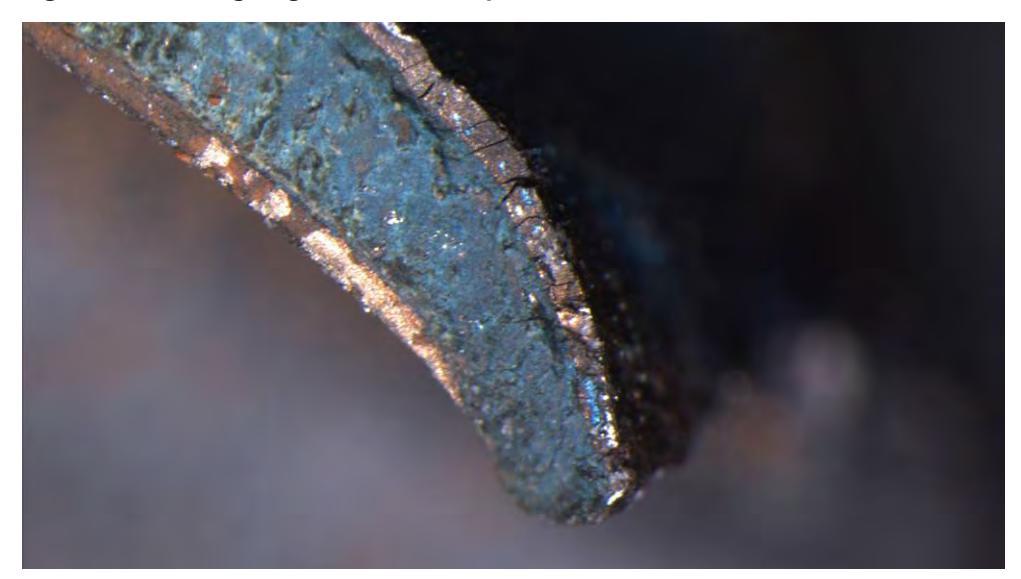
The blade fracture had exposed the blade external surface coating, which was optically measured at a thickness of 90-100 μ m adjacent to the trailing edge. The immediate trailing edge of the blade at the plane of fracture had sustained a glancing impact or contact with an adjacent component, distorting the corner against the direction of rotation and causing the local spalling and flaking of the coating (Figure 17). The brittle, low ductility of the coating was further attested by multiple coating cracks around the damaged areas.

Figure 17. Trailing edge distortion at plane of CT blade fracture

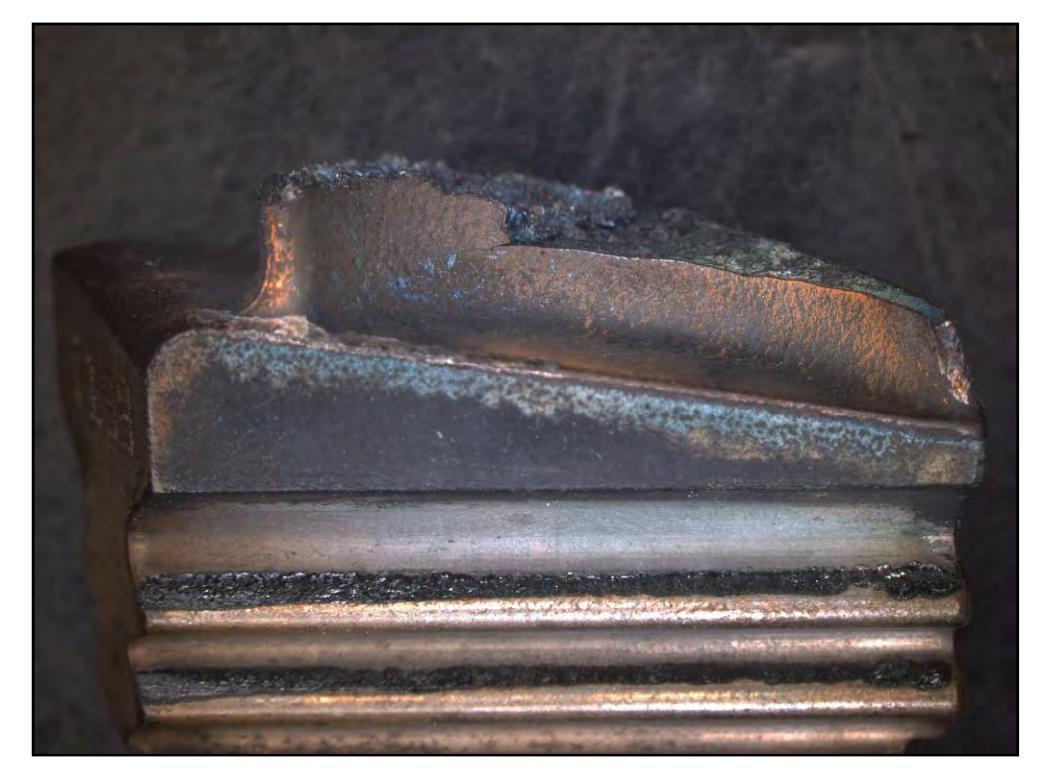
The external surfaces of the fractured and adjacent blades showed variable deposits of a light brown material that was typical of the combustion product deposits found throughout the engine hot-section (Figure 18). Under microscopic study, traces of this material were evident extending over the fractured cross-sectional surfaces of the blade coating – most notably on the concave edges. That deposit had spalled away from the coating towards the areas distorted by the trailing edge mechanical damage.

Figure 18. Light brown combustion deposits on blade surfaces

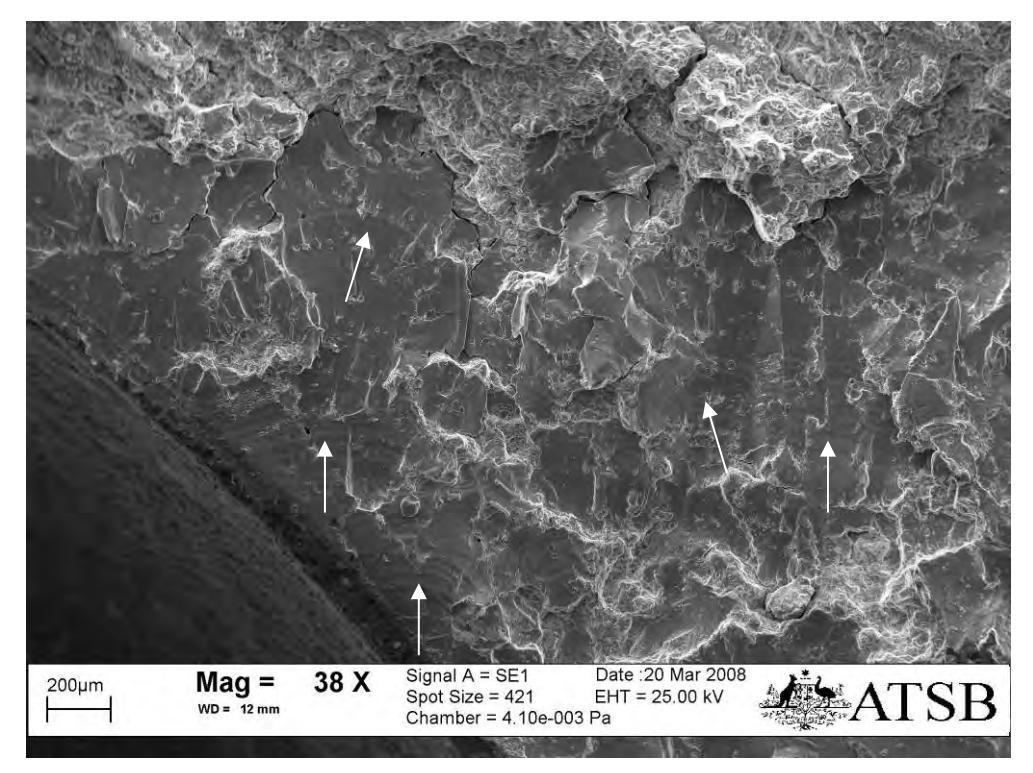
Detailed examination conducted under the scanning electron microscope (SEM) confirmed the presence of multiple planes of fatigue crack progression markings, generally radiating in a trailing-edge to leading-edge direction, or inward from the coating-substrate interface regions (Figure 19). Towards the trailing edge tip, the surfaces presented an increasing degree of adherent products and oxide, which showed angular cracking and spalling as a result of the mechanical damage sustained in that area (Figure 20). The level of oxidation of the fracture surface at the trailing edge tip precluded any meaningful assessment of the fracture morphology.

Figure 19. SEM image of fatigue – overstress transition (as shown in Fig 16). Direction of crack plane propagation shown with arrows

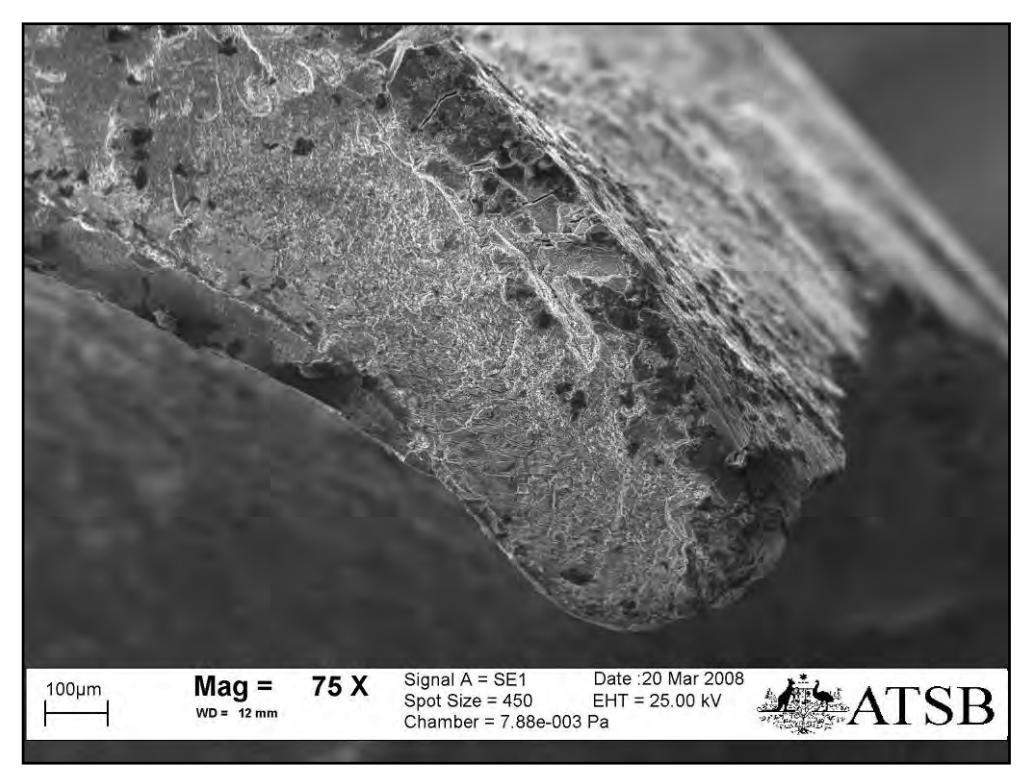
Figure 20. Oxidised fatigue origin region

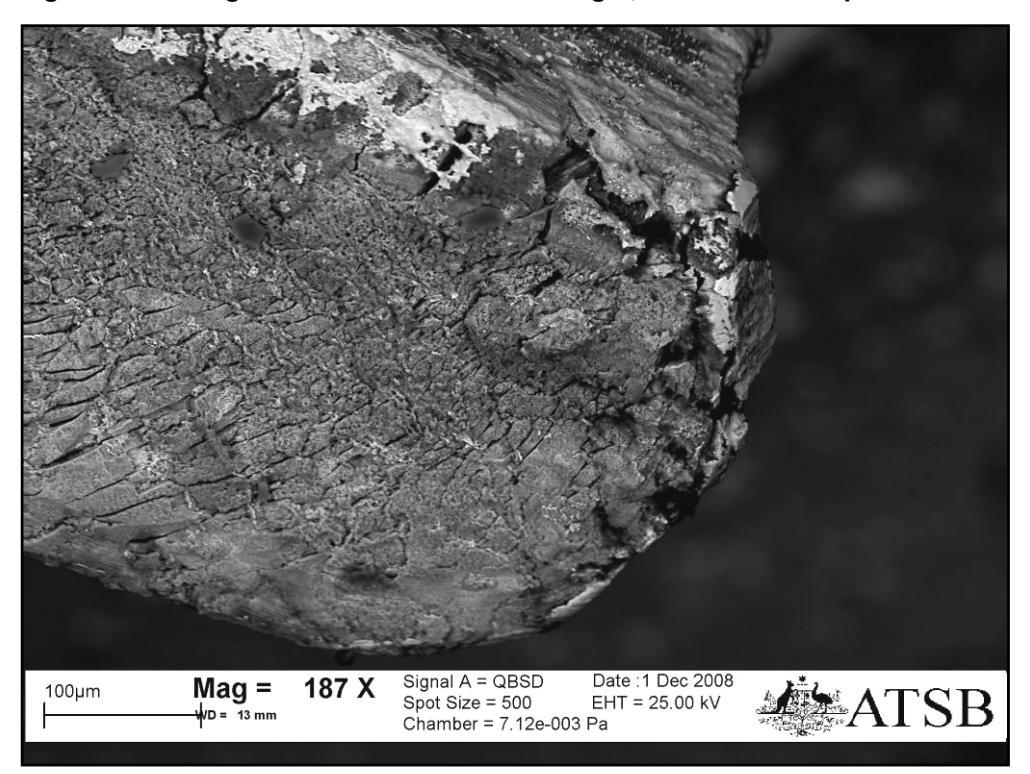
Figure 22. Damaged and oxidised fracture origin, with metallic deposits.

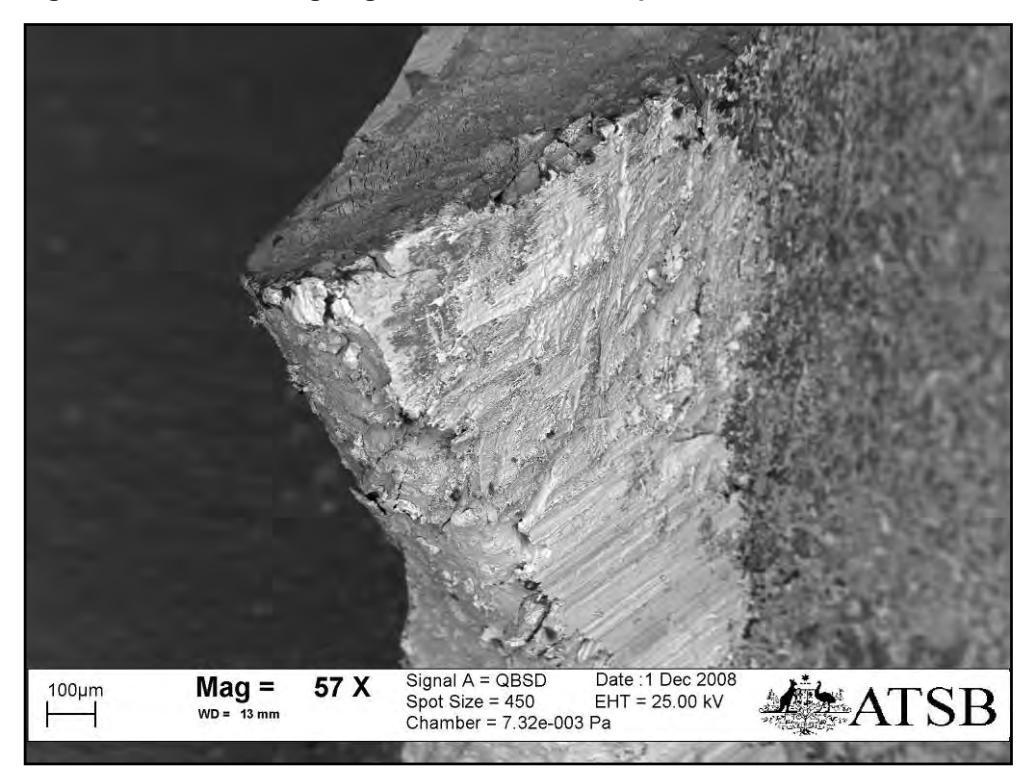
Under back-scattered electron imaging (BSE), characteristic compositional differences across the examined surfaces were evident through the atomic-number based contrast inherent to this imaging mode. The oxidation / deposits across the fracture plane were clearly evident, as was the splattering of previously molten metallic material across the fracture and blade aerofoil surfaces (Figure 22). At low magnifications, imaging of the blade trailing edge and root showed evidence of the rotational contact that produced the metallisation effects (Figure 23).

Figure 23. Blade trailing edge contact & metal deposition

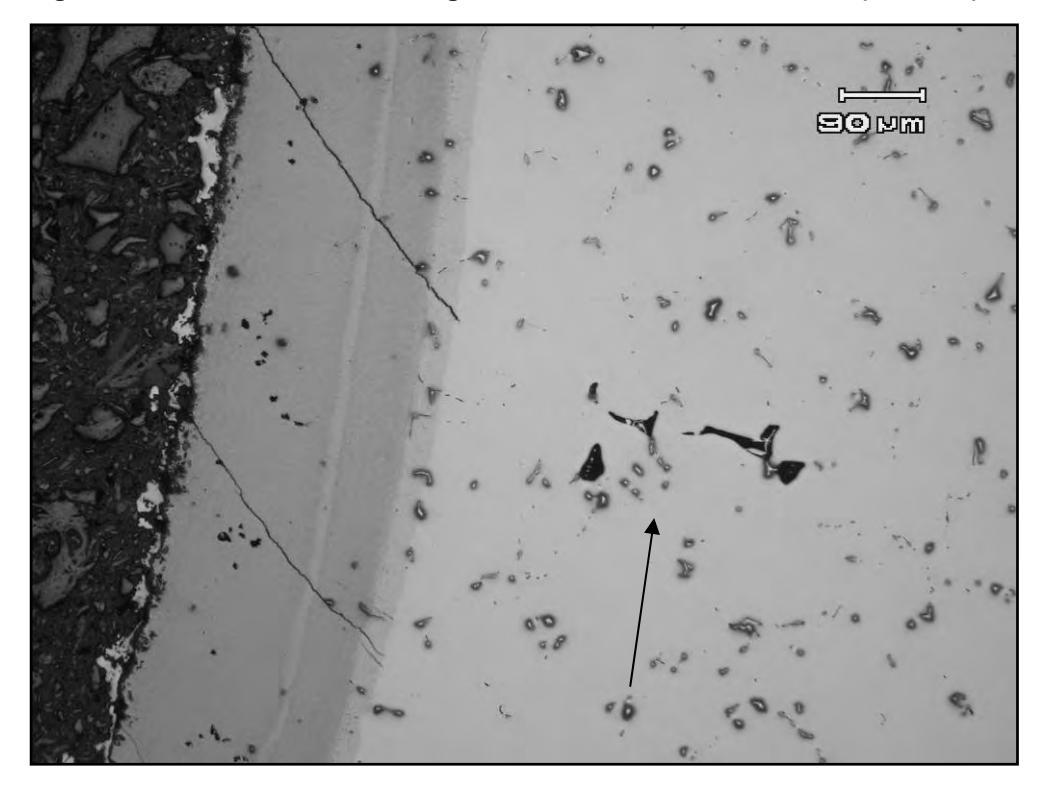
Figure 25. Isolated micro-shrinkage void within blade TE material (arrowed)

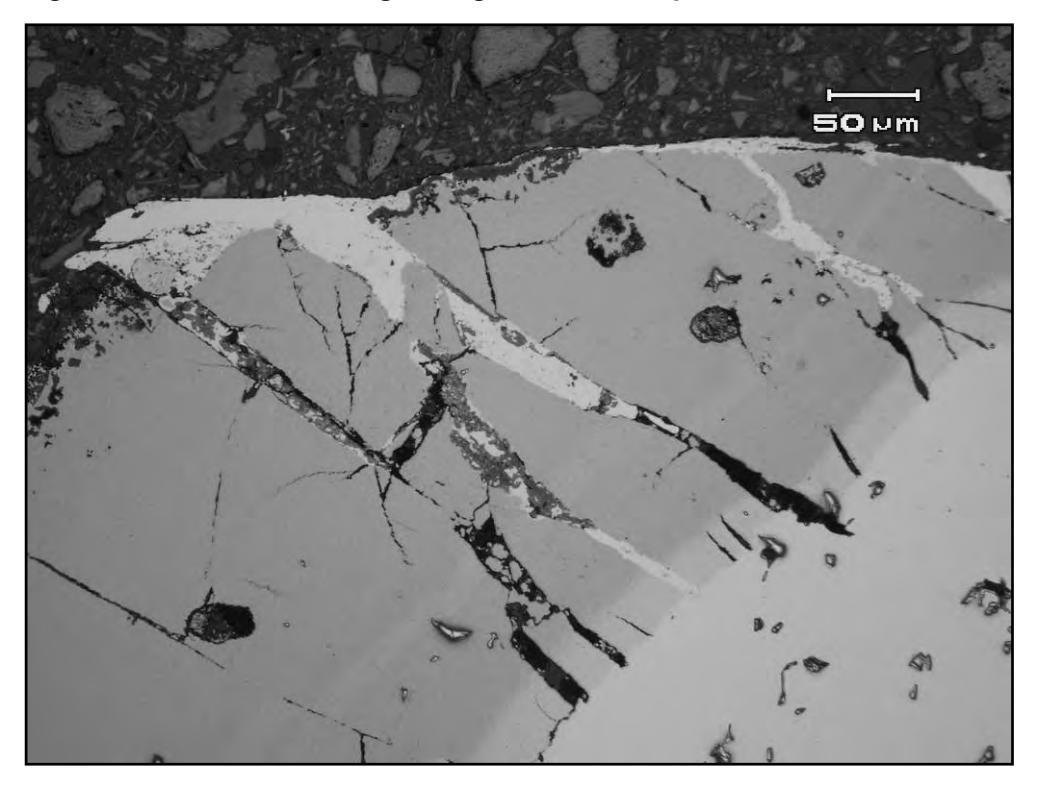
Figure 26. TE surface coating damage and metal deposition within cracks

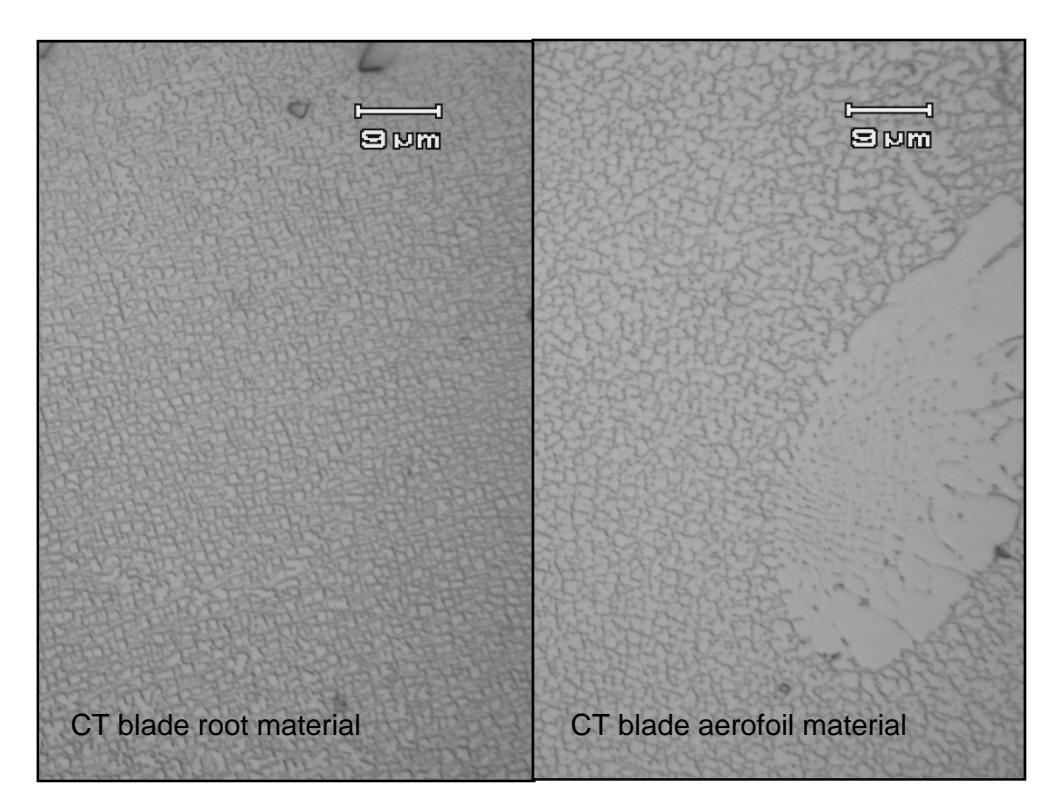
Figure 28. Comparison of the level of γ ` spheroidisation between the CT blade root and aerofoil material

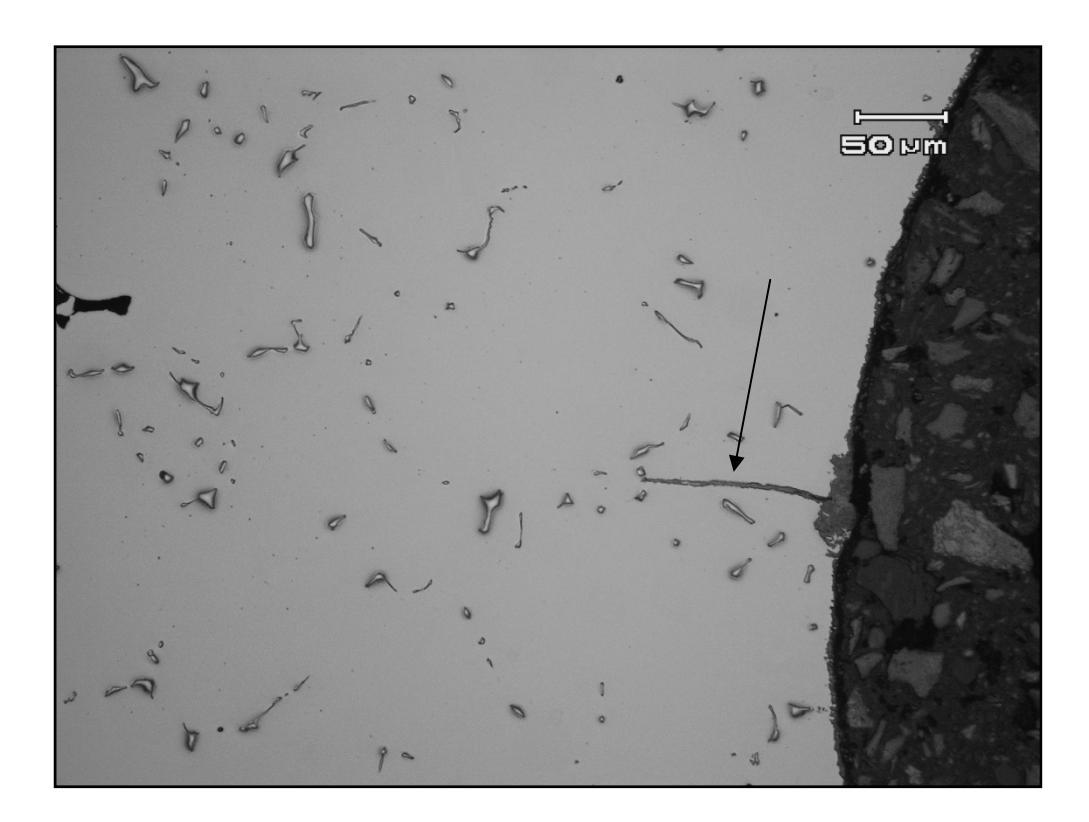
A shallow, transgranular and oxide-filled crack (Figure 29) was noted within the first fir-tree waist of the blade root – the crack extended to a maximum 100 μ m depth and was associated with a localised area of increased oxidation at its origin.

Figure 29. Shallow crack within blade root fir-tree (arrowed)
