ATSB TRANSPORT SAFETY INVESTIGATION REPORT

Aviation Occurrence Investigation – AO-2008-007 Interim Factual

# Hard landing – Darwin Airport, NT 7 February 2008 VH-NXE Boeing Company 717 - 200

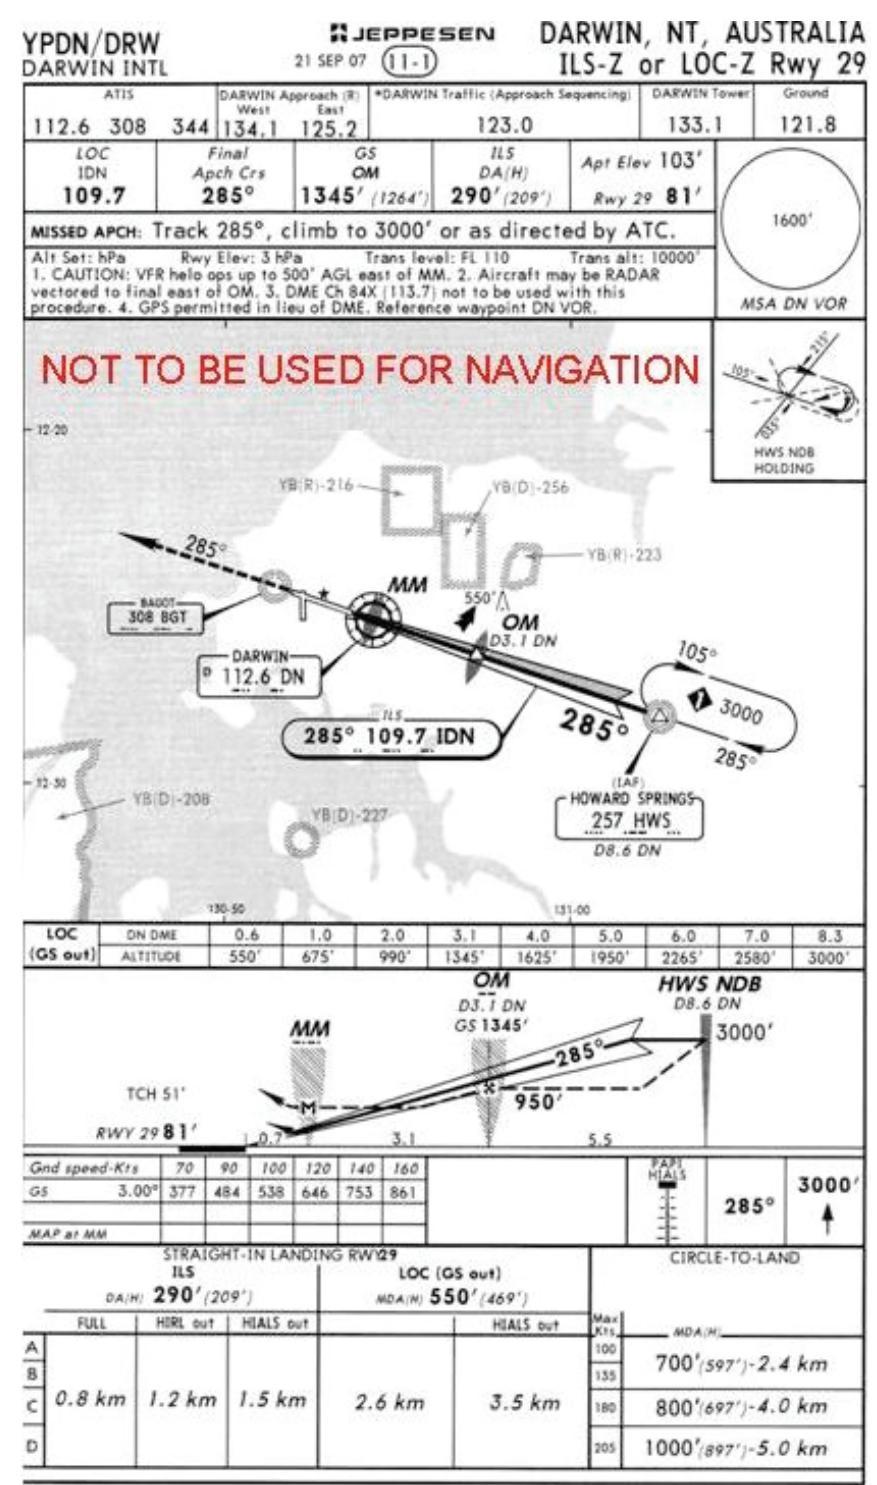
Figure 1: Darwin Runway 29 ILS approach chart

The profile diagram on the Jeppesen Darwin ILS-Z or LOC-Z Rwy 29 chart dated 21 SEP 07 (Figure 1) identifies an incorrect level segment after passing Howard Springs Non-Directional Beacon (NDB).

The 27 JUN 08 revision will show the descent starting at Howard Springs NDB.

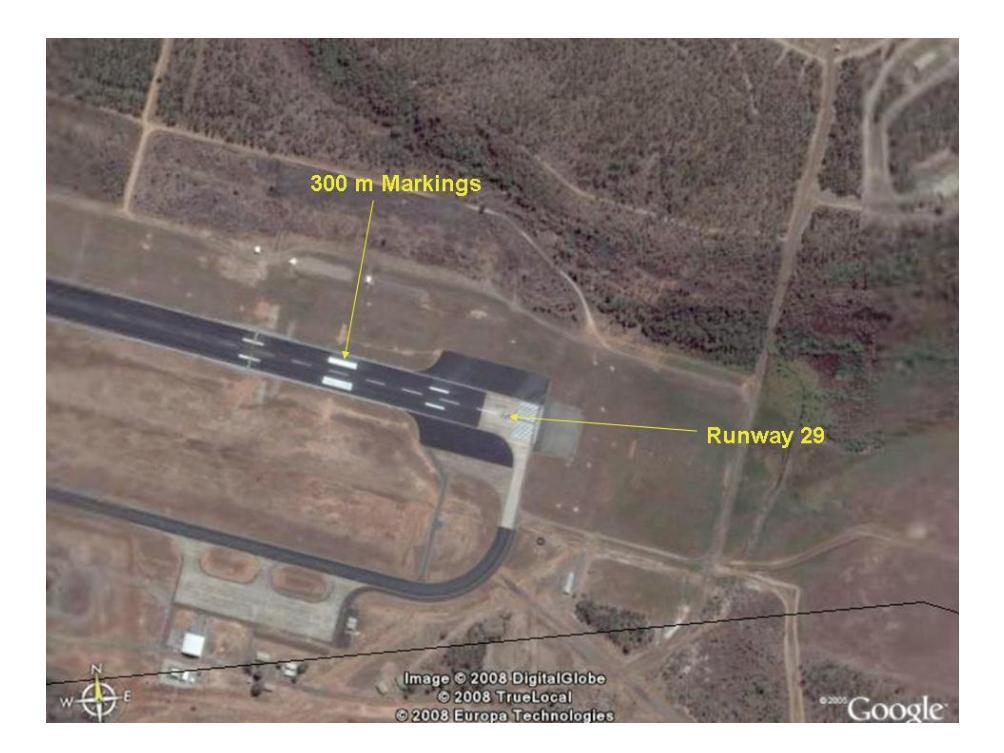
# Figure 2: Darwin Runway 29 touchdown markings and environs

At 2114:51, the aircraft landed heavily on the left main landing gear prior to the 300 m runway markings (Figure 2), to the left of the runway centreline, and with a rate of descent of about 900 FPM (Appendix A).

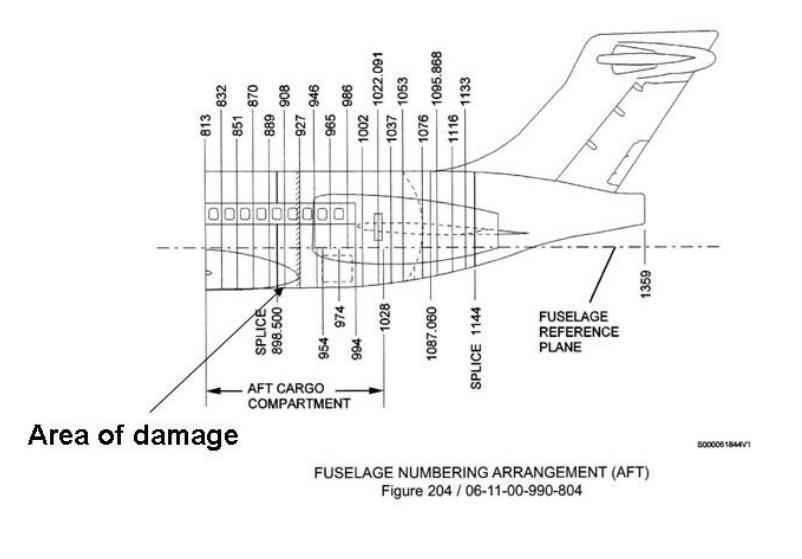
### Figure 3: Aircraft dimensions showing area of damage

Damage to the aircraft included several creases to the skin on the fuselage above the wing area and underneath the fuselage behind the wing (Figures 3 and 4). Several longerons<sup>7</sup> in the rear cargo area were damaged. The left main landing gear and the outer left main tyre were also damaged.

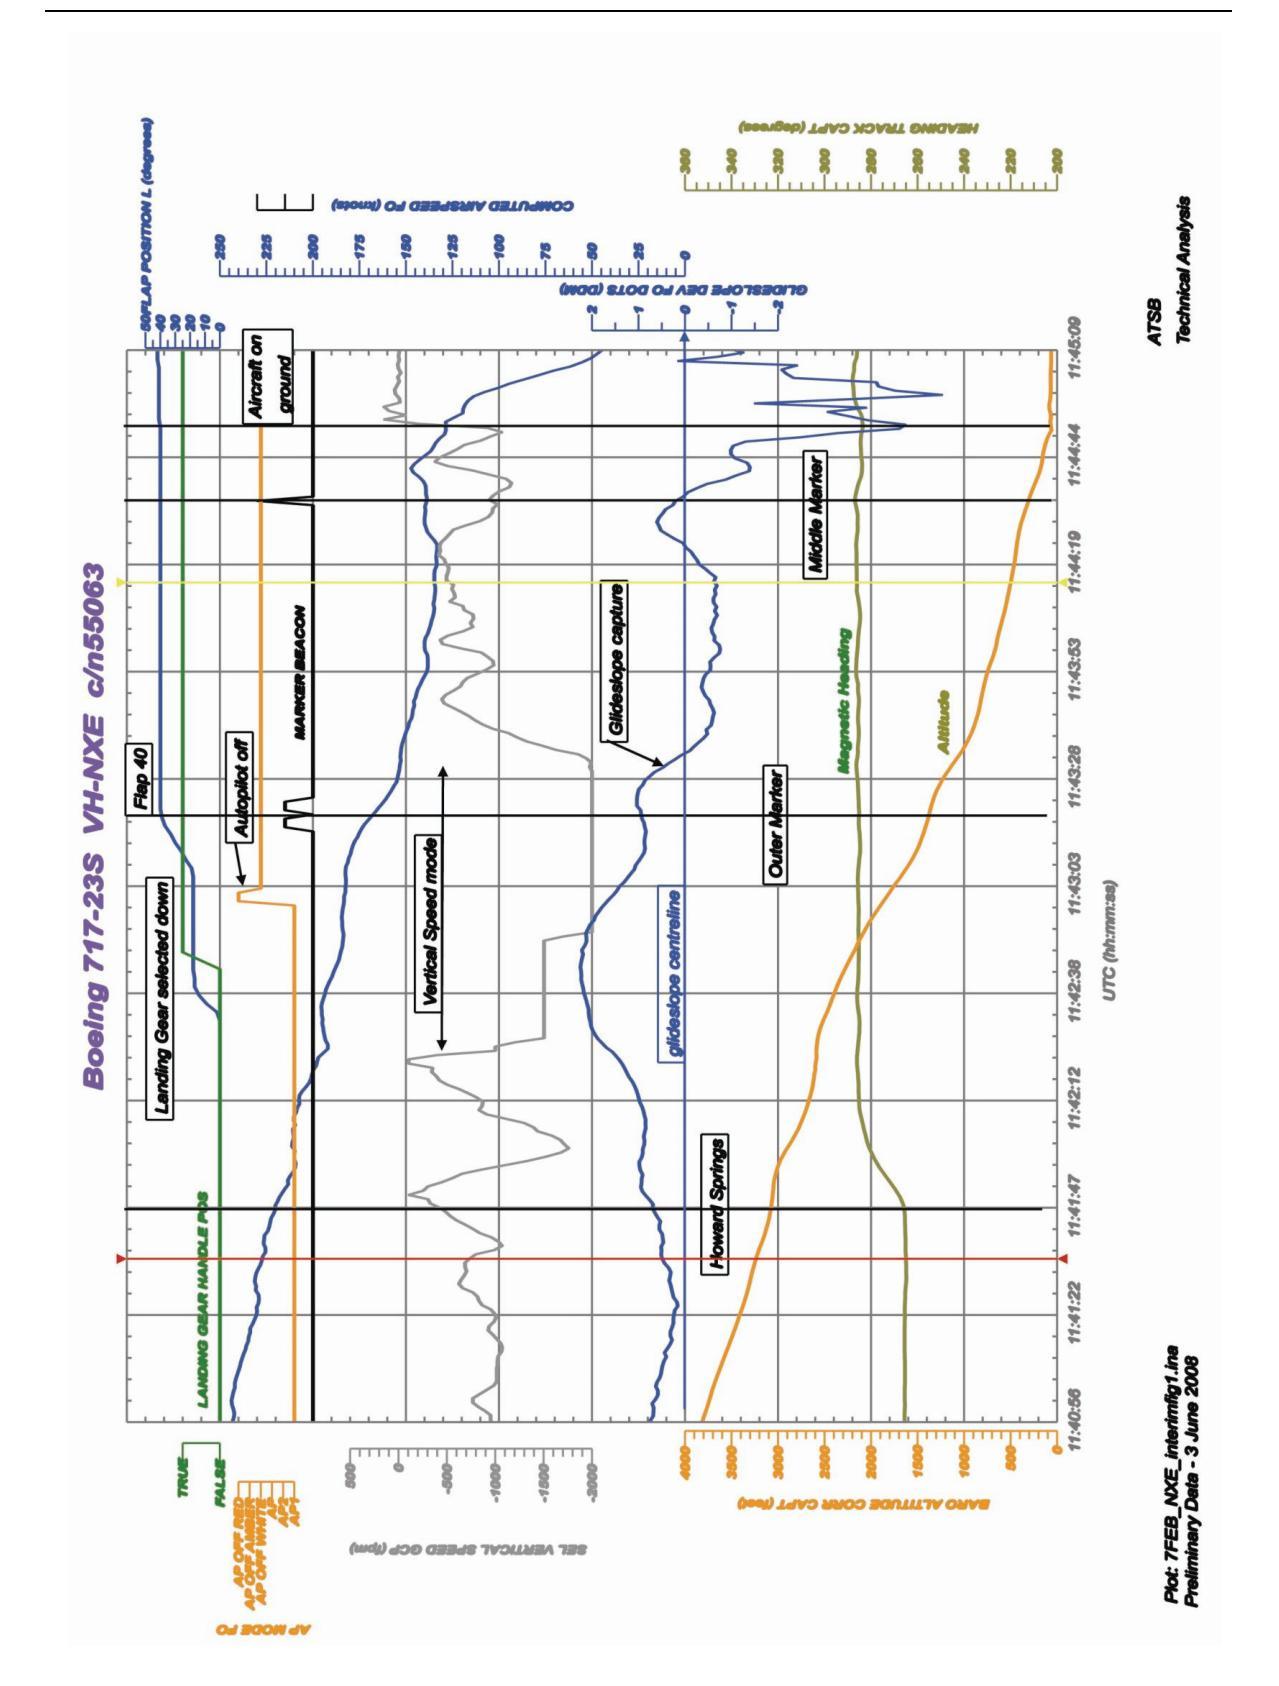
# **APPENDIX A: FLIGHT RECORDER DATA - APPROACH**

Information from the aircraft's flight data recorder (FDR) indicated that the aircraft flew over the Howard Springs NDB at about 3,000 ft above mean sea level (AMSL), with a computed air speed of 220 knots at 2111:47 Central Standard Time<sup>2</sup> (Appendix A).

The copilot disconnected the autopilot at 2113:00 when the aircraft was at 1,861 ft AMSL, with a descent rate of 2,000 feet per minute (FPM), and from where the remainder of the approach was flown manually by reference to the ILS and visual reference with the runway lighting.

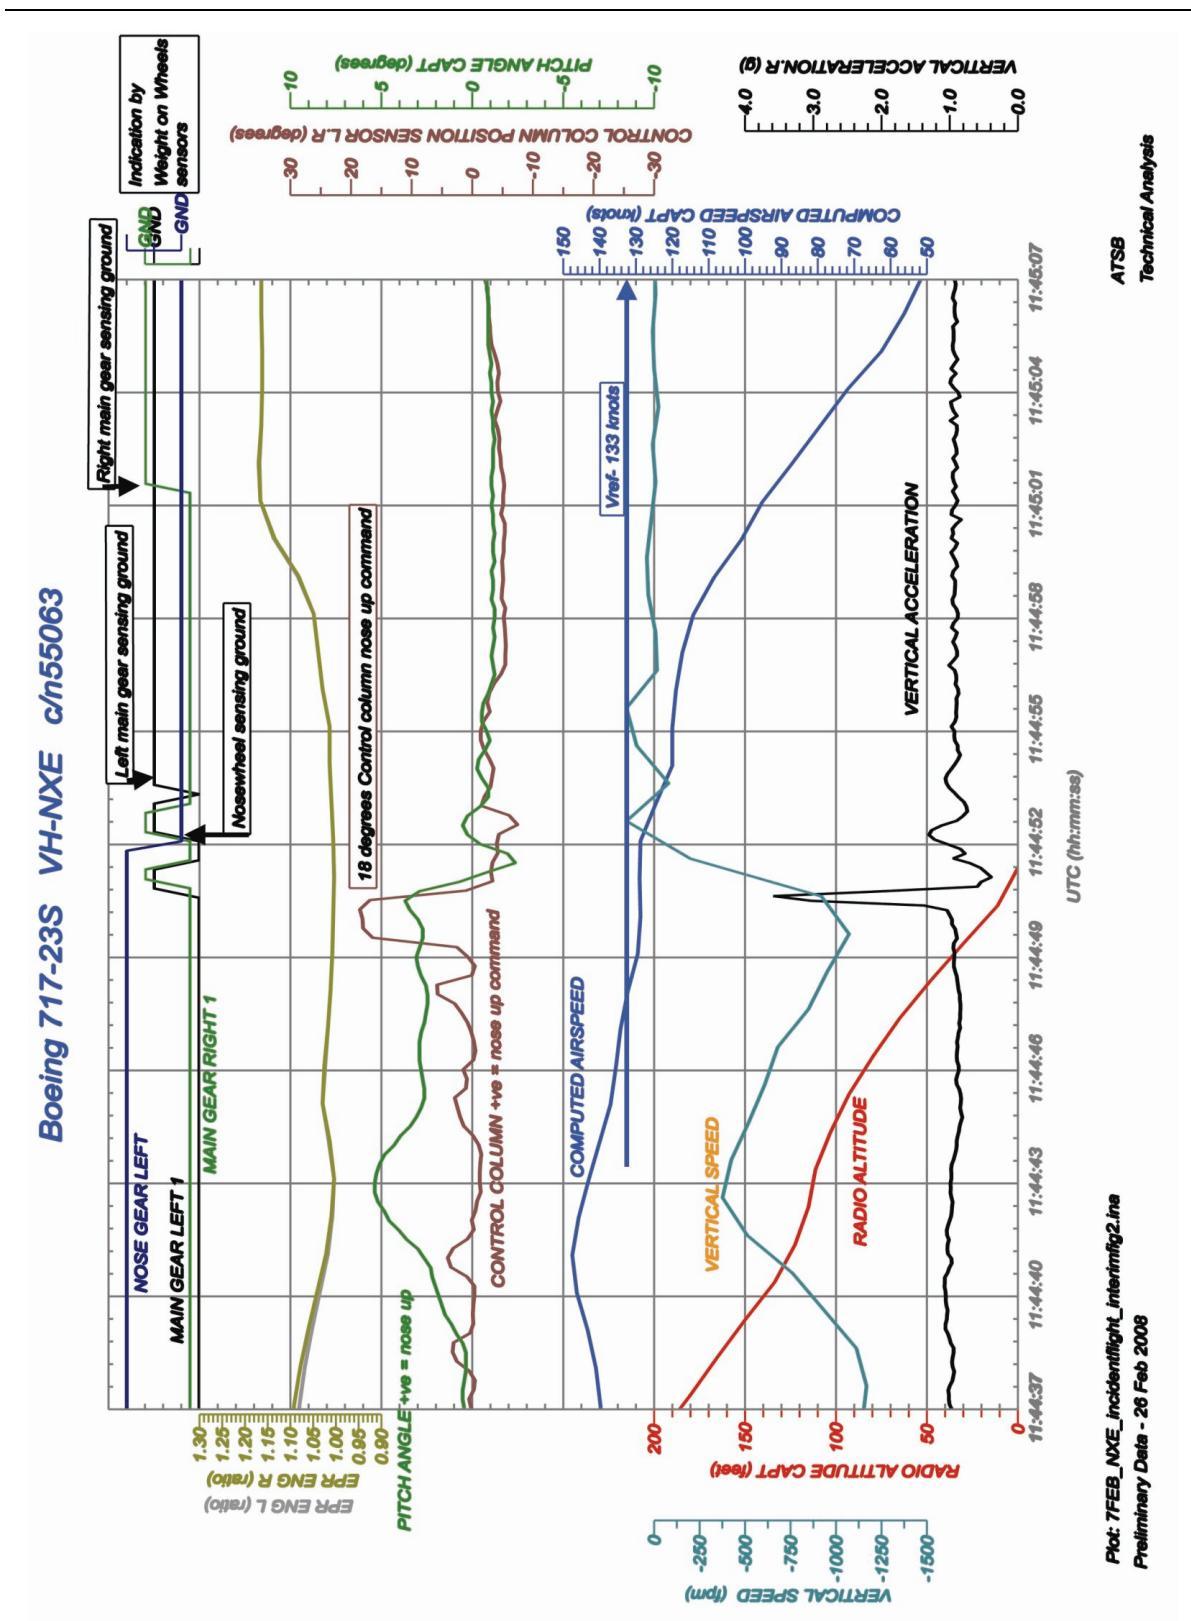
# **APPENDIX B: FLIGHT RECORDER DATA – SHORT FINAL**

The FDR information at Appendix B displays the aircraft's flight path parameters from a radio altitude of 180 ft to after touchdown.

At approximately 30 ft radio altitude, the FDR recorded a rate of descent of approximately 1,000 FPM at the same time as an abrupt control column nose-up command was applied and the autothrottle retarded the thrust to idle. The copilot recalled hearing the synthesised calls of radio altitude from the aircraft's radar altimeter.

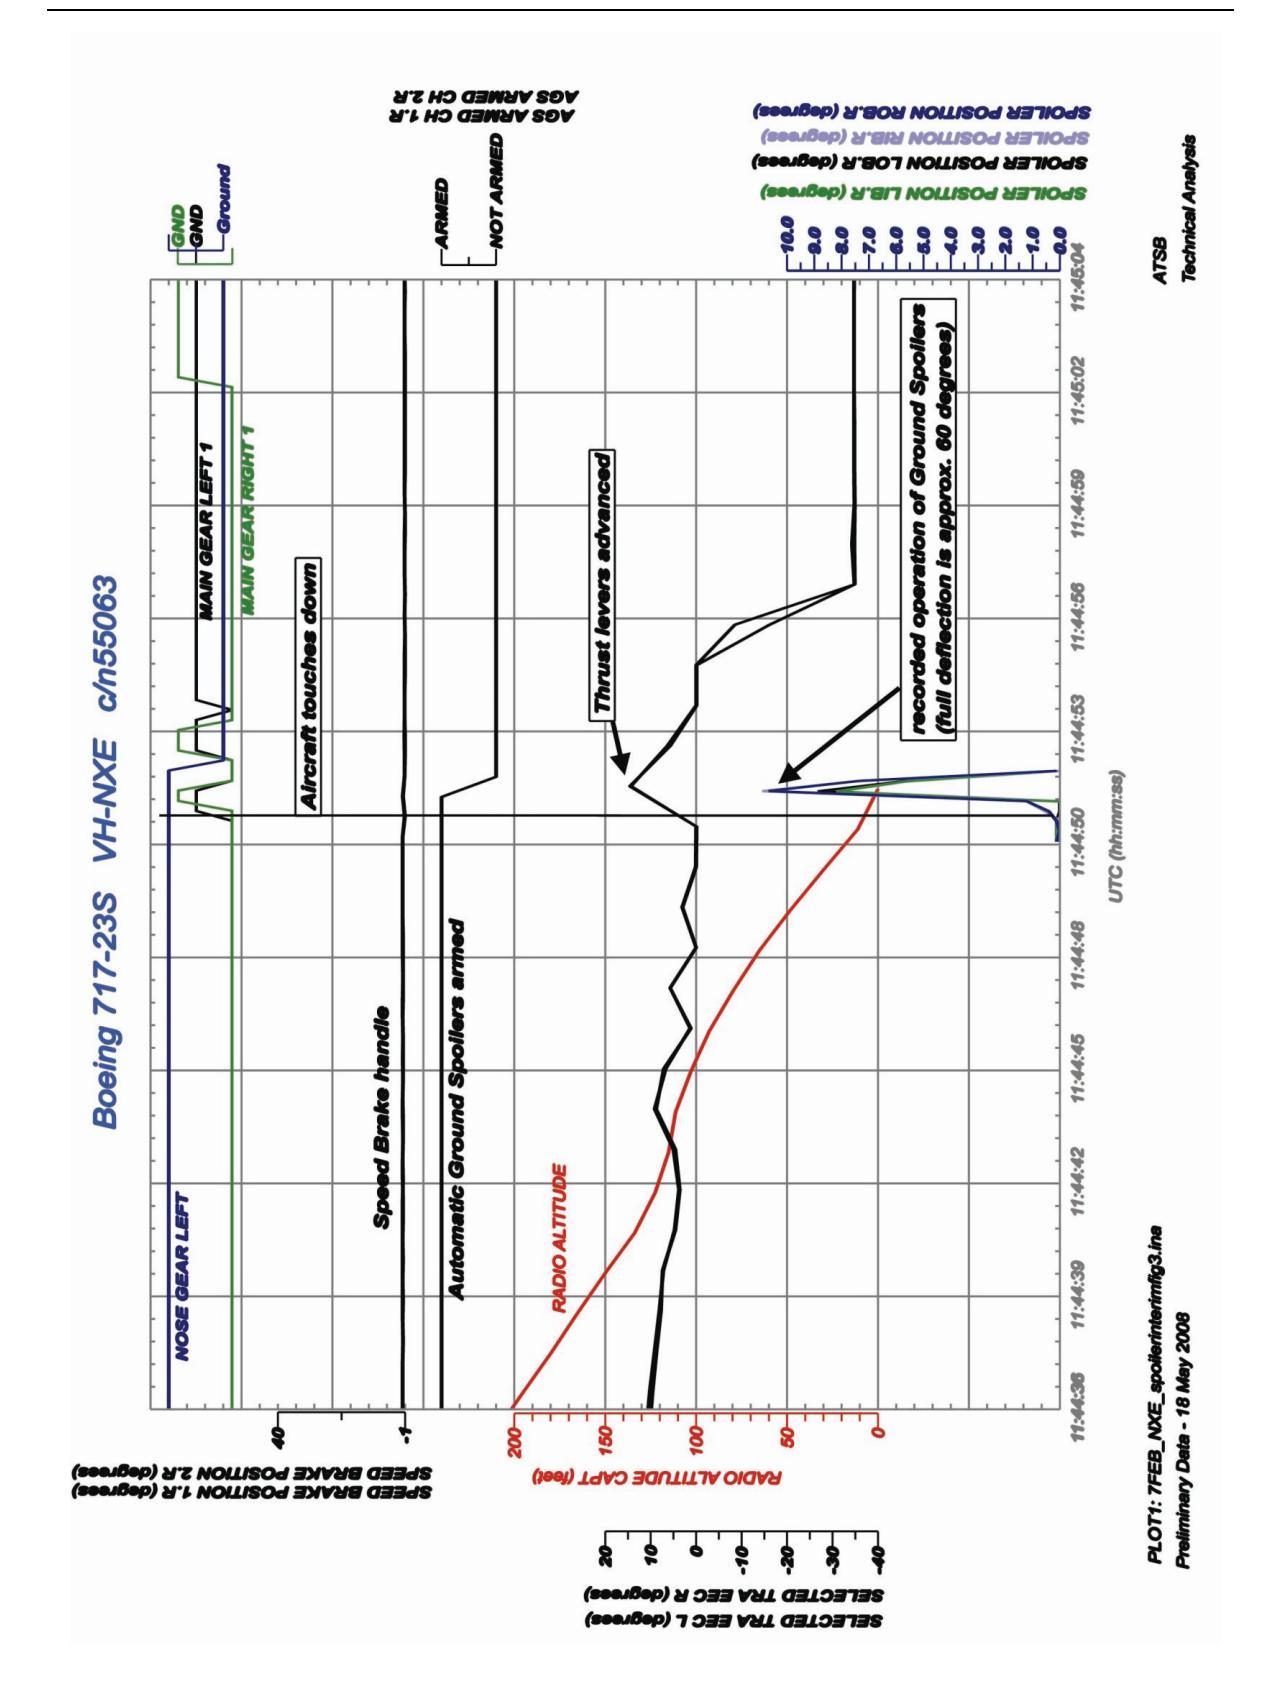
# **APPENDIX C: FLIGHT RECORDER DATA – SPOILERS**

During the landing, the ground spoilers<sup>5</sup> partially extended then retracted. The ground spoilers are automatically deployed by a signal provided from the main wheel spin-up or a ground contact signal from the main gear. If the thrust levers are advanced to a high thrust lever position while the ground spoilers are extended, the spoiler panels automatically retract. The FDR recorded the thrust levers had been advanced after initial touchdown, beyond the position necessary to automatically retract the spoiler panels. The flight crew did not manually extend the ground spoilers (Appendix C).
