Aviation Occurrence Investigation – AO-2008-007 Preliminary

# Hard landing – Darwin Airport, NT 7 February 2008 VH-NXE Boeing Company 717 - 200

Hard landing - Darwin Airport, NT, 7 February 2008, VH-NXE, Boeing Company 717 - 200

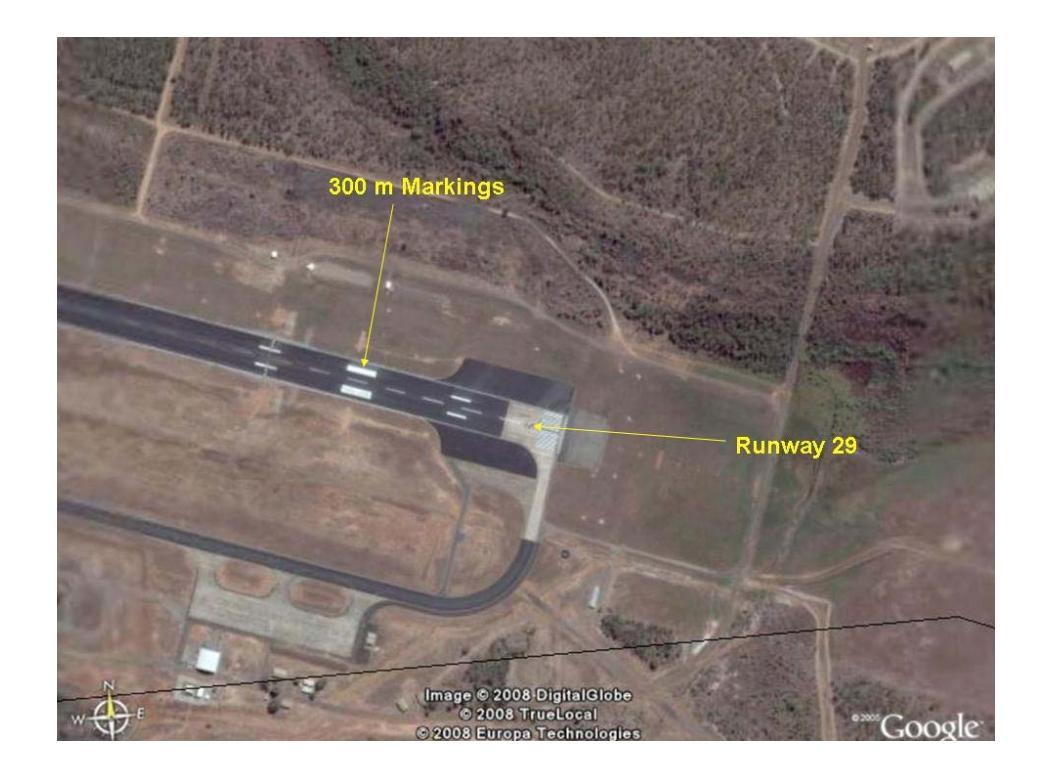
#### Figure 2: Darwin Runway 29 touchdown markings and environs

At 2114:50, the aircraft touched down with a rate of descent of about 1,000 ft/min, which resulted in a hard impact with the runway prior to the 300 m runway markings (Figure 2). The aircraft then bounced before settling onto the runway. The crew completed the landing rollout and taxied the aircraft to the terminal.

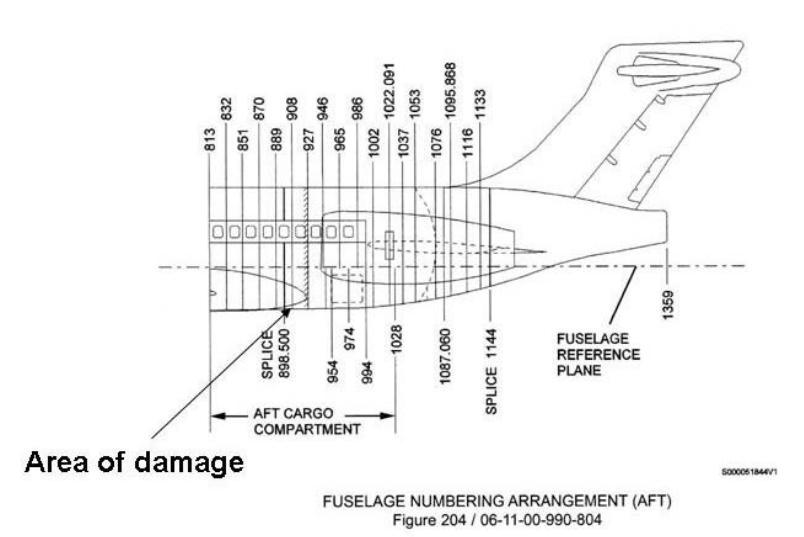
#### Figure 4: Damage on the underside of aircraft

Damage to the aircraft included several creases to the skin on the fuselage above the wing area and underneath the fuselage behind the wing (Figures 3 and 4). Several longerons<sup>5</sup> in the rear cargo area were damaged. The left main landing gear and the outer left main tyre were also damaged.
