ATSB TRANSPORT SAFETY REPORT

Aviation Occurrence Investigation AO-2008-070 Preliminary

In-flight upset 154 km west of Learmonth, WA 7 October 2008 VH-QPA Airbus A330-303

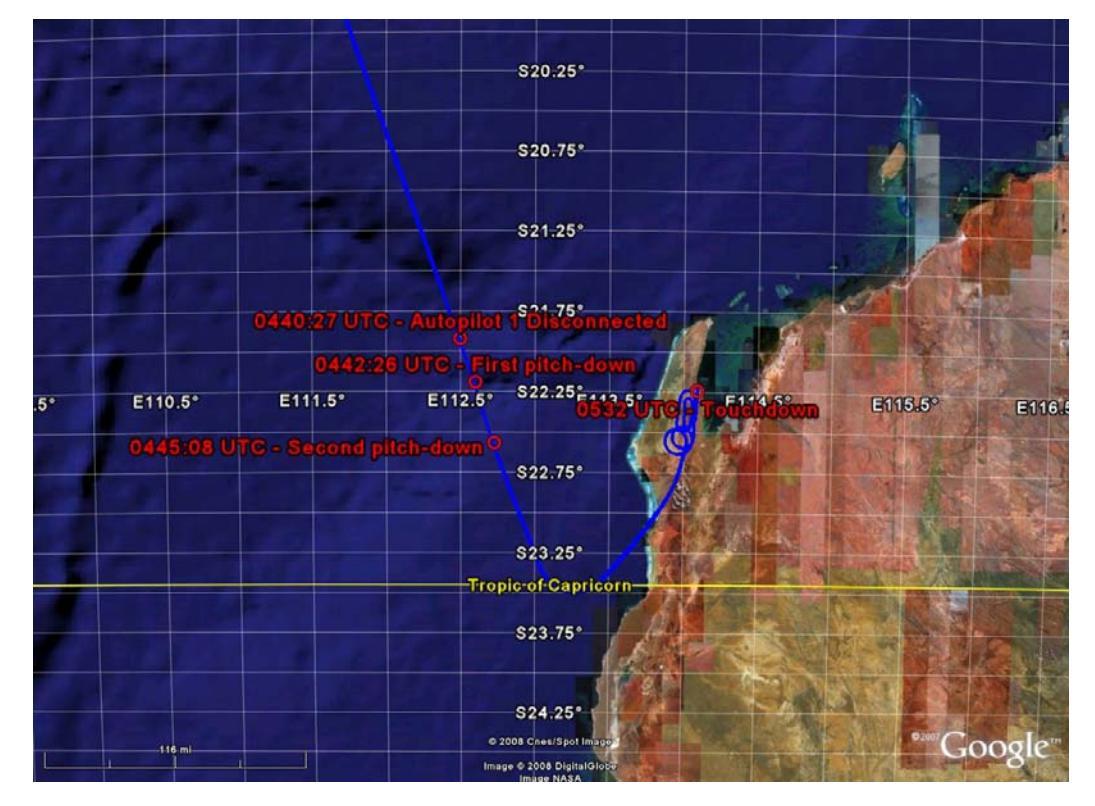
Figure 1: Aircraft track and key events

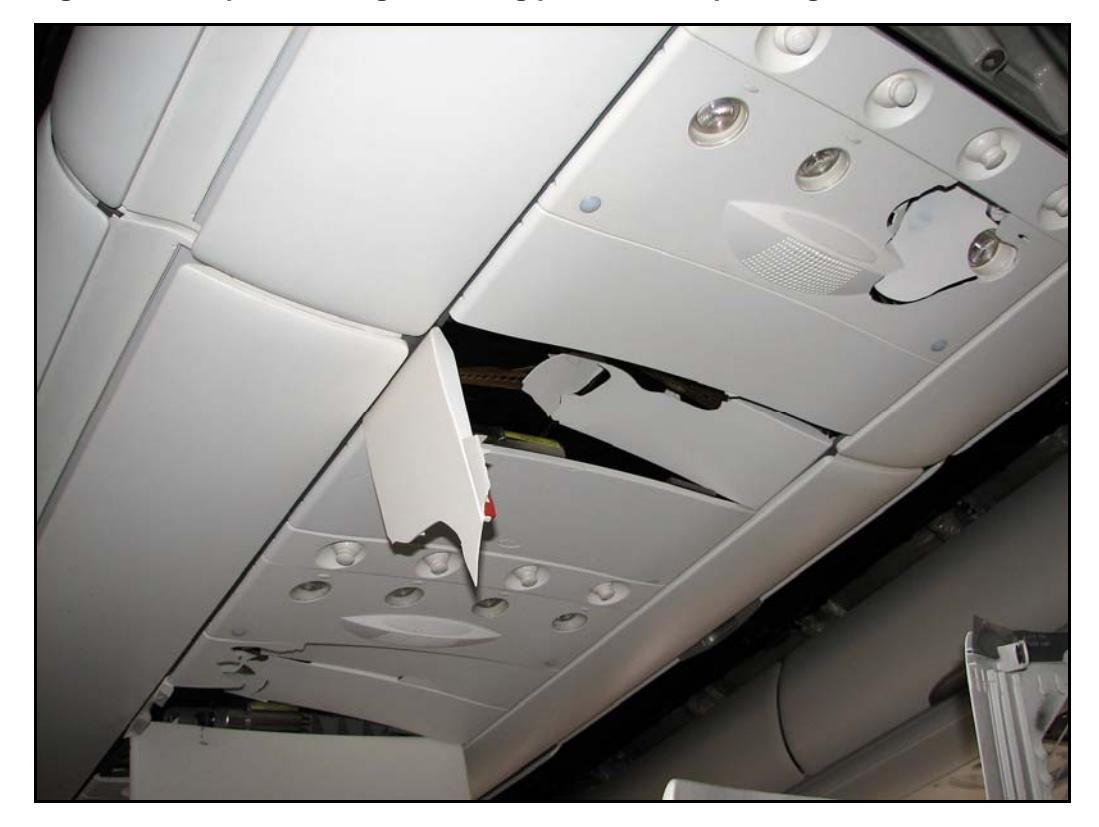
Inspection of the aircraft interior revealed damage mainly in the centre and rear sections of the passenger cabin. The level of damage varied significantly. Much of the damage was in the area of the personal service units above each passenger seat, and adjacent panels. The damage was typically consistent with that resulting from an impact by a person or object. There was evidence of damage above approximately 10 per cent of the seats in the centre section of the cabin, and above

approximately 20 per cent of the seats in the rear section of the cabin. In addition, some ceiling panels above the cabin aisle-ways had evidence of impact damage, and many had been dislodged from their fixed position.

Figure 2: Example of damage to ceiling panels above passenger seats

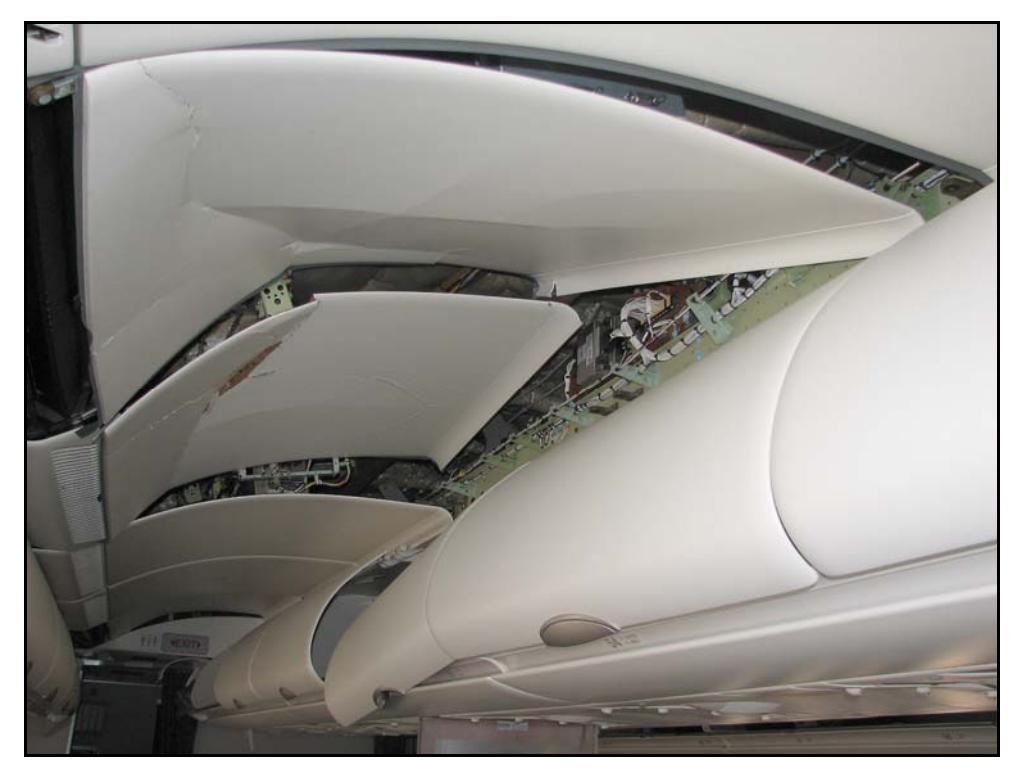
Figure 3: Example of damage to ceiling panels in aisle

Due to the level of damage to ceiling panels in the cabin, all the ceiling panels were removed and wiring looms were visually inspected. No defects were observed.

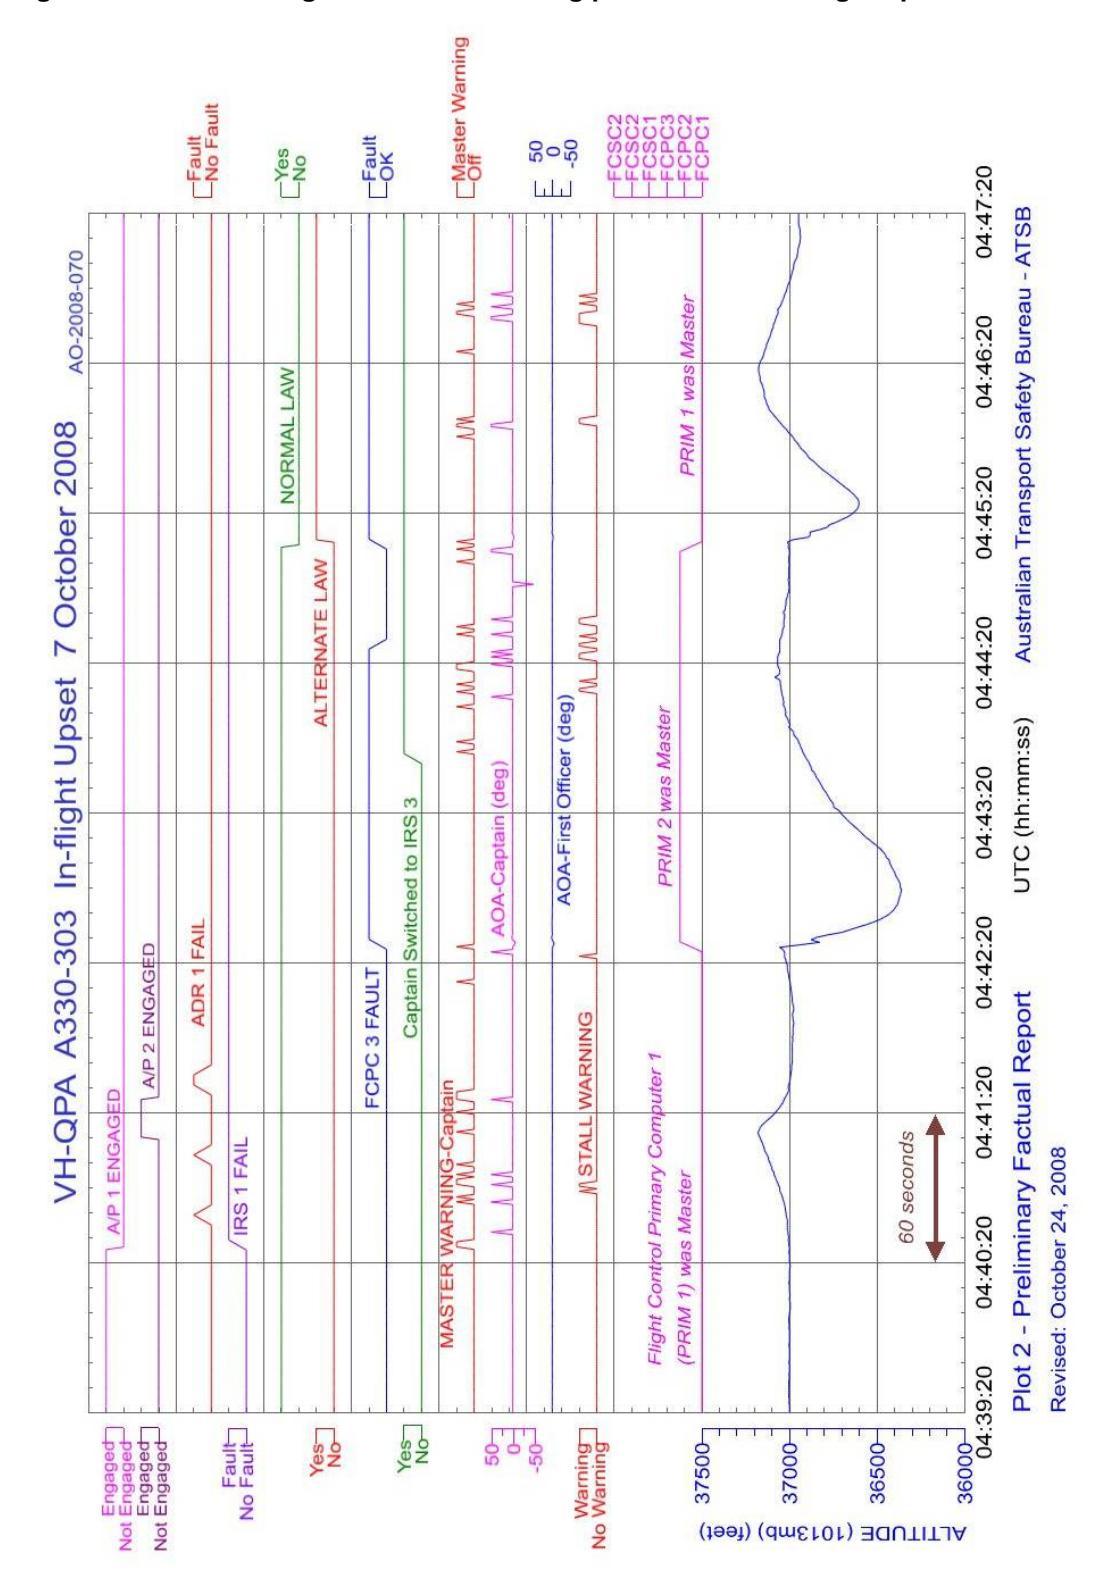
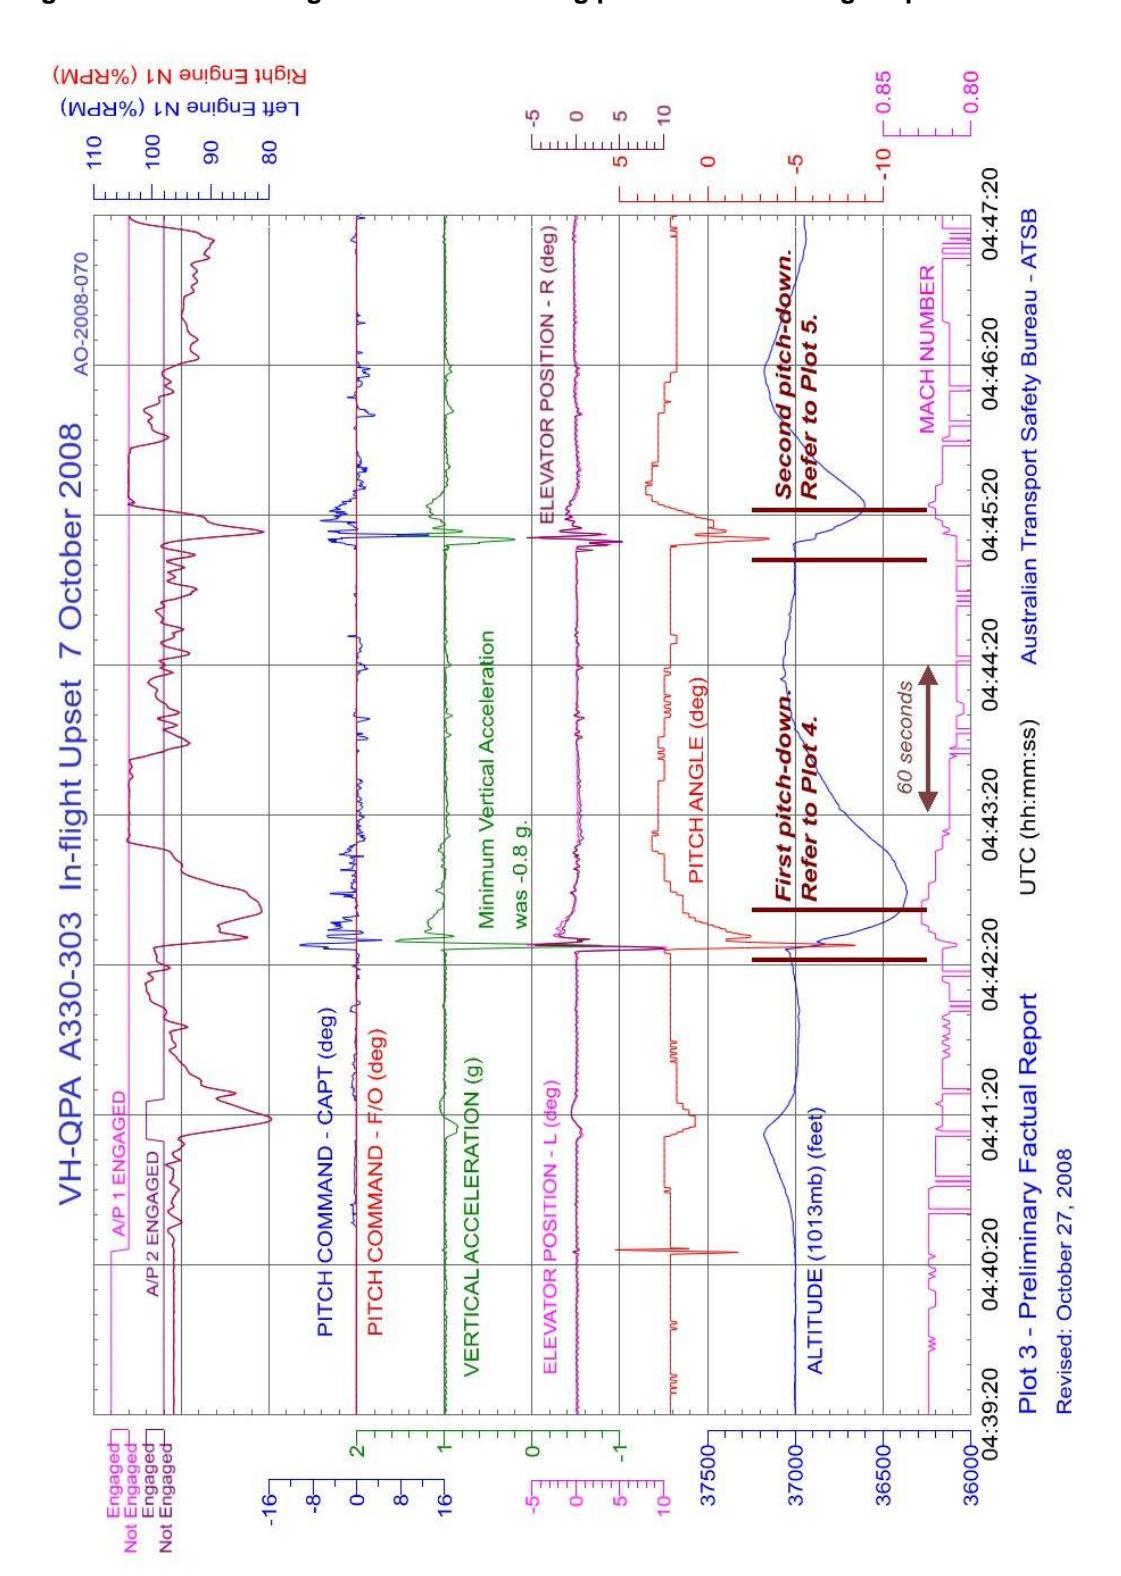
Figure B2: Plot showing selected data during period of both in-flight upset events

Figure B3: Plot showing selected data during period of both in-flight upset events

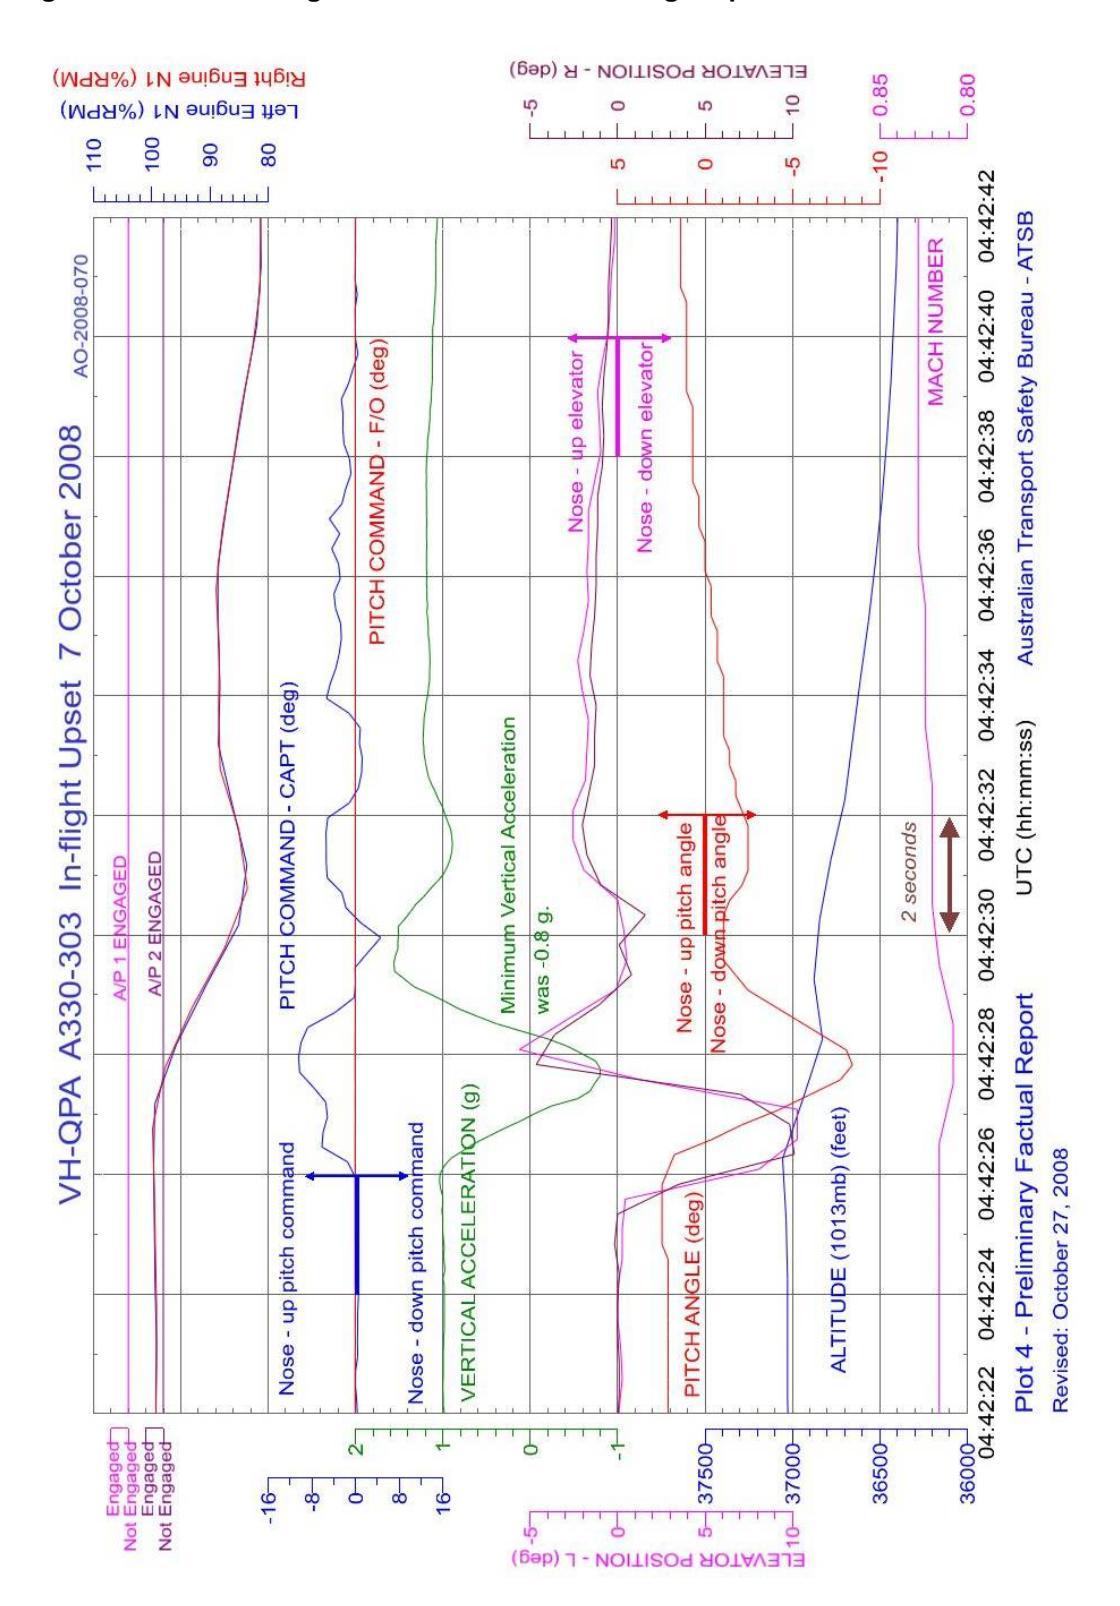
Figure B4: Plot showing selected data for first in-flight upset event

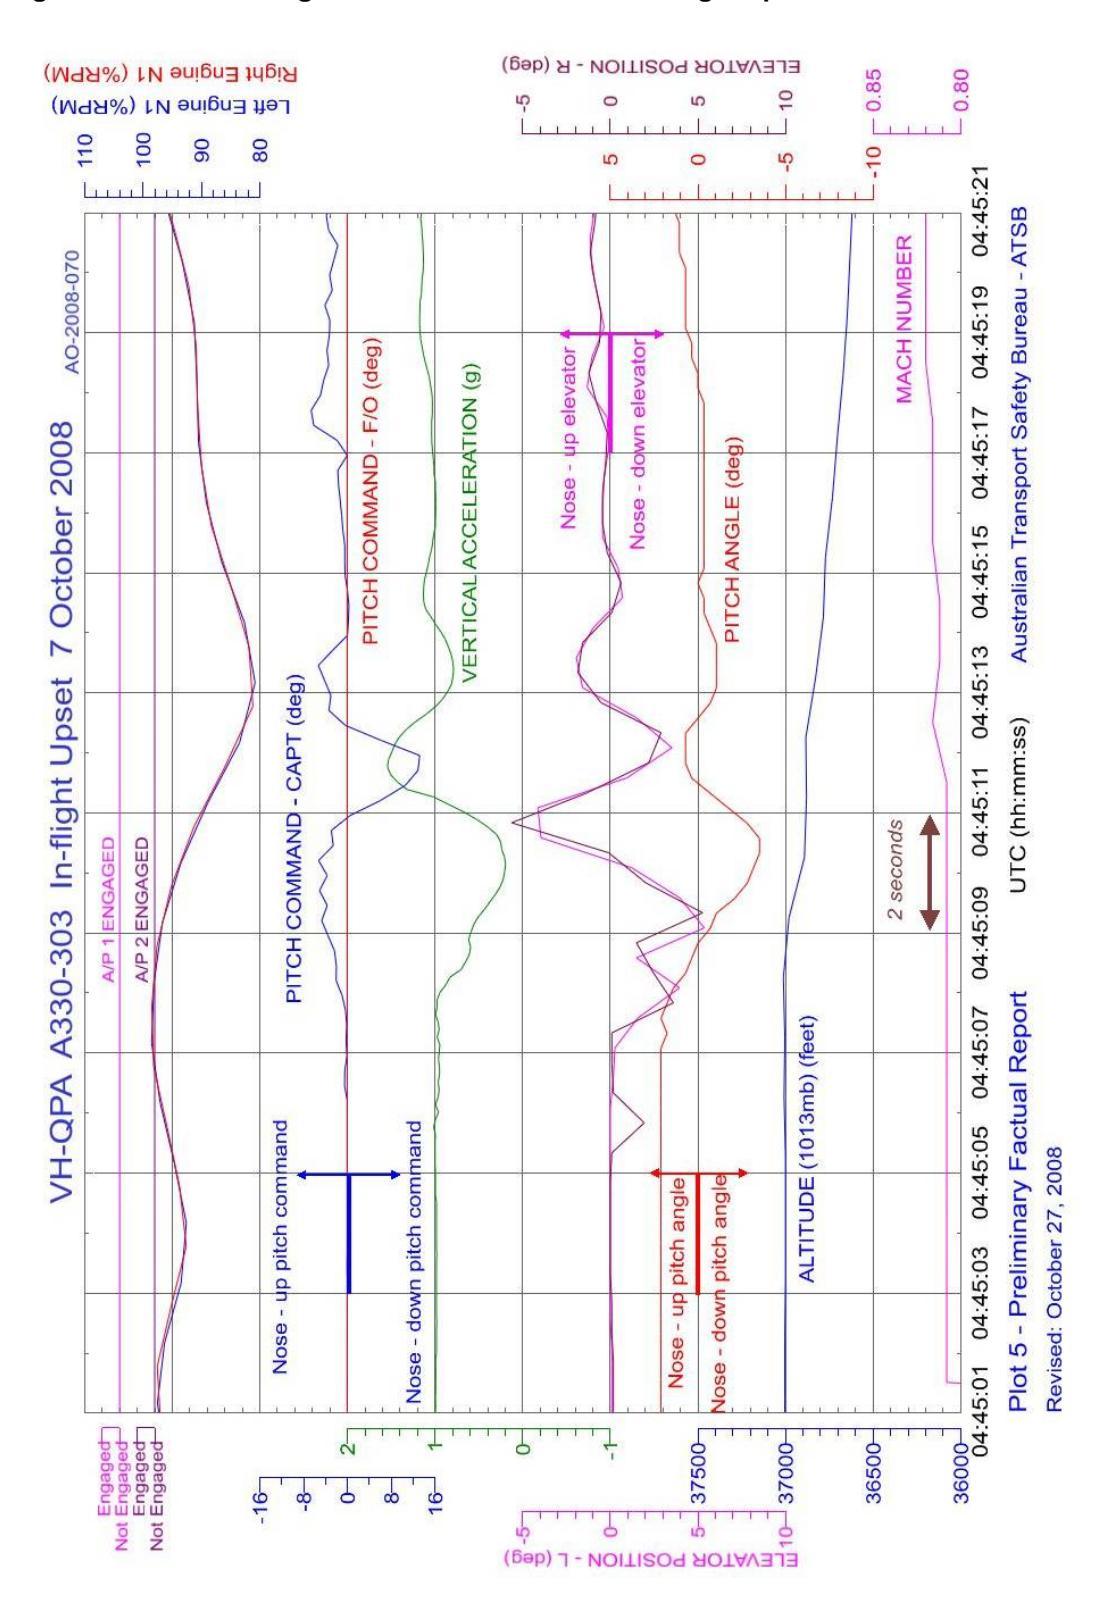
Figure B5: Plot showing selected data for second in-flight upset event
