ATSB TRANSPORT SAFETY INVESTIGATION REPORT Marine Occurrence Investigation No. 249 Final

Independent investigation into the collision between the Australian registered fishing vessel

Allena

Northern Fortune

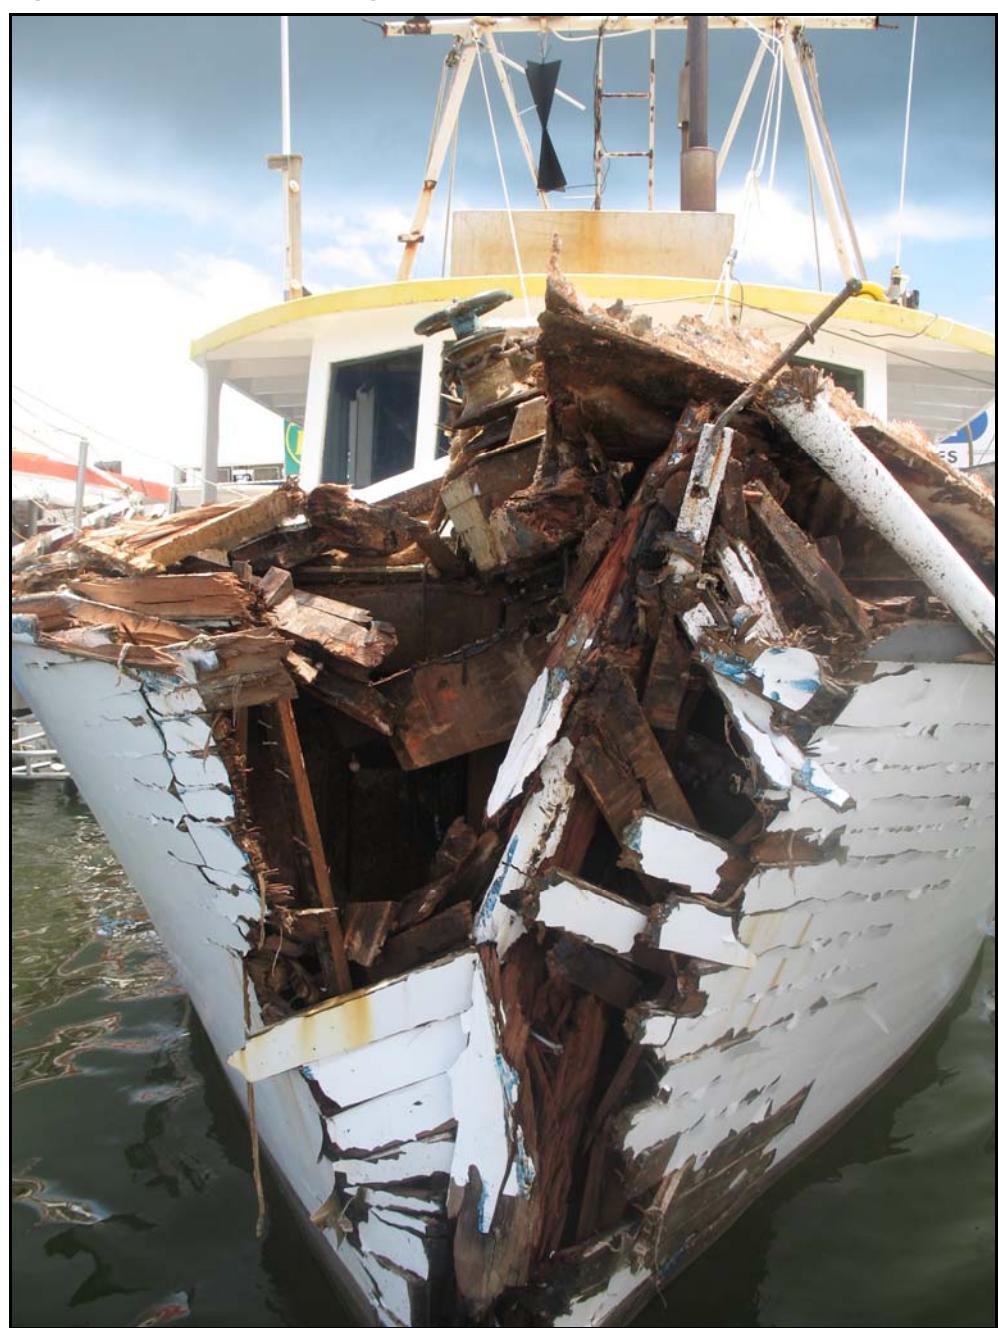
Figure 4: Allena's damaged bow

Once it was apparent that the vessel was not sinking, the skipper recalled the fishermen. The lower accommodation was flooding and the bow was badly damaged (Figure 4). The bilge pump had started automatically with the ingress of water. The skipper switched it over to manual in case its float switch became jammed by debris in the water.

The fishermen helped to secure the paravanes¹¹ and other loose equipment. They then lifted up the decking in the lower accommodation and used all of the available pumps to control the ingress of water through the damaged bow.

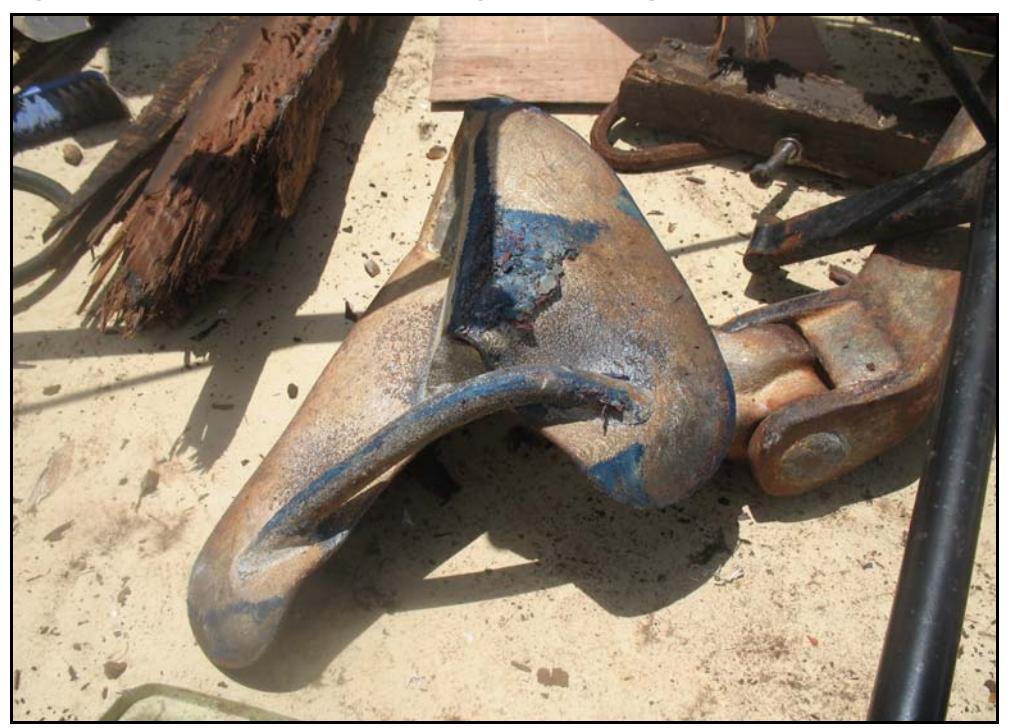
Figure 5: Allena's anchor showing paint scrapings

Paint samples were taken from *Allena*'s anchor (Figure 5) and from recently created contact marks on *Northern Fortune*'s port side, about 8 m forward of the bridge (Figure 6). The contact marks were consistent with the ship being struck by a metal and wooden object which then slid partway down the ship's side.
