# Collision with terrain involving Lancair Legacy, VH-ICZ

Shepparton Airport | 25 October 2013

**ATSB Transport Safety Report** Aviation Occurrence Investigation

Aviation Occurrence Investiga AO-2013-193 Final – 1 December 2014 Cover photo: Global Composite Solutions

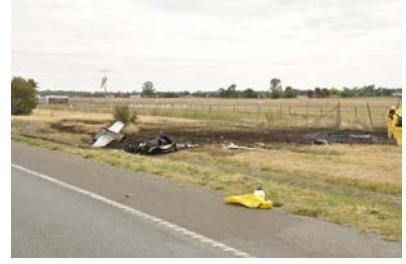
#### **VH-ICZ** accident site

At about 1415 Eastern Daylight Time on 25 October 2013, an amateur-built Lancair Legacy aircraft, registered VH-ICZ, with the pilot and one passenger on-board, took off from Shepparton Airport, Victoria, for a flight to Yarrawonga, Victoria. Witnesses reported that the take-off and initial climb appeared normal, however shortly after, the aircraft's pitch angle increased, after which it entered a descending right turn. The turn and descent continued until the aircraft collided with terrain alongside the airport boundary, fatally injuring the occupants and destroying the aircraft.

The ATSB found that shortly after take-off, and for reasons which could not be determined, the aircraft entered a steep climb, likely entered an aerodynamic stall, and began a descending right turn that continued until the aircraft collided with terrain.

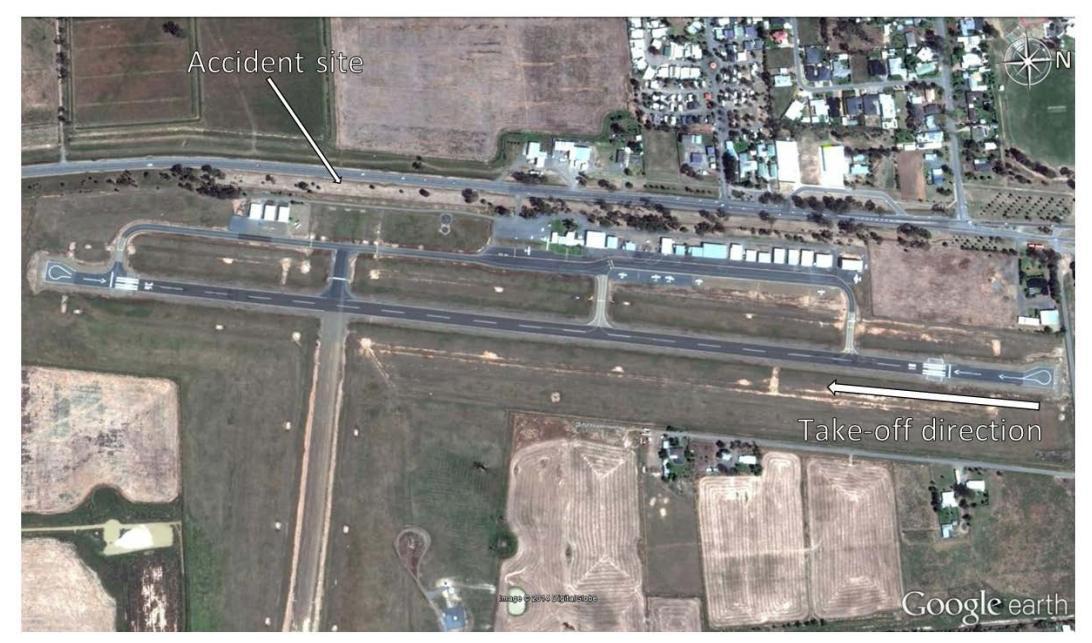
#### Figure 1: VH-ICZ accident site

The pilot (of ICZ) was witnessed preparing the aircraft for flight, which included 'clipping in' the canopy and completing run-up checks<sup>2</sup>. The aircraft was then taxied to the holding point for runway 18<sup>3</sup>, waited for another aircraft to land, and then took off. The take-off and initial climb appeared normal to witnesses; however, shortly after the initial climb, the aircraft's pitch angle increased, followed by a descending right turn which continued until the aircraft collided with terrain (Figure 1). The aircraft was destroyed by impact forces and a fuel-fed fire. The pilot and passenger were fatally injured.

The ATSB's initial examination of the wreckage found that the aircraft had struck the airport boundary fence in a right wing low attitude. The ground impact marks and aircraft damage were consistent with a right wing impact, followed shortly after by the propeller and engine.

Both wing fuel tanks had ruptured and an intense, post-impact fuel-fed fire had destroyed much of the aircraft's composite structure. Despite this, all of the major aircraft components were identified at the accident site, and no evidence of pre-impact damage was apparent. Similarly, there was no

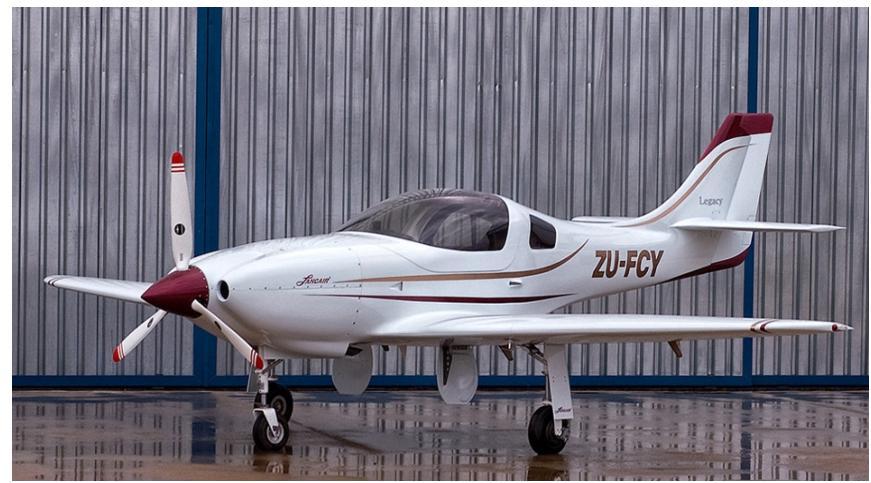
Figure 2: VH-ICZ after being repaired in South Africa

In 2010, the aircraft was involved in a forced-landing accident resulting from engine problems. The aircraft sustained significant damage to the landing gear, propeller and airframe. The aircraft wreckage was subsequently purchased and repaired by a South African aeronautical manufacturing company, at which time the engine was rebuilt and fitted with a McCauley 3A32C418 3-blade propeller. That particular propeller was rated to a maximum of 280 hp at 2,500 RPM. This was not the standard combination recommended by the kit manufacturer for this aircraft. Test flights of the rebuilt aircraft were conducted during May 2012; after which it was sold, disassembled and imported into Australia during July 2012.

When examined as part of the ATSB's aircraft documentation review, the checklist completed as part of the SCoA application process did not list any previous accidents or incidents in the aircraft history, and no major repairs were noted. Similarly, while the aircraft's maximum take-off weight (MTOW) had been increased as a part of the repair process in South Africa, that increase was not noted on the checklist.
