Engine failure involving a Beech Aircraft Corporation Model 200, Super King Air, VH-ZMP

277 km NNW of Marshall Islands International Airport (Majuro Atoll) | 12 September 2013

ATSB Transport Safety Report Aviation Occurrence Investigation AO-2013-154 Final – 11 December 2014 Released in accordance with section 25 of the Transport Safety Investigation Act 2003

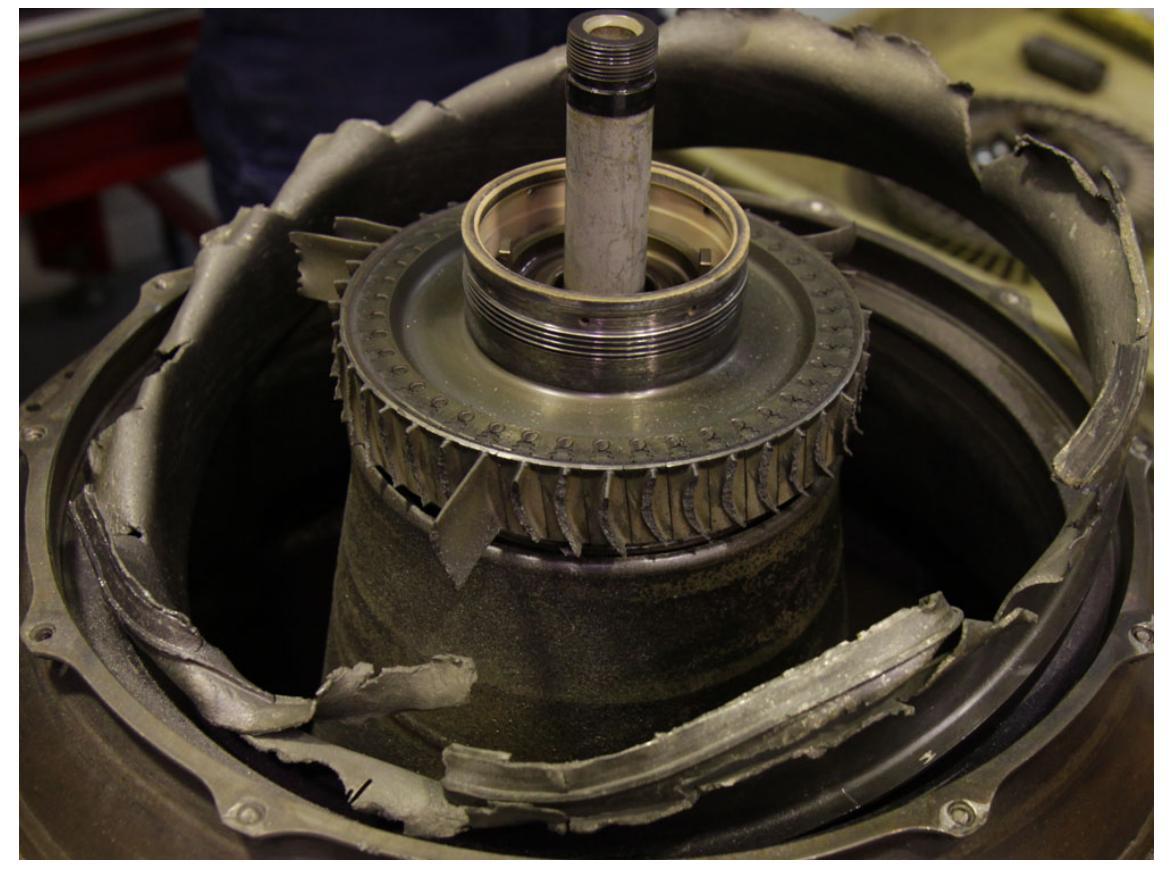
Figure 3: Second-stage power turbine disk

- Most of the blades from the second-stage power turbine disk had fractured and released at their base at the blade platform (Figure 3). The fracture surfaces of the remnant blade stubs were consistent with failure by overstress with no evidence of any pre-existing defects or progressive crack growth. The power turbine housing successfully contained the released blades.

The fatigue failure and subsequent breakdown of the first-stage sun and planet gear teeth in the reduction gearbox from the occurrence engine resulted in the above-described disconnection between the power turbine and propeller reduction gearbox. This led to an immediate 'loss of load' of the power turbine, allowing it to accelerate and shed its blades due to the resulting overstress.

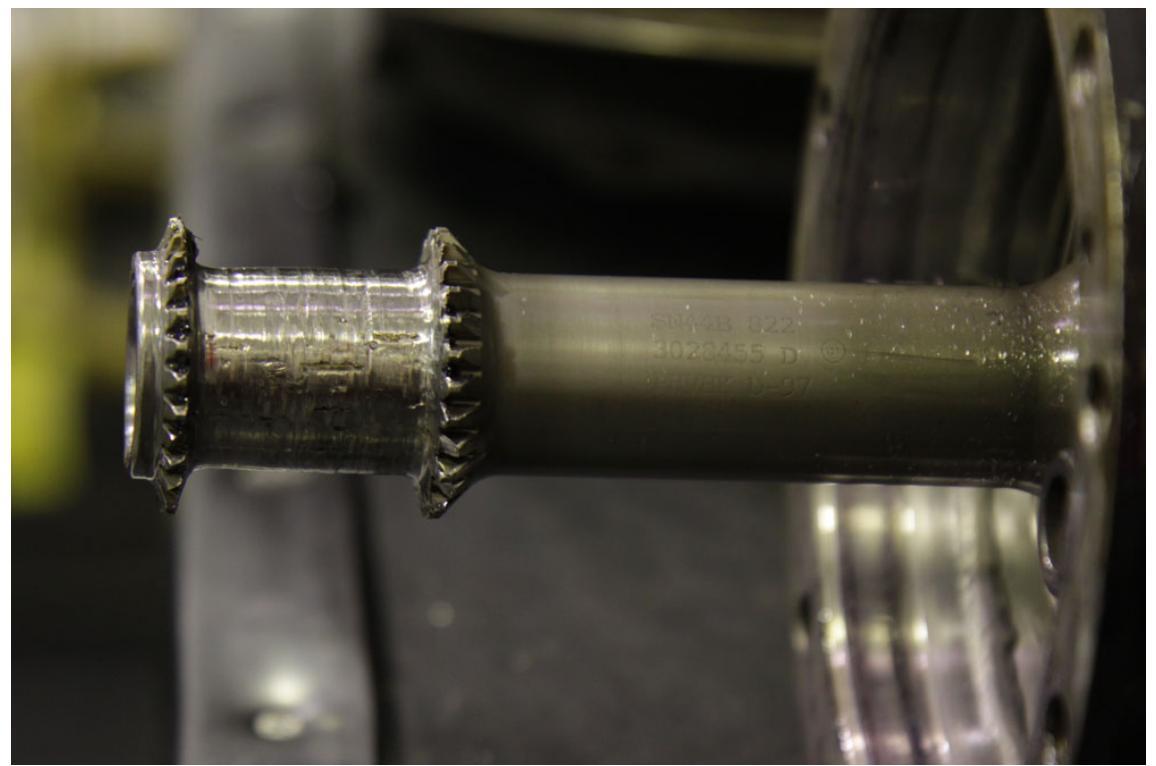
Figure 4: Remnant first-stage sun gear

- Within the reduction gearbox:
 - All of the teeth on the first-stage sun gear had been effectively 'machined' from the shaft (Figure 4).
 - All three first-stage planet gears showed significant deformation and chipping of the gear teeth, some of which had fractured by a fatigue cracking mechanism (Figure 5 and Figure 6).

A metallurgical examination of the recovered engine components showed that several teeth from each first-stage planet gear within the reduction gearbox had failed due to the initiation and propagation of fatigue cracking. The examination also showed that virtually no remnants of the contact portion of teeth from the mating sun gear remained. No identifying features that could have initiated the cracking, such as corrosion pitting, excessive wear or mechanical damage, were observed around the fatigue crack origins from the planet gears. The appearance and location of the fatigue cracks in the tooth fillet radius was consistent with exposure to cyclic bending loads.

A comprehensive review of the available maintenance documentation for the engine revealed that the failed first-stage sun gear and planet gear set had accumulated 12,426 hours total time in service and 10,216 cycles. In the absence of any identified contributory defect, maintenance or operational issues, it was probable that the development of the fatigue cracking was related to their high time in service and that the gears had reached the end of their fatigue life.

The discrepancy in first-stage reduction gear service life was subsequently addressed by the manufacturer's September 1999 introduction of the mandatory requirement to replace the first-stage reduction gears at every overhaul. However, engines that have not been overhauled since 1999 (including the subject engine) could still be operating with first-stage reduction gears in excess of the 12,000 hour life limit, while still complying with AD/ENG/5 Amdt 9 and the manufacturer's baseline TBO requirements. Pratt and Whitney Canada (P&WC) have indicated that, based on the current rate of in-flight shut downs (one per 10,000,000 flight hours) relating to reduction gear deterioration, and provided that the engine is maintained in accordance with P&WC's instructions for continuing airworthiness, there is no immediate action required in these situations. Nevertheless, the ATSB encourages operators and maintainers of affected engines to review their maintenance records and give consideration to the replacement of high-time gearsets.

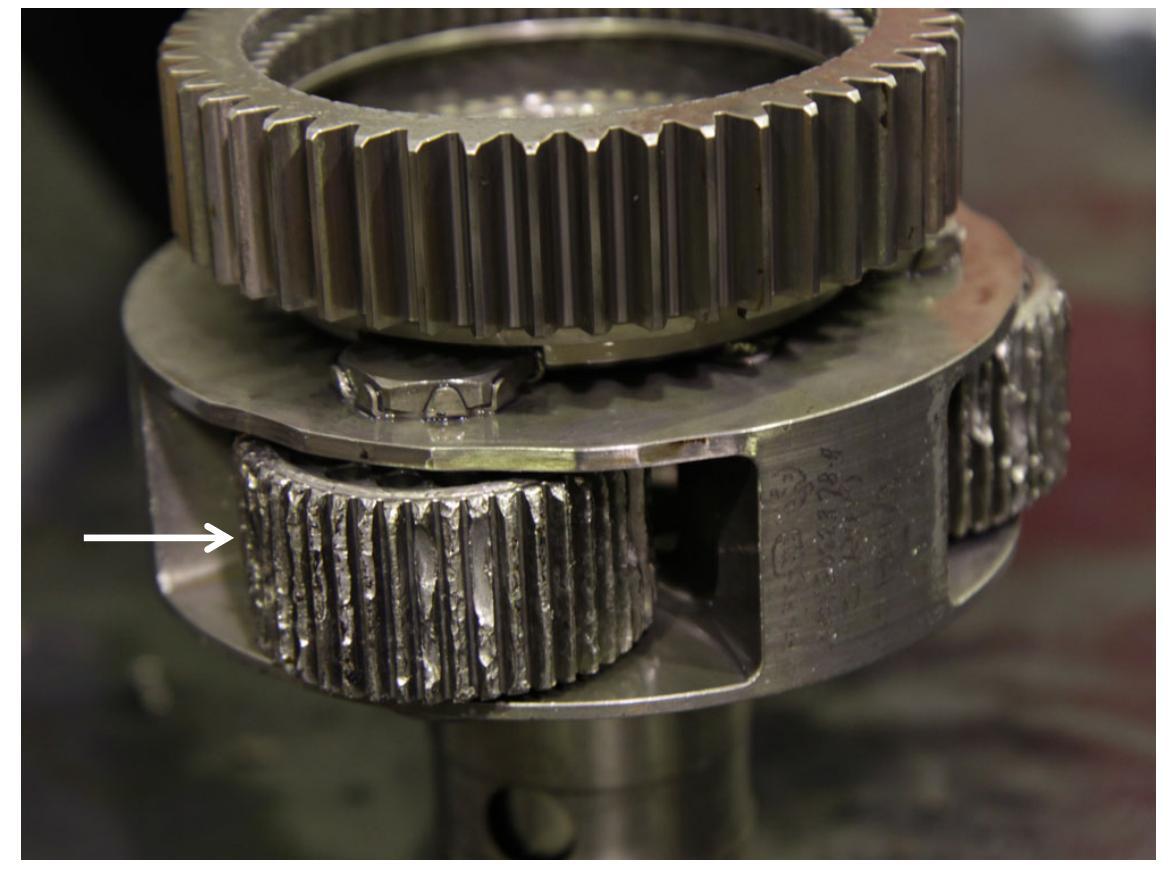
Figure 5: A damaged first-stage planet gear (arrowed) in situ within the gear carrier

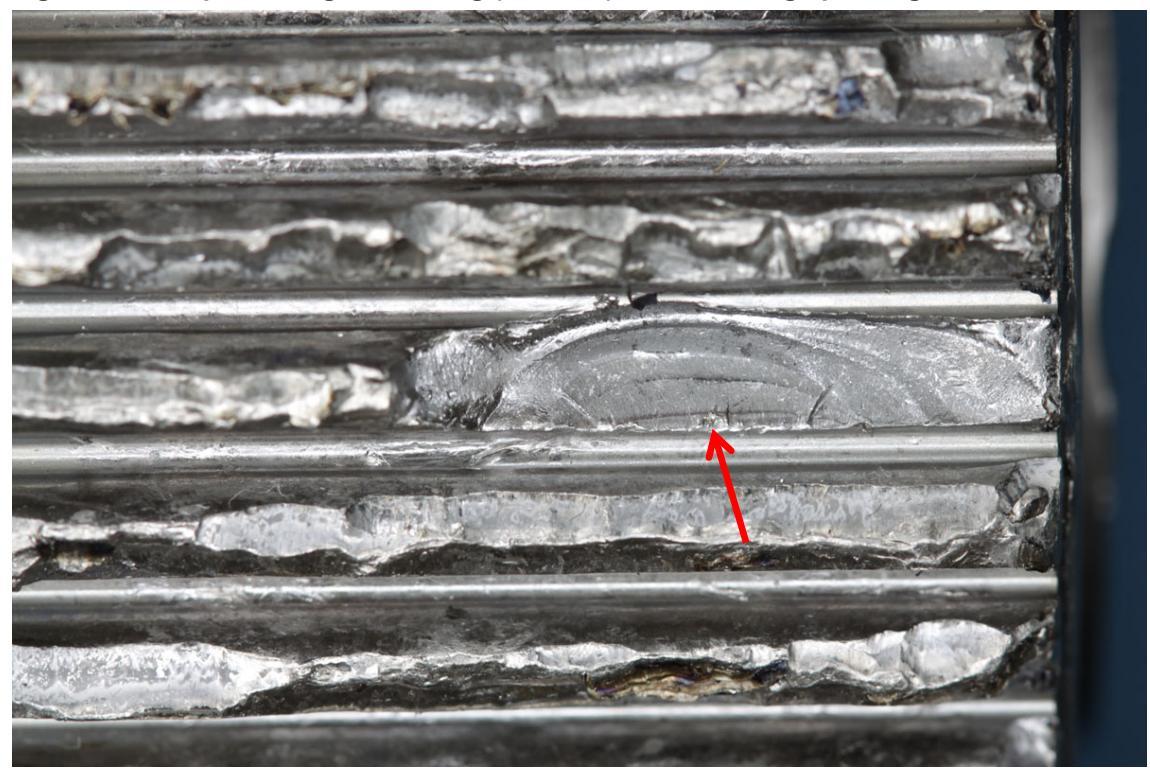
Figure 6: Example of fatigue cracking (arrowed) on a first-stage planet gear tooth

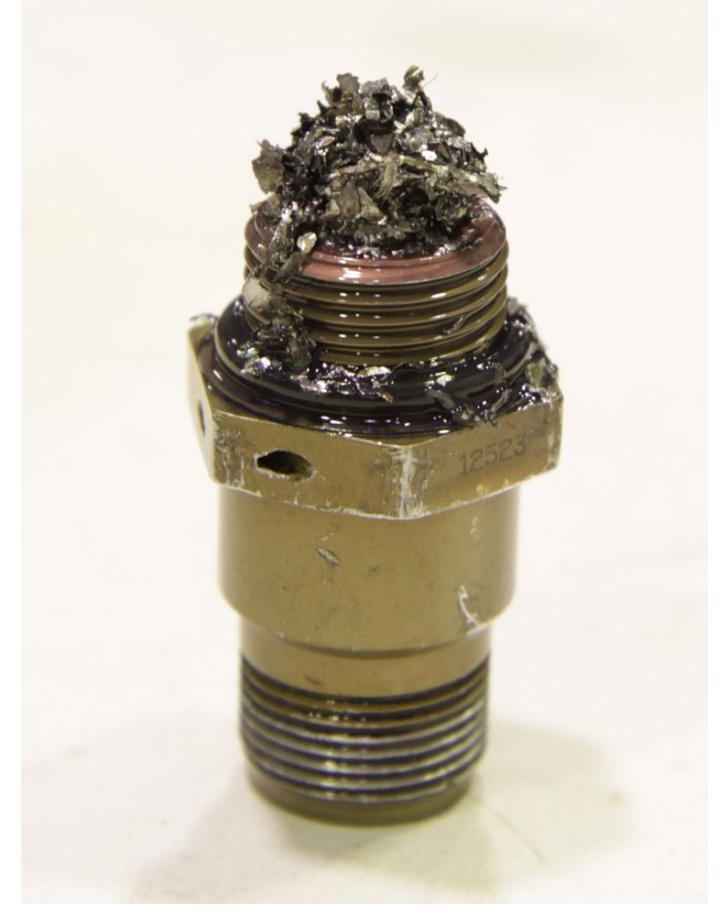
- The reduction gearbox magnetic chip detector and sump screen had captured a significant quantity of metallic debris (Figure 7). Subsequent analysis revealed the captured debris to be similar in composition to the alloy used in the reduction gear set.

Engines experiencing an accelerated rate of failure may trigger momentary or intermittent illumination of chip detector warning lights, or popped circuit breakers with no associated chip detector light, resulting from the rapid build-up of large amounts of metallic debris. This scenario was considered a likely explanation for the lack of an otherwise expected chip detector warning light prior to the subject engine failure.
