Hard landing involving a Kavanagh Balloon, VH-CNX

60 km NW of Gold Coast Airport, Queensland on 26 September 2014

ATSB Transport Safety Report Aviation Occurrence Investigation AO-2014-157 Final – 23 December 2014 Released in accordance with section 25 of the Transport Safety Investigation Act 2003

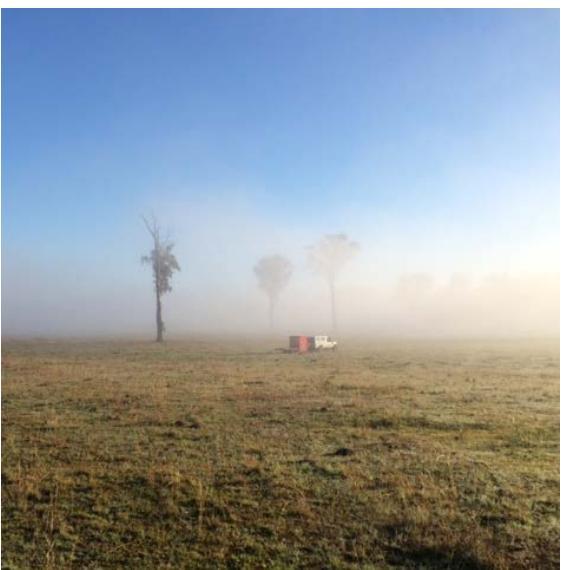
During the approach, the pilot observed a light ground fog (Figure 1) and was heading directly into the sun, making the landing site difficult to see. The pilot attempted to obtain an accurate rate of descent from the altimeter, but it was reading erratically. When approaching treetop height, the balloon had a forward speed of about 14.5 kt. The pilot instructed the passengers to put cameras away and adopt the landing position, but not all of them complied. He repeated his instructions to the passengers, the altimeter continued to read erratically and, facing directly into the sun, made visual assessment of the approach difficult.

Figure 1: Landing site showing ground fog
