Serious injury on board the passenger ship *Seven Seas Voyager*

Sydney, New South Wales | 1 February 2014

ATSB Transport Safety Report

Marine Occurrence Investigation 306-MO-2014-001 Final – 23 January 2015 Cover photo: Courtesy of Peter F Williams

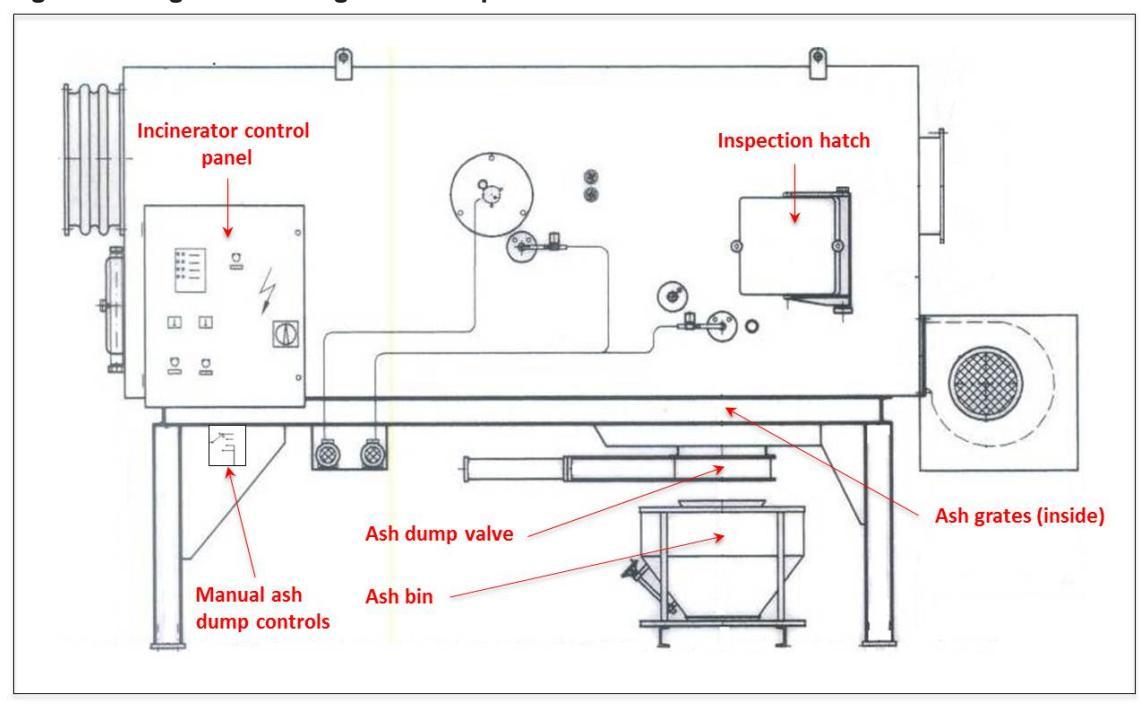
Figure 2: Diagram showing main components of waste incinerator

At 0840, the first engineer inspected the incinerator furnace through the inspection hatch (Figure 2) and found that it needed to be cleaned of ash before work could commence. The incinerator operator attended and used the manual controls to open the ash grates and the sliding ash chamber dump valve to release the ash into an ash waste bin. The first engineer then shut off the air to the incinerator's operating system.

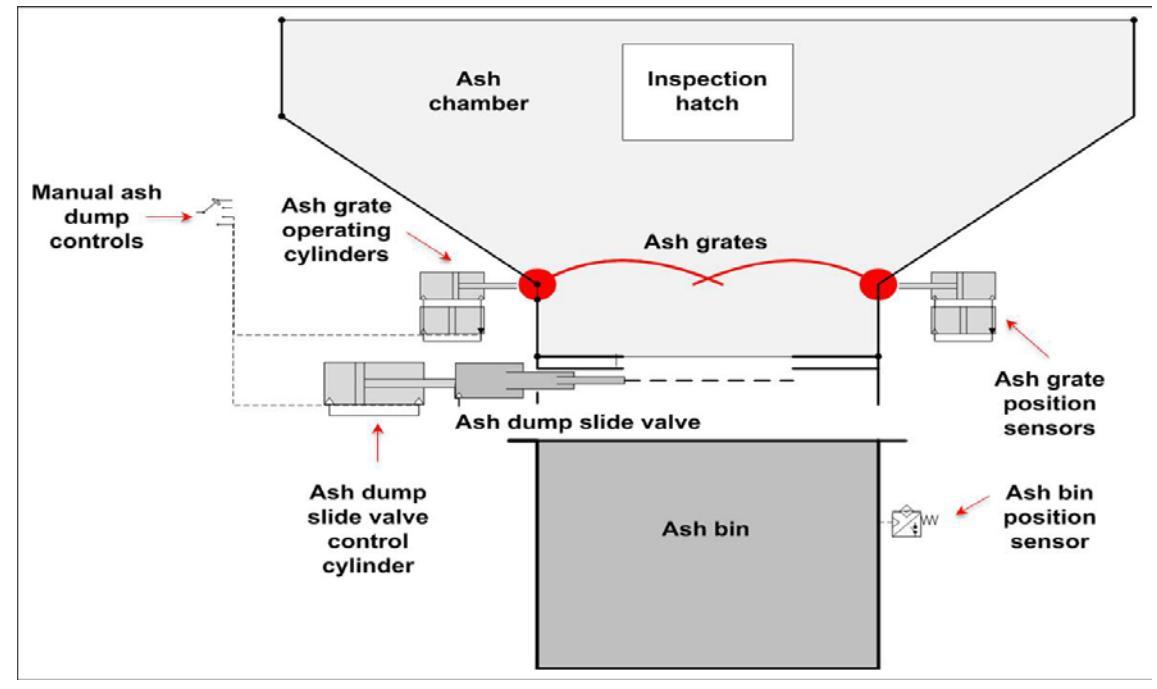
Figure 3: Sketch of incinerator ash dumping system and sensors

The ash grates and ash dump valve were operated by pneumatic cylinders which were fitted with sensors to detect their position (open or closed). Another sensor was fitted to detect when an ash bin was in place under the incinerator. A control switch was mounted on the side of the incinerator for manual activation of the ash dumping system.

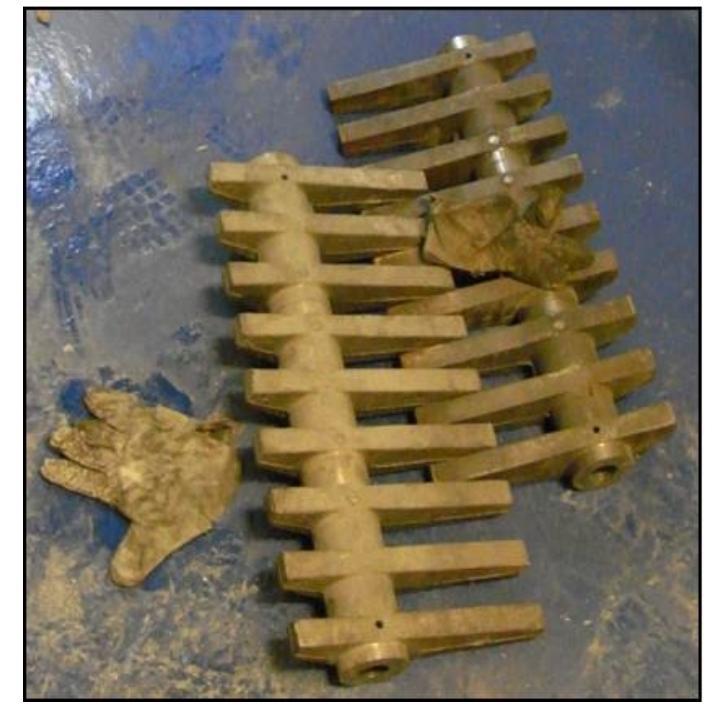
Figure 4: New ash grates (for replacement)

The accumulated ash in the incinerator's ash chamber was held in check by two cast iron grates (figure 4). A sliding ash dump valve was located below the grates and sealed the incinerator ash chamber. When dumping ash, the sliding ash dump valve was opened and the grates swung down to open. This allowed the ash to fall out of the incinerator into an ash bin.

In early 2013, the deteriorated condition of the ash grates was reported to the first engineer. The first engineer ordered replacement ash grates, which were received in April. In November that year, the first engineer's handover notes indicated that the ash grates required replacement.

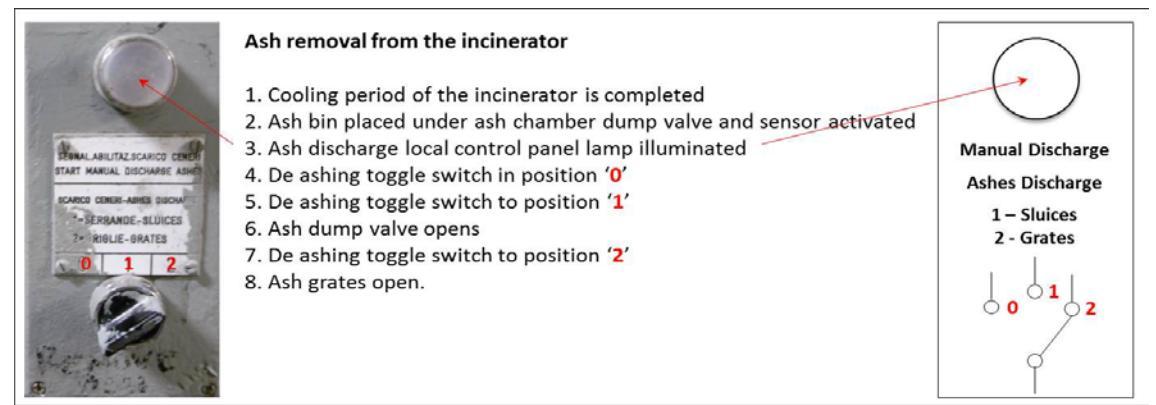
Accumulated ash had to be periodically manually released by the incinerator operators (Figure 5). To do this, the incinerator was shut down, allowed to cool and a waste bin was placed under the ash dump valve, making contact with the bin sensor, energising the control circuit.

When the control switch was moved to position 1, the ash dump valve would open and then in position 2, the grates would open and the ash would fall into the ash bin. When the ash bin was full, the control switch would be moved to position 0. The grates would close and, once in the fully closed position, the dump valve would close. If the ash bin was removed while the manual control switch was not in position 0, the grates and dump valve would automatically close in the same sequence. If either grate did not fully close, the dump valve would not receive the signal to close and, hence, would remain open.

At 0850 on 1 February 2014, when the incinerator operator completed dumping ash into the ash bin, the de-ashing toggle switch was left in position 2 (Figure 5). The subsequent removal of the ash bin released the bin sensor switch, initiating the closing sequence for the ash grates and then the ash dump valve. However, as the after ash grate did not fully close, the ash dump valve was not signalled to close and remained open.

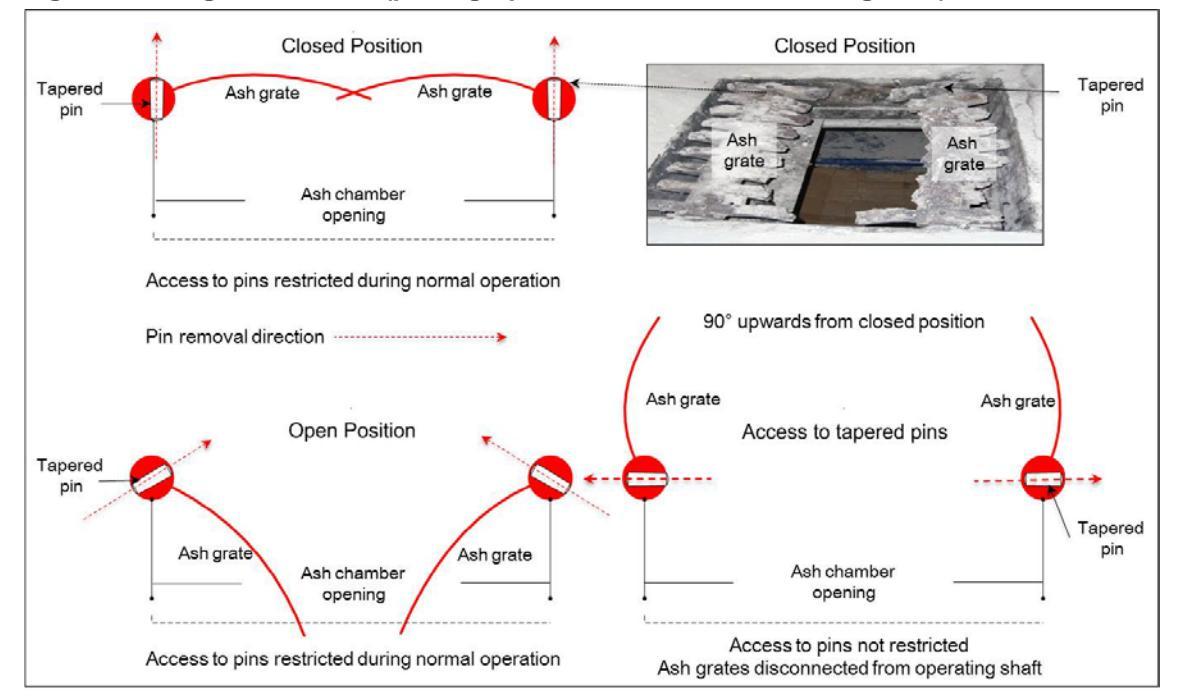
Figure 6: Ash grate removal (photograph shows the worn out ash grates)

The incinerator ash grates rotated on a steel shaft passing longitudinally through the grate body and were secured to the shaft with tapered pins (Figure 6). The ash grates opened in a downwards direction and released ash below. However, this did not allow access to remove the tapered pins. The grates needed to be swung 90° upwards to expose the bottom of the pin. This would require disconnection of the pneumatic cylinders, which in turn depressurised the system.

However, *Seven Seas Voyager's* planned maintenance system (PMS) contained no information about waste incinerator ash grate replacement, a task that would have been periodically undertaken by different engineering staff since 2003. Therefore, in this respect, the shipboard procedures that documented requirements for the PMS had not been effectively implemented.

The ATSB recommends that Prestige Cruise Services take action to ensure that all shipboard repetitive non-routine maintenance activities are addressed and appropriately documented within the ship's planned maintenance system.

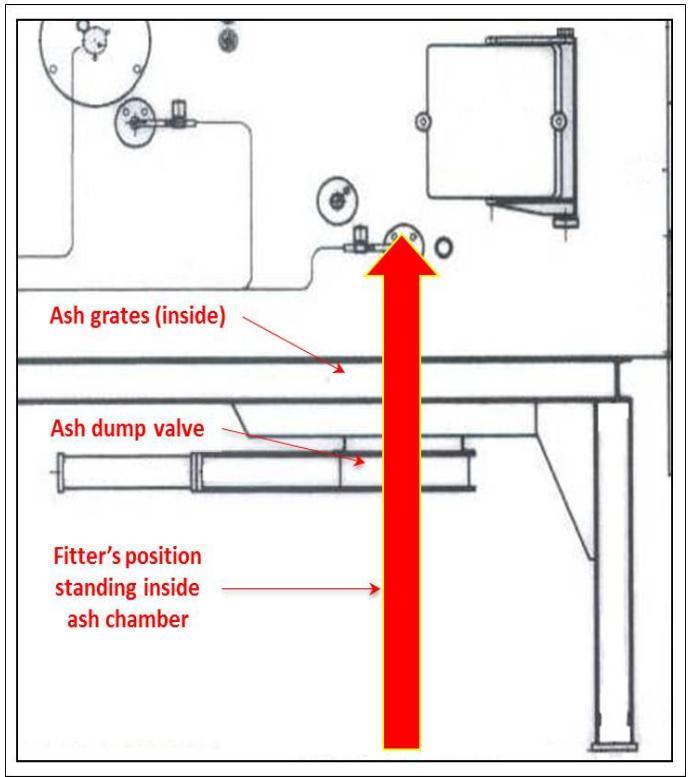
Figure 7: Fitter's position standing in the ash chamber

Shortly after 0900, the fitter decided to see what the ash grate replacement task involved. The open ash dump valve allowed him to access the grates (Figure 7). Assuming that it was safe to start removing the grates, he began punching the taper pins holding the grates. Unable to hit the punch squarely on the pin, he then stood up within the opening of the dump valve and the deteriorated ash grates to get a better view.

As he stood with his upper body inside the ash chamber, the fitter began moving the grates to better position them and punch the taper pins out. When he moved the after grate to the fully closed position, the sensor switch signalled the ash dump valve to close. The air to the valve's operating system had been shut off but residual air in the system allowed the valve to close against the fitter's body.

At the time, the incinerator electro-pneumatic control systems had not been properly isolated and it was not safe to start the grate replacement task. Isolating the air to the system was only one part of the process. The residual air pressure in the pneumatic system still needed to be released. In addition, it was necessary to isolate the system's electrical power and prevent sensor switches activating.

- The ash dump valve's electro-pneumatic control systems were not properly isolated and air pressure in the valve's operating system was not released, leaving residual pressure that allowed the valve to close.

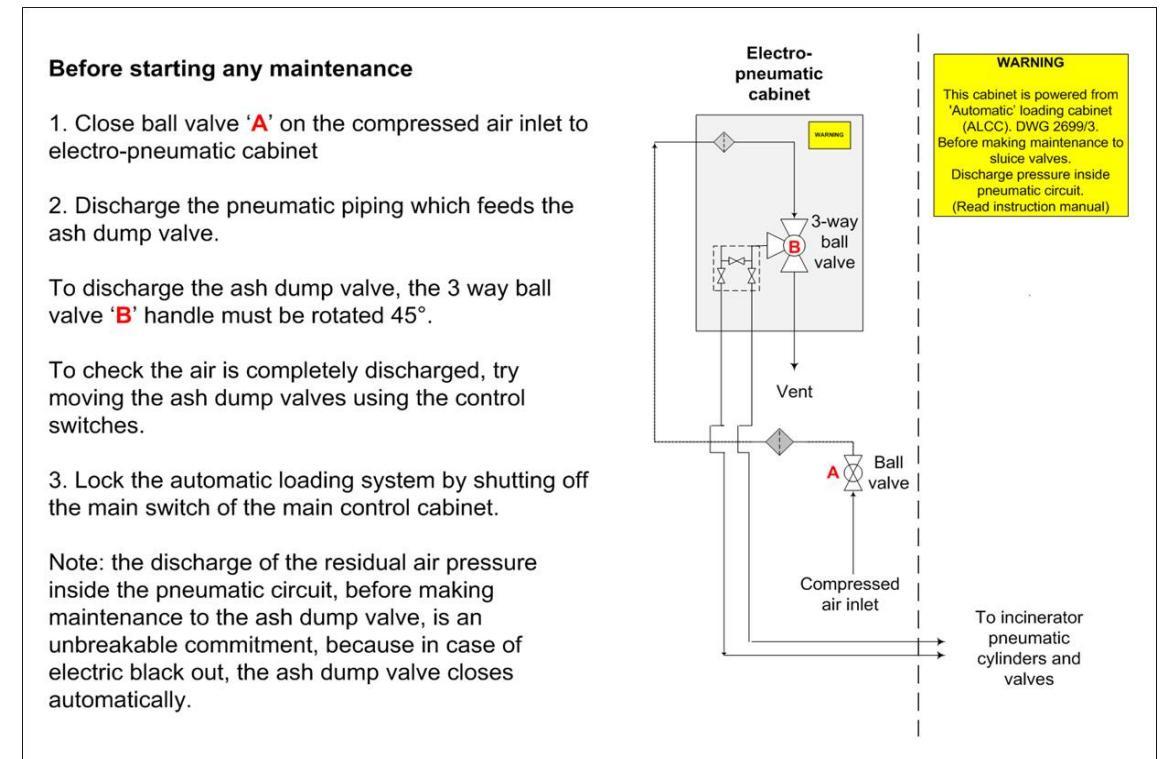
Figure 8: Isolation of pneumatic system

The incinerator manufacturer's instruction manual contained detailed instructions for isolating its control systems before starting any maintenance (Figure 8). The instructions warned that the loss of electrical power to the control system while there was residual air pressure in the pneumatic circuit would result in the ash dump valve automatically closing. The electro-pneumatic control cabinet door also had a warning notice that stated 'before maintenance to sluice valves (ash grates) discharge the pressure inside the pneumatic circuit'.

However, the manual contained no instructions or guidance for ash grate replacement. With the incinerator being used regularly, the grates would deteriorate and need periodic replacement. Therefore, it could reasonably be expected that the manual should have provided some instructions or guidance to safely complete the task.

While the instructions for isolating the system and the warnings on the electro-pneumatic cabinet were appropriate, they were not followed on 1 February. It is possible that shutting off the air was considered sufficient isolation for the task at hand. The inclusion of some level of instructions in the manual could have prompted other precautions to be taken. Such instructions could also have been included by the ship's engineers in the PMS during the ship's life.

The ATSB recommends that ISIR Impianti SrI take action to ensure that their equipment maintenance instructions contain all detail necessary to allow the safe completion of routine and non-routine maintenance activities.
