Derailment of freight train 2DA2

Union Reef, Northern Territory | 30 December 2013

ATSB Transport Safety Report Rail Occurrence Investigation RO-2013-028 Final – 17 February 2015 Source: Cover photo Genesee & Wyoming Australia.

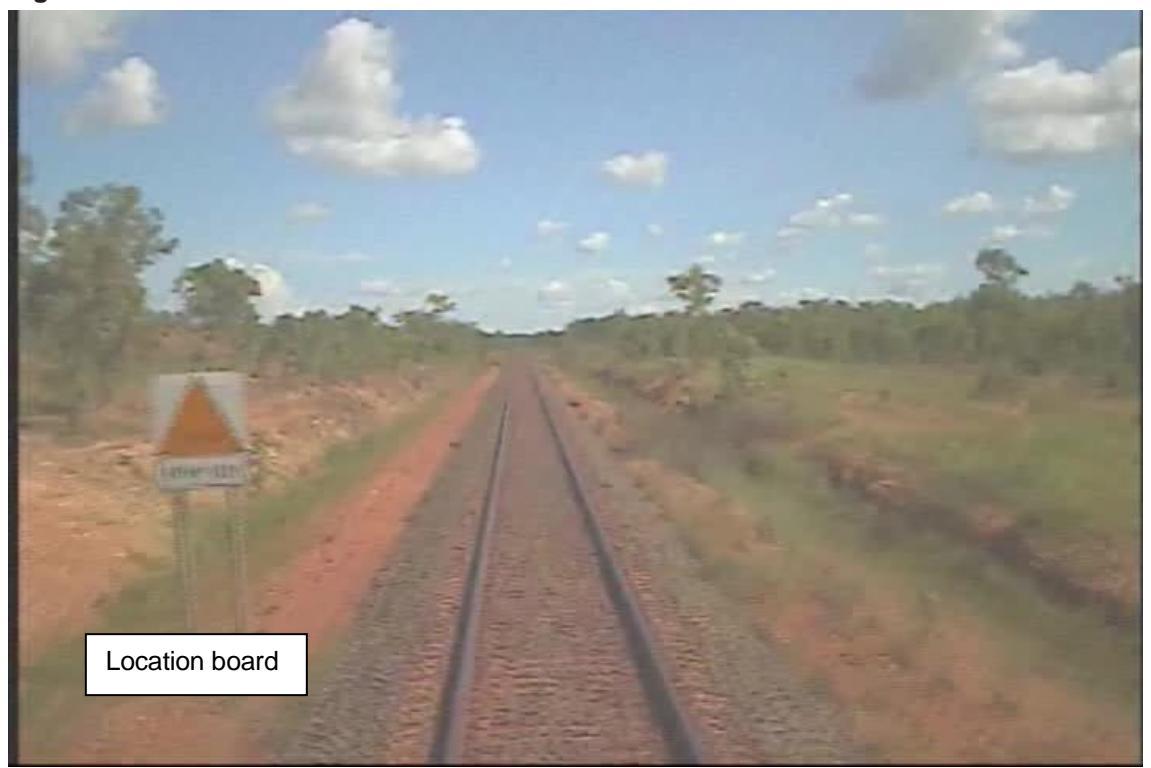
Figure 1: Union Reef location board at 4500 m – as seen from 2DA2.

Less than 1 minute later (1541:54), train 2DA2 passed the Union Reef location board, 4500 m (Figure 1) from the crossing loop, at about 69 km/h. The location board is a trigger point for train crews to follow a procedure to remotely operate the points via a four digit code transmitted by UHF^2 radio.

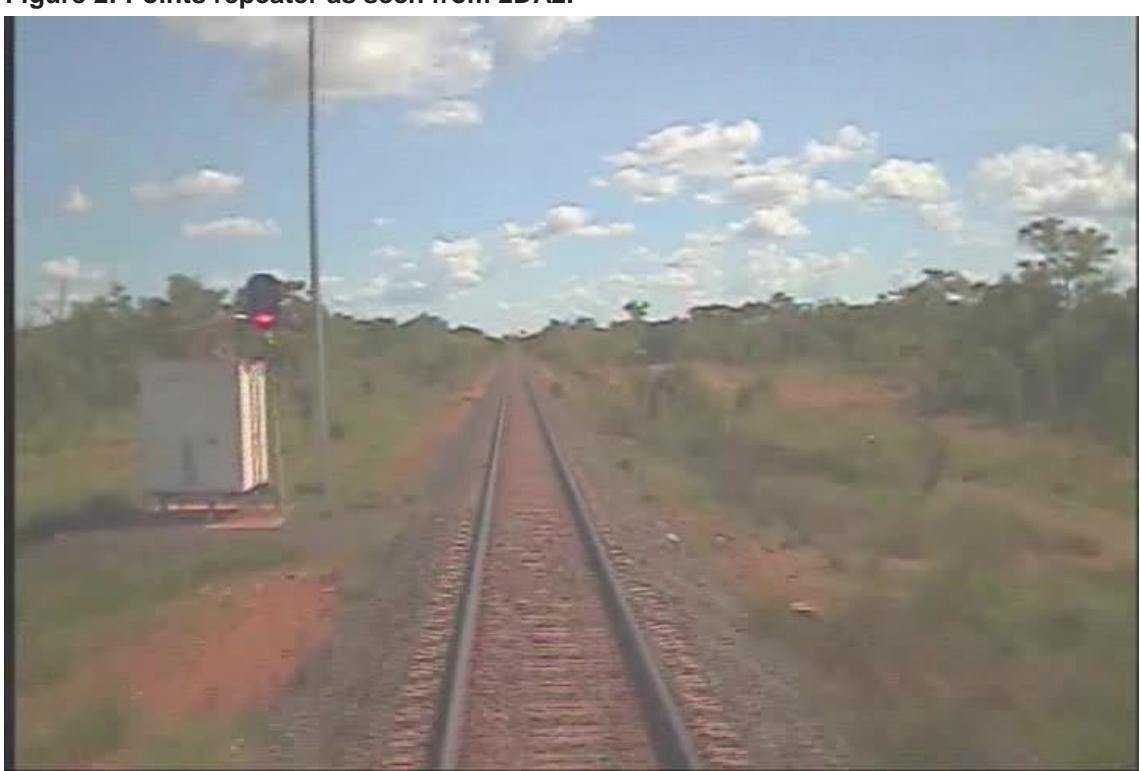
Figure 2: Points repeater as seen from 2DA2.

At 1545:43, train 2DA2 passed the colour light point indicator [repeater] located 1183 m from the points, at about 53 km/h (Figure 2); the indicator still displaying red. The crew members cross-called the displayed indication³ as per the GWA procedure.

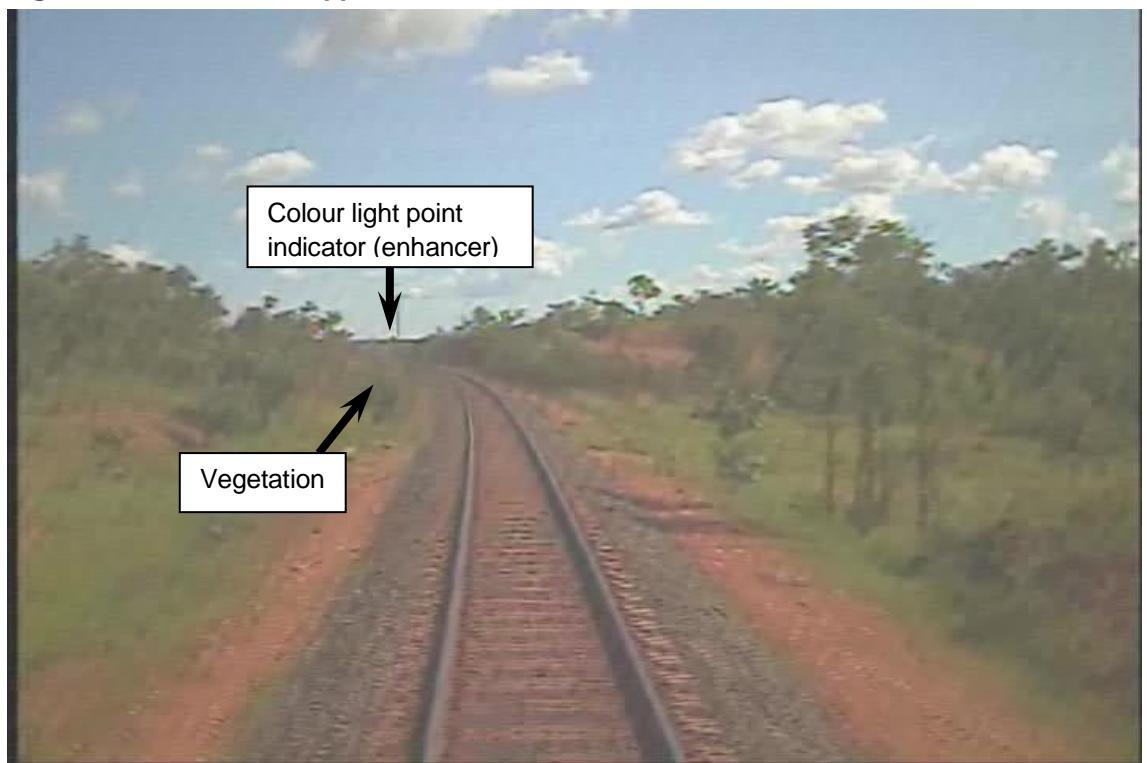
Figure 3: Time of brake application, as seen from 2DA2.

At 1546:53, when 178 m from the points (Figure 3), the train crew observed the points stand indicator was displaying an unclear indication and applied the train brakes. Both crew members then noticed that the points had not fully transitioned for access onto the loop track.

The General Electric LocoCAM forward facing video camera footage, although not clear, indicates that the sighting of the colour light enhancer was not continuous and unimpeded. Based on the footage, the enhancer was only clearly visible about 180 m from the points, which coincides with the driver making the brake application (Figure 3).

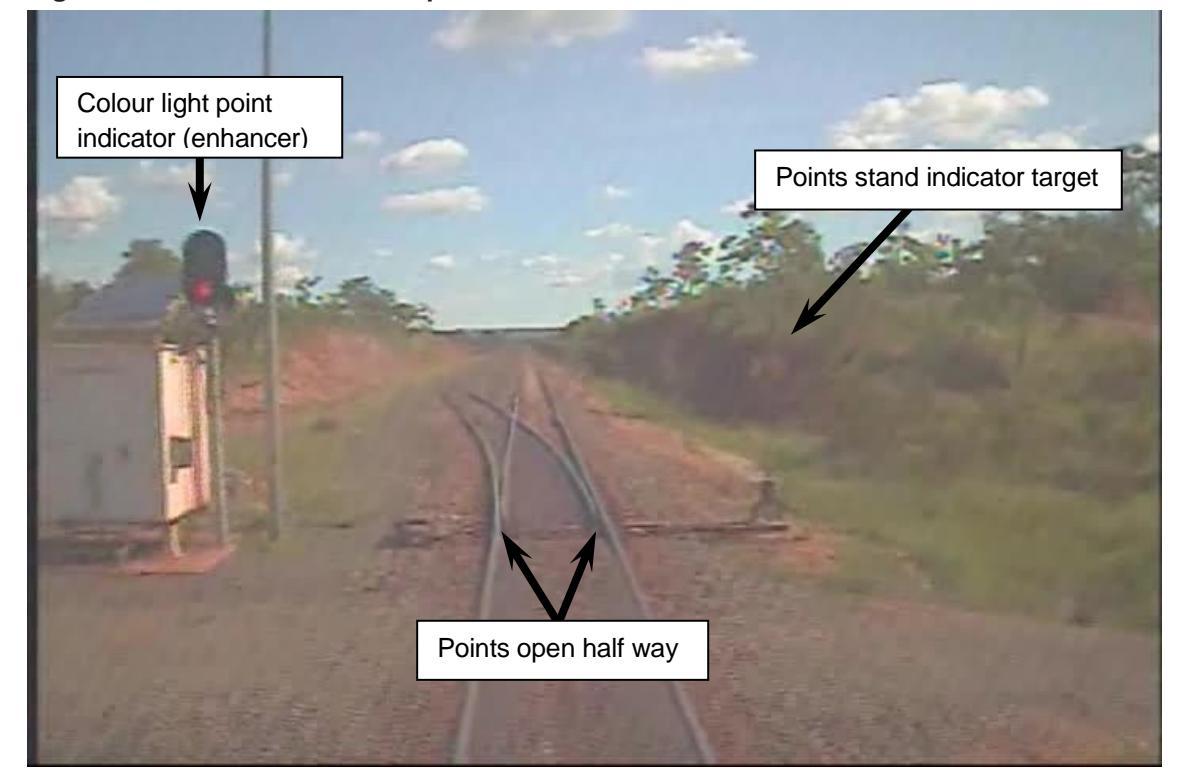
Figure 4: Points indicators and points at Union Reef as seen from 2DA2.

Train 2DA2 was unable to stop and, at 1547:08, it travelled over the open points (Figure 4) at 40 km/h and derailed. The train continued to travel derailed for a further 107 m, coming to rest between the main and loop lines.

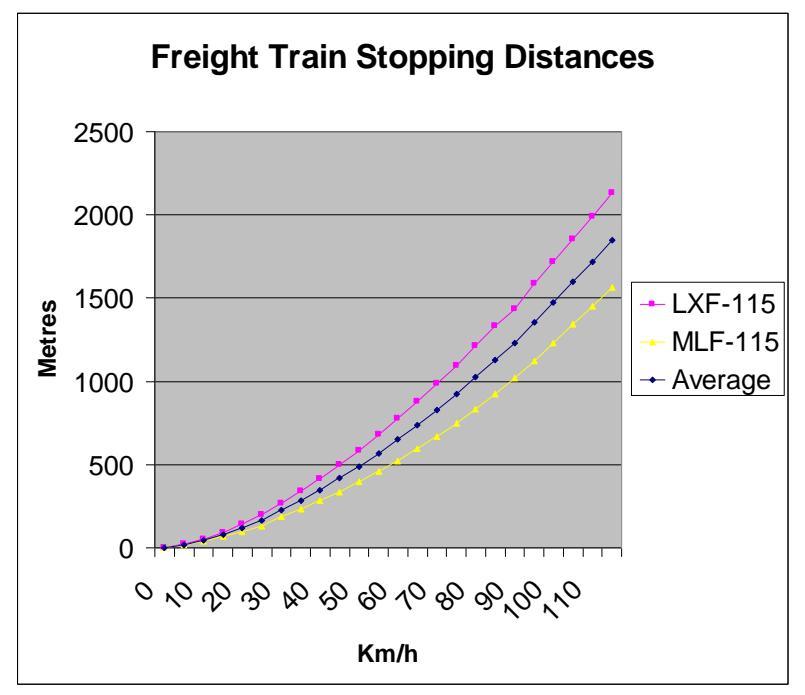
Figure 5: Freight train full service braking curve.

While the two assessments of sighting distance varied slightly, neither provided sufficient braking distance for a train travelling at 47 km/h to come to a stand before the points. Based on a 180 m sighting distance, and an average full service braking curve for freight trains (Figure 5), the maximum approach speed for trains to stop before the points should be no more than about 25 km/h.

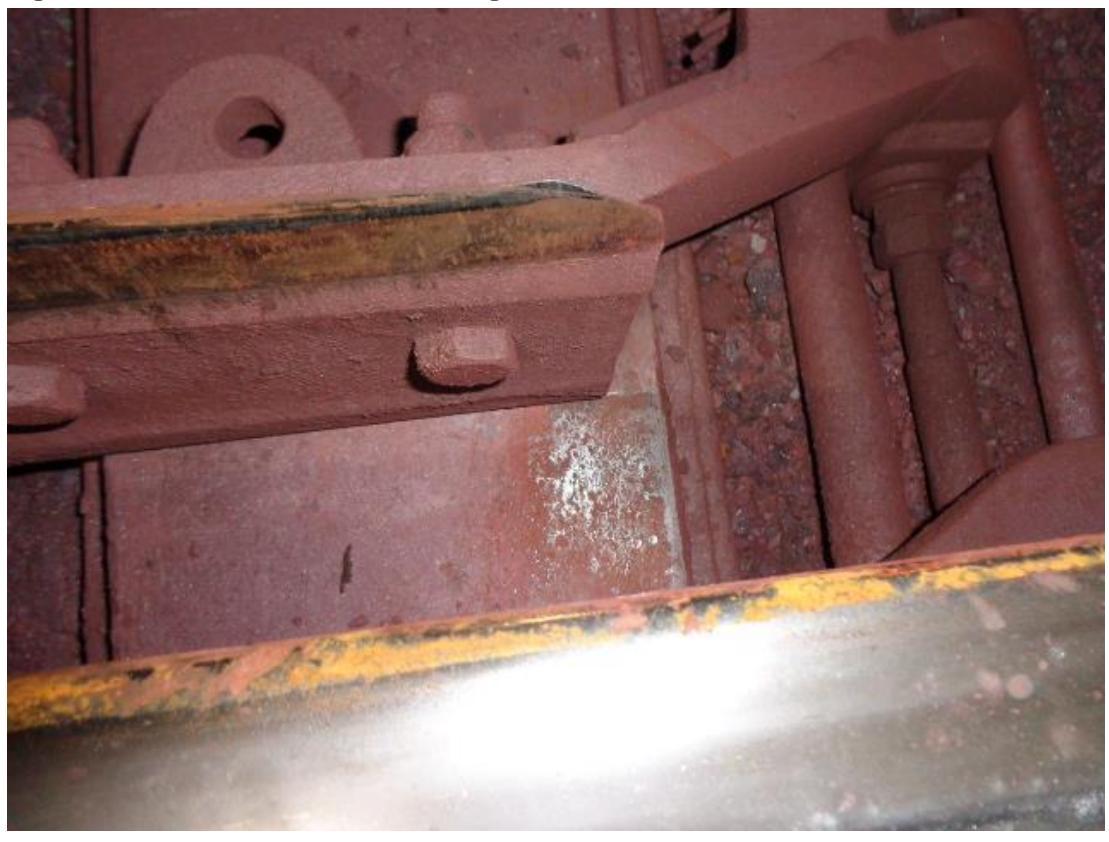
A number of follow up tests confirmed that the points were mechanically correct and within specified tolerances. However, there was evidence of iron ore product build-up between the point blade and the stock rail that prevented the points fully transitioning from the normal to the reverse position.

It is likely that the points at the northern entry into the Union Reef crossing loop failed to completely move fully from the normal to reverse position due to iron ore product obstruction. As a result of this obstruction, the points were unable to be detected and locked at the reverse position (Figure 4), resulting in the colour light indicator system maintaining the indications at red. Furthermore the points appeared to be dry and lacking adequate lubrication (Figure 6), adding further resistance to movement and increasing the likelihood of failure.

Figure 6: Points at Union Reef - lacking lubricant.

Following this occurrence, Genesee Wyoming Australia (GWA) reviewed the reliability, inspection and maintenance frequency of motorised self-restoring points machines. Similarly, with a view to identifying and addressing any increased risk in these locations, GWA specifically undertook to monitor the functionality and performance of track/points exposed to the accumulation of mining products.
