# Separation issue between a Robinson R44, VH-YDK, and a Bell 412, VH-EWA

Jandakot Airport, Western Australia, on 16 November 2014

ATSB Transport Safety Report Aviation Occurrence Investigation AO-2014-182 Final – 26 February 2015 Released in accordance with section 25 of the Transport Safety Investigation Act 2003

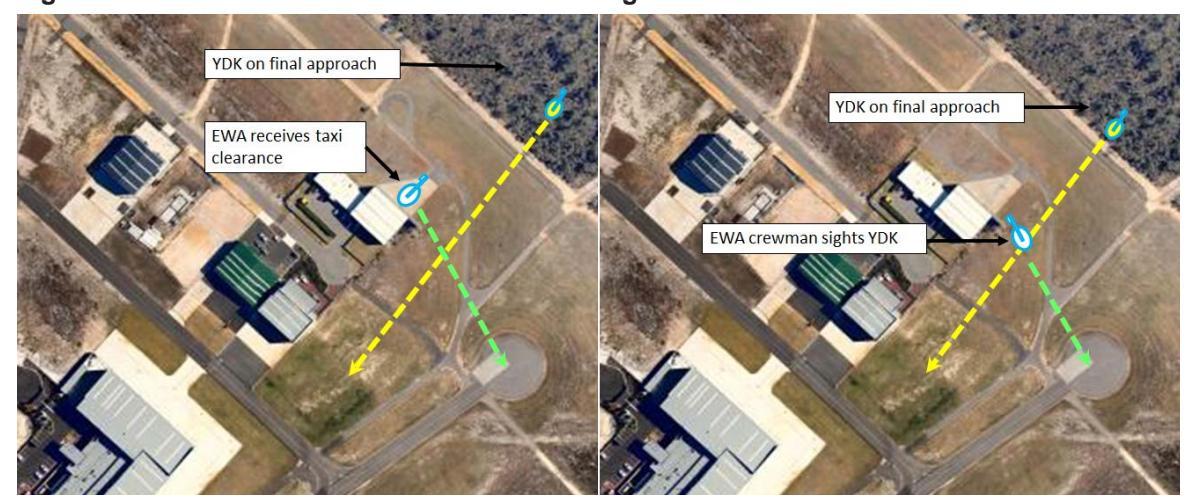
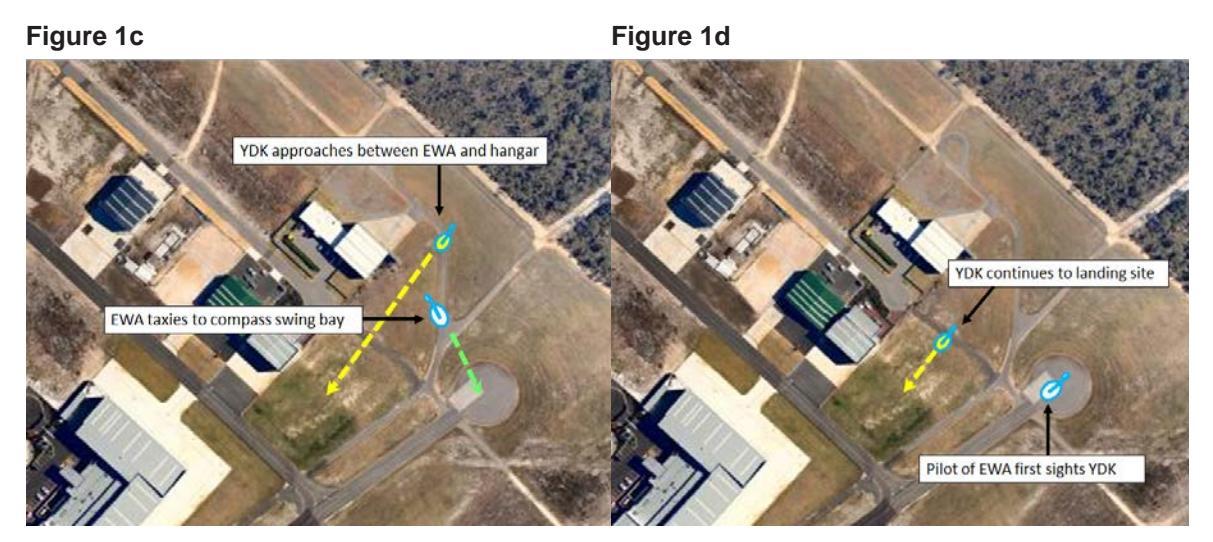
#### Figure 1: Sequence of events and approximate helicopter tracks Figure 1a Figure 1b

As YDK turned onto final, at about 400 ft above ground level (AGL), the pilot of YDK sighted EWA outside its hangar with the rotors turning. He elected to continue the approach as he assumed that the pilot of EWA would sight YDK and remain stationary.

When at about 200 ft AGL,<sup>2</sup> the pilot of YDK observed EWA commence taxiing and he brought YDK into a hover over the trees at the edge of the precinct, about 100 m from EWA (Figure 1b). At about 1350, the pilot of YDK broadcast on the Tower frequency: 'Rescue 65, YDK just out your left hand window'. The pilot of EWA was still monitoring the Ground frequency and did not hear that call. The pilot of YDK did not receive a response. YDK then descended and passed behind EWA towards a landing on the middle of the grassed area (Figure 1c).

The pilot of EWA continued to taxi towards the compass swing bay, and as he turned the helicopter into the 240° direction approaching the bay, first sighted YDK which was then passing behind EWA and about 30 m away (Figure 1d).

YDK landed on the grass between the hangar and taxiway B.

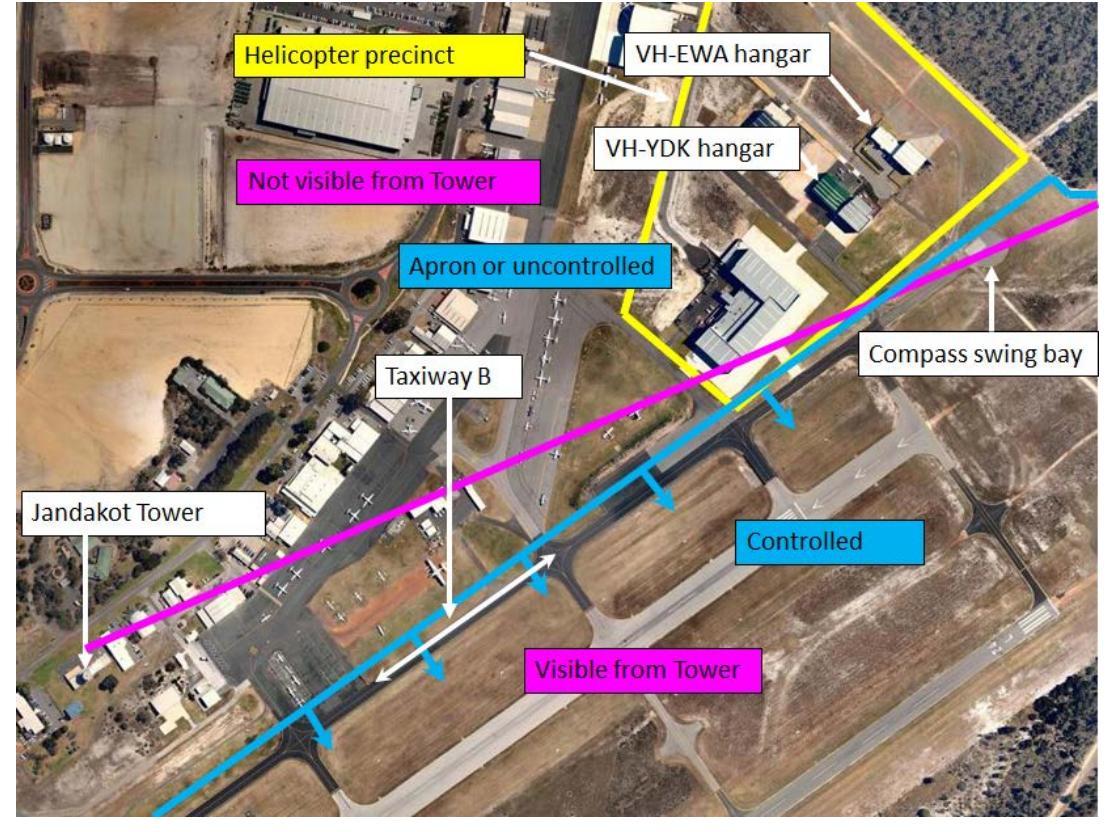
#### Figure 2: Jandakot Airport

The 'helicopter precinct' (Figure 2) is located in the north-eastern section of Jandakot Airport. Due to buildings situated between the control tower and the precinct, all ground movements are uncontrolled, as the controllers have no visibility of taxiing aircraft in the precinct. The precinct is considered to be an apron area. Air traffic control (ATC) only provides take-off or landing clearances where they can see the aircraft.

The standard instruction from the ADC for helicopters landing within the precinct was to report on the ground; for helicopters taking off from within the precinct, the standard instruction from SMC was to report on the tower frequency when ready for take-off. A clearance to the helicopter precinct entitled the helicopter to approach anywhere in the uncontrolled section. No specific clearance to land or taxi (or take off) was issued as the precinct was uncontrolled. The airspace above the precinct was contained within Jandakot Class D airspace and was therefore controlled during Tower hours.

There was no requirement for the SMC to advise the ADC that an aircraft was taxiing from the helicopter precinct to a taxiway nor was there any procedure for the ADC to advise SMC that an aircraft was approaching the uncontrolled apron (AIP GEN 3.4 page 56).<sup>3</sup>

As a result of this occurrence, the operator of VH-YDK has recommended all company pilots to aim for the intersection of taxiways B and H for arrivals, approaching along taxiway B. Departures are to be down taxiway B unless there are fixed wing aircraft on the taxiway, in which case the strip between the taxiway and runway is to be used.

The operator of VH-EWA has recommended company pilots change to Tower frequency prior to taxiing.

The operator of EWA reported that approach to the helicopter precinct should be via hover taxi from an established runway and then taxiway to eliminate conflict in the uncontrolled zone of the helicopter precinct. The operator will continue to liaise with Airservices and Jandakot Airport operator in an attempt to have this procedure implemented.
