BUREAU OF AIR SAFETY INVESTIGATION REPORT

## BASI REPORT B/901/1026

Air North Queensland Pty Ltd Cessna 500 Astec Eagle VH-ANQ 15 kilometres south of Mareeba Airport, Queensland 11 May 1990

Report B/901/1026

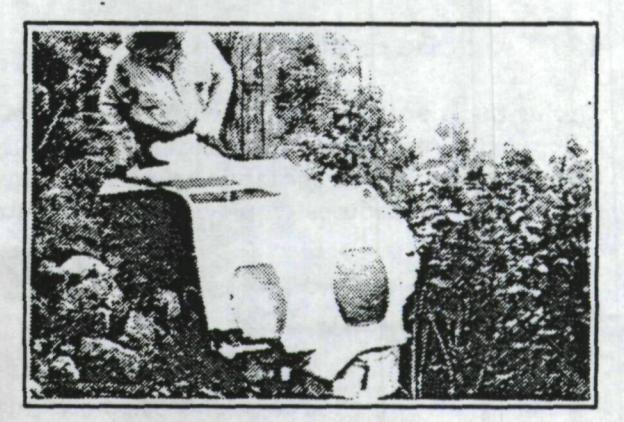
Some components of the GNS were recovered from the accident site. Damage to these components was such that the operational status of the GNS prior to the impact could not be determined.

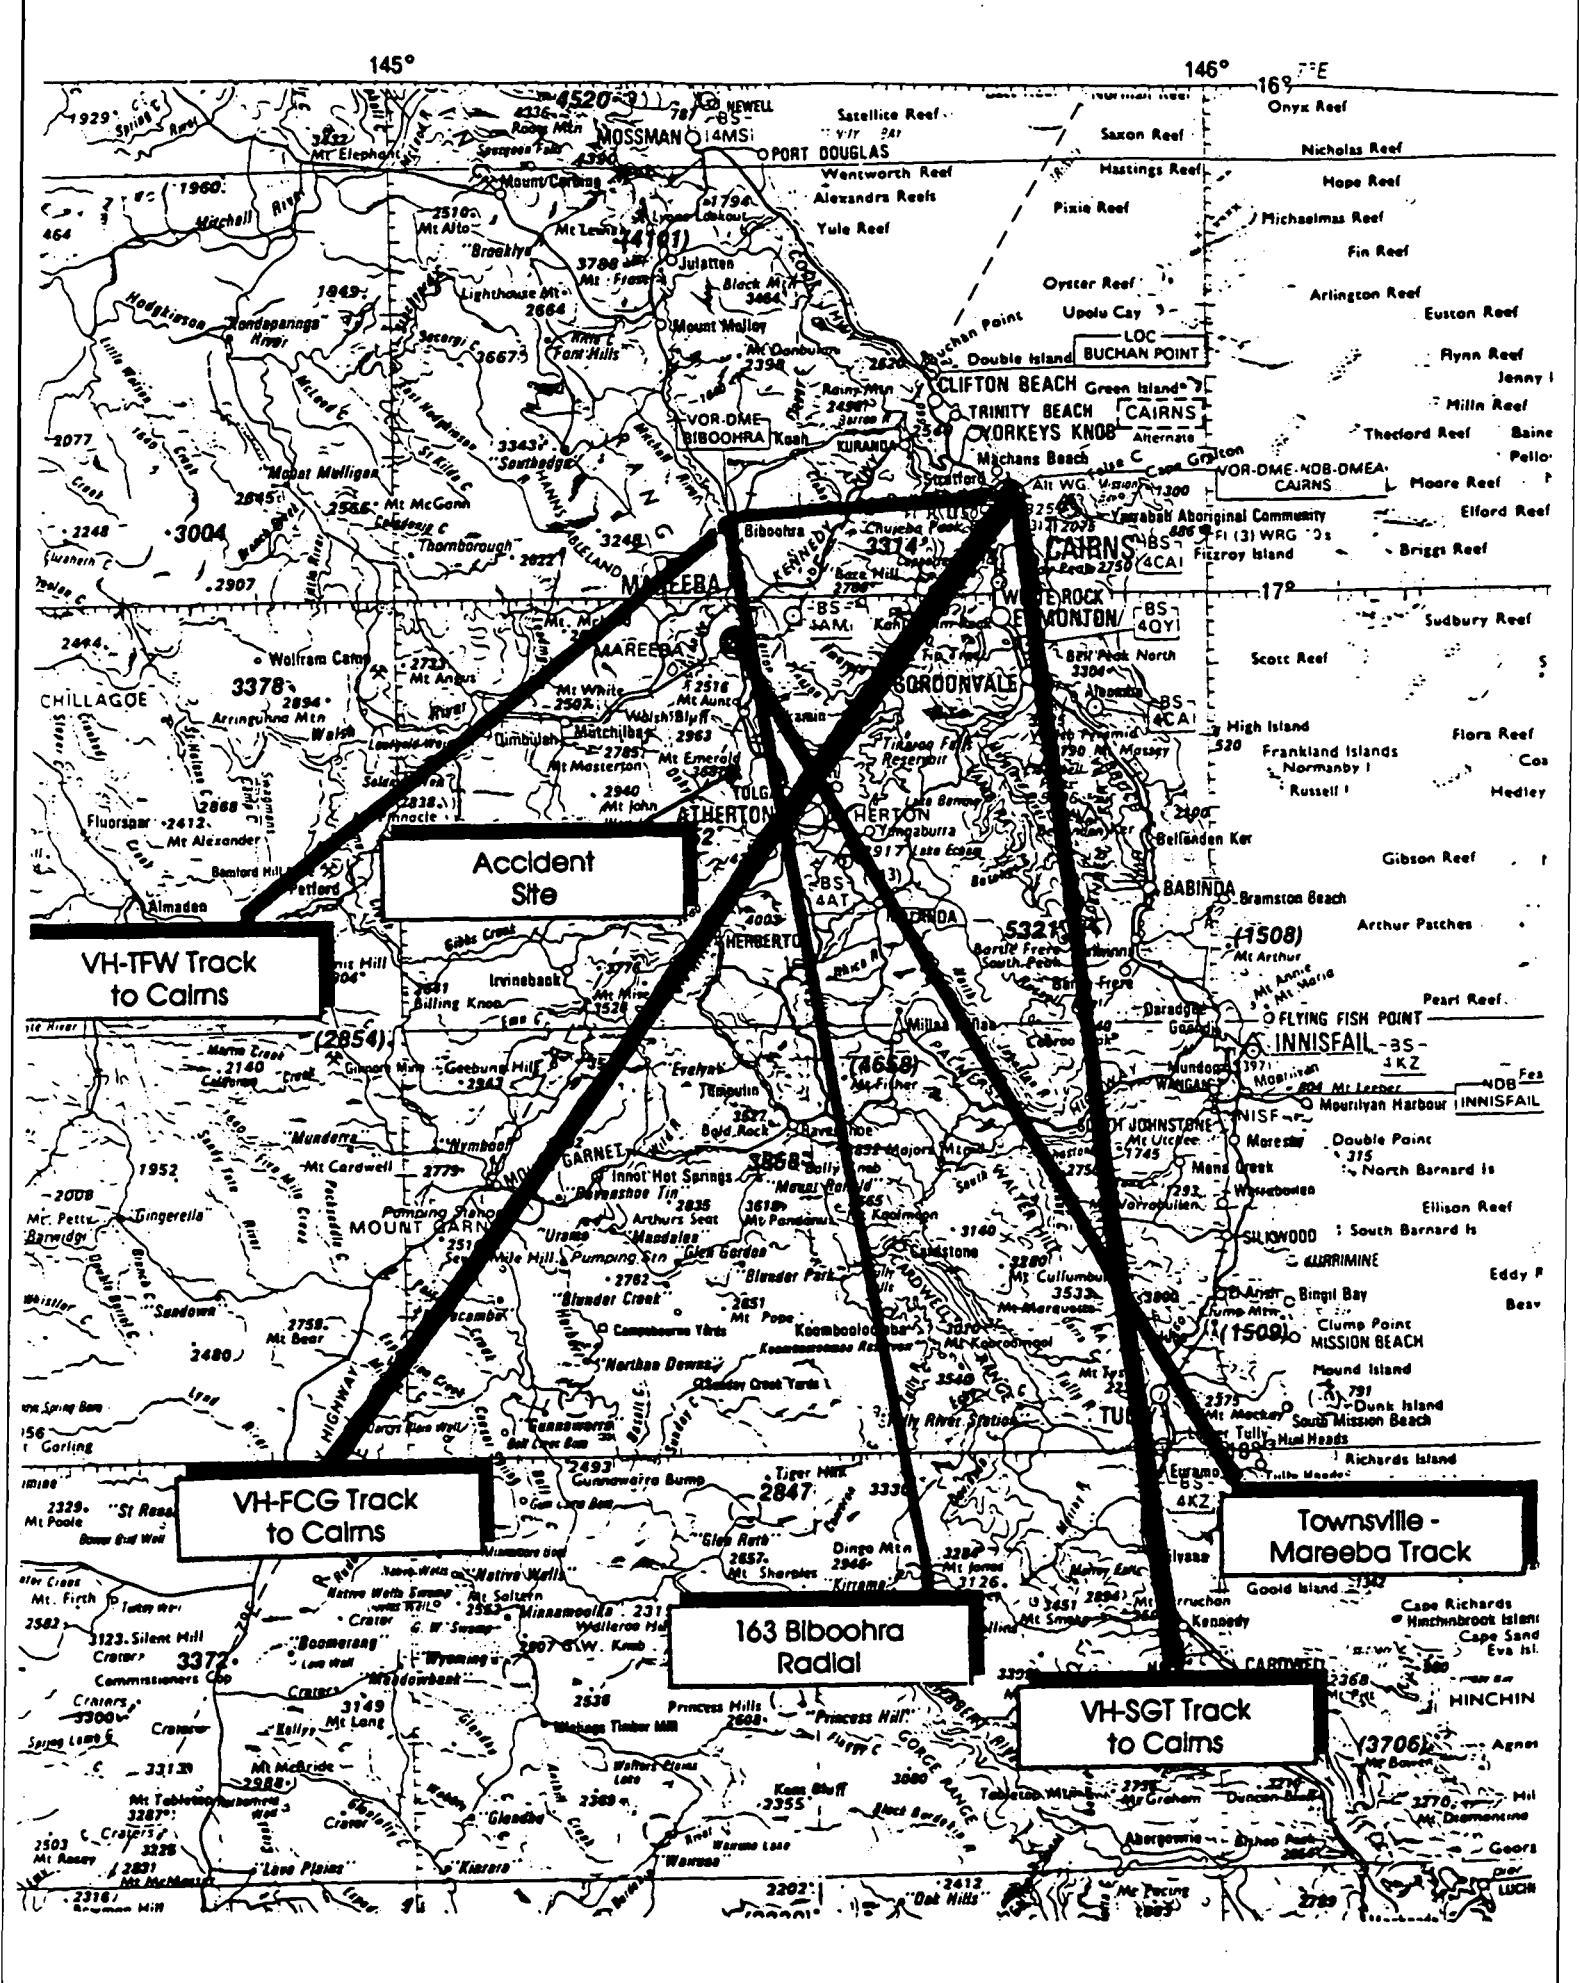
### 2. Relevant Map of Portion of Townsville WAC (World Aeronautical Chart)

When the pilot first contacted Cairns Approach during the descent into Mareeba he advised that VH-ANQ would be tracking via the 163 radial of the Biboohra VOR. However, the impact site on Mt Emerald is approximately three nautical miles (5.5 kilometres) to the left (west) of the nominated track.

The pilot had reported that the aircraft was tracking on the 163 radial, however, the impact site is three nautical miles (about 5.5 kilometres) west of the nominated track. Again, the reason for this variance from a nominated position could not be determined. There are several possible explanations including an error in the onboard navigational equipment, the VOR or GNS, or a deliberate course change by the pilot possibly to avoid cloud or obtain visual contact with the ground. The ground based VOR equipment was checked and was operating correctly and other aircraft that were interrogating it at the time did not report any faults. As stated earlier the onboard aircraft equipment could not be checked because
