# Loss of separation between a foreign military Boeing 737 and a Cessna 206, VH-RAP

Darwin Airport, Northern Territory, 12 March 2014

ATSB Transport Safety Report Aviation Occurrence Investigation AO-2014-047 Final – 14 July 2014 Released in accordance with section 25 of the Transport Safety Investigation Act 2003

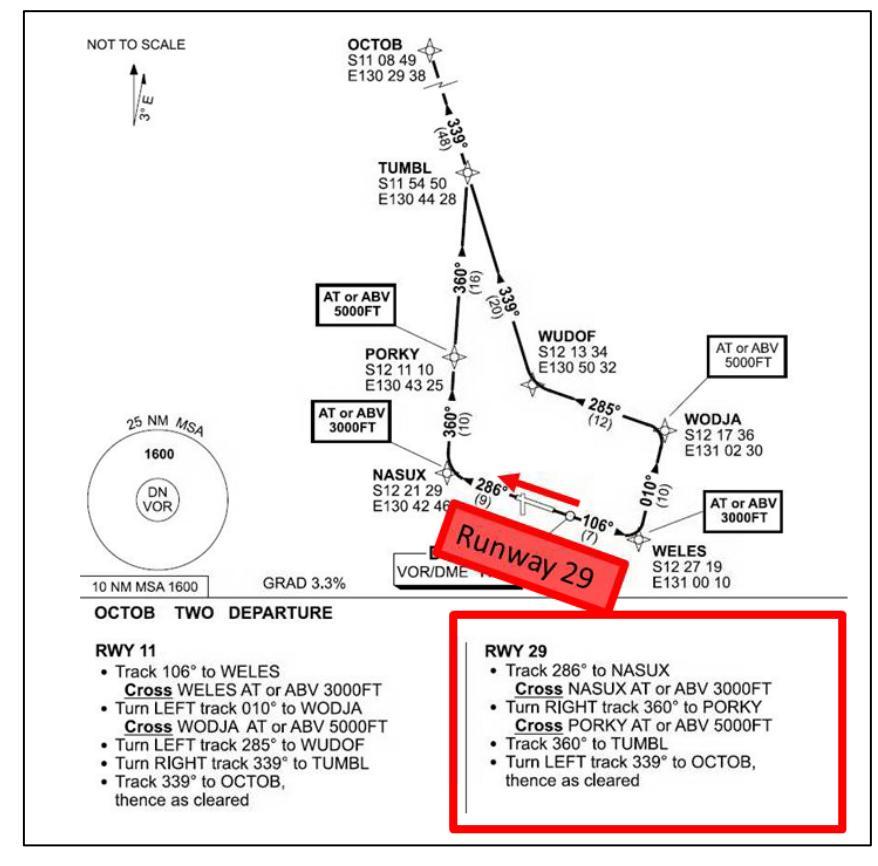
#### Figure 1: Darwin OCTOB TWO SID

The planner cleared Convoy 7186 to track to the destination via the 'OCTOB' waypoint at 5,000 ft above mean sea level (AMSL) and for an 'OCTOB TWO' standard instrument departure (SID)<sup>2</sup> from runway 29 (Figure 1). The crew read back that they were cleared via the OCTOB TWO departure up to 5,000 ft. The planner advised that a read back of OCTOB as the first waypoint was also required. The co-pilot looked up the departure plate for the OCTOB TWO departure and reported that this was an unusual clearance, with the first point being OCTOB rather than the intermediate waypoints as depicted in the procedure chart. The co-pilot then read back 'OCTOB as OCTOB TWO departure'.

<sup>&</sup>lt;sup>2</sup> When departing from runway 29, the SID required pilots to maintain runway heading for 9 NM prior to conducting a right turn to the north, with a requirement to reach 3,000 ft by 9 NM at waypoint NASUX.
