Australian Government Australian Transport Safety Bureau

# Loss of control involving Eurocopter MBB BK117 B-2 VH-VSA

28 km SSE of Port Pirie Aerodrome, South Australia | 15 February 2013

Aviation Occurrence Investigation AO-2013-030 Final – 15 July 2014 Cover photo: Helicopter operator

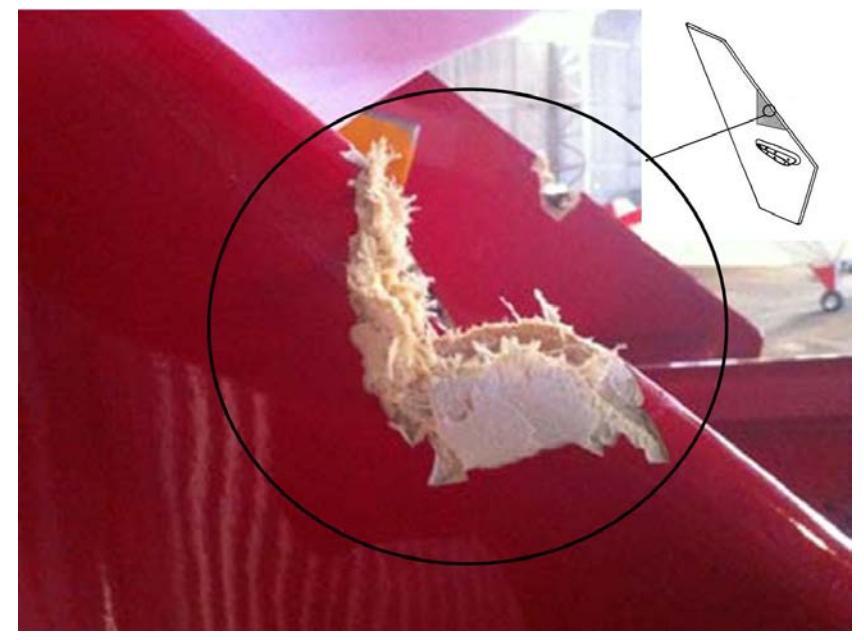
Figure 2: Horizontal stabiliser end plate damage

After landing, the Mayday call was cancelled and all occupants disembarked with no injuries. The helicopter sustained minor damage to the horizontal stabiliser end plates (Figure 2), which were struck by the main rotor blades. The main rotor blades themselves were undamaged.

- the damage to the stabiliser end plates from the main rotor blade strikes was within the foam insert area of both stabiliser end plate leading edges and was repairable
- although there was paint transfer from the stabiliser end plates on the main rotor blades, the blades were defect free and in a serviceable condition
- there were no defects in the hydraulic or pitot static systems
- an auto flight control system self-test function had recorded a pitch servo modular failure, a yaw servo failure and a pitch trim switch failure. These fault codes were considered by the operator to be the product of the recovery actions taken by the pilot and not defects or faults that had contributed to the incident.
