Australian Government Australian Transport Safety Bureau

Propeller loss involving Jabiru J430, VH-TJP

North of French Island, Victoria | 8 March 2013

ATSB Transport Safety Report Aviation Occurrence Investigation AO-2013-046 Final – 19 August 2014 Released in accordance with section 25 of the Transport Safety Investigation Act 2003

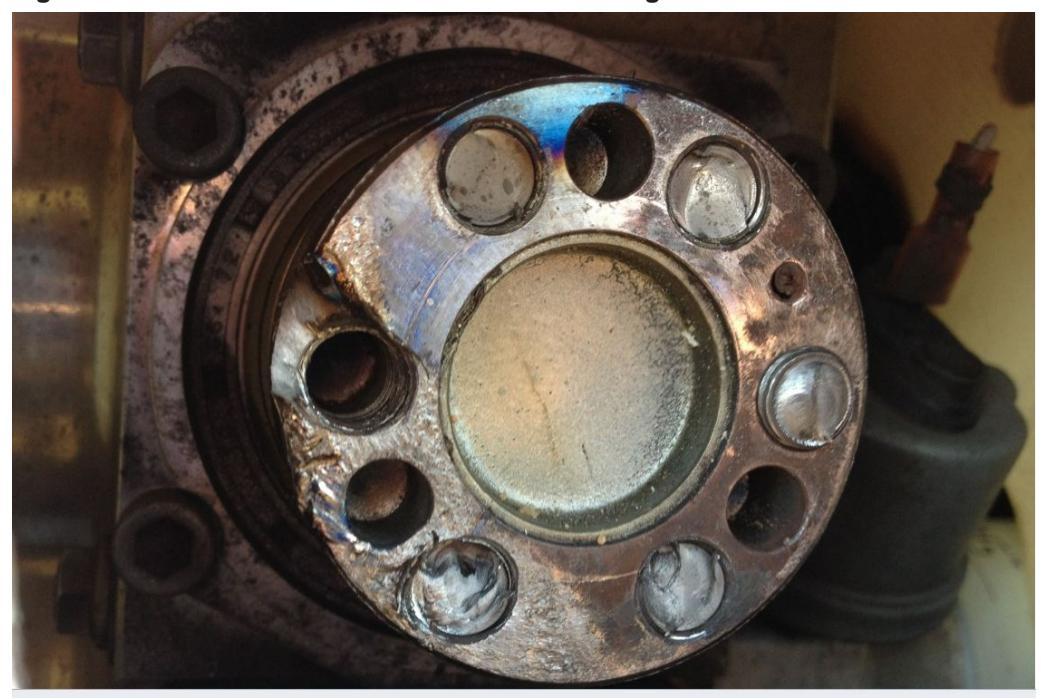
Figure 1: Forward end of TJP's crankshaft showing five broken screws

The five fractured screws had corroded after immersion in salt water and required ultrasonic cleaning. Microscopic examination found that the screw directly opposite the empty, tapped hole in Figure 1 had initially failed by fatigue cracking that began at the root fillet radius, but changed to bending overstress; final failure of the remaining half of the cross-section was by ductile shear. The four remaining screws had also failed by fatigue cracking, which initiated at the thread root then proceeded across the section with final failure by overstress (Figure 7). The failure plane of these four screws was approximately level with the crankshaft faying surface, while that of the bending/shear-overload, fifth screw was approximately two threads proud of that surface (Figure 1).

The absence of dowel pins in the sockets at the end of the crankshaft (see Figure 1) and absence of mating holes in the prop flange (Figure 6) were noted. At the time that this assembly was manufactured, there was no requirement for the installation of interference-fit dowels - these were introduced to the flange/crankshaft joint in July 2011(at engine Serial Number 2446). Positive-location dowels serve directly to limit any rotational slippage that may occur within the flange joint – preventing the assembly from bearing against the fastening screws and producing the fatigue cracking as sustained by the assembly from TJP.

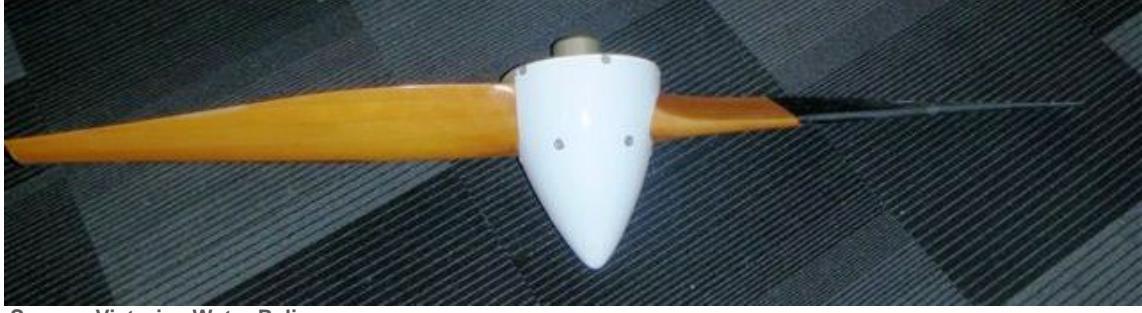
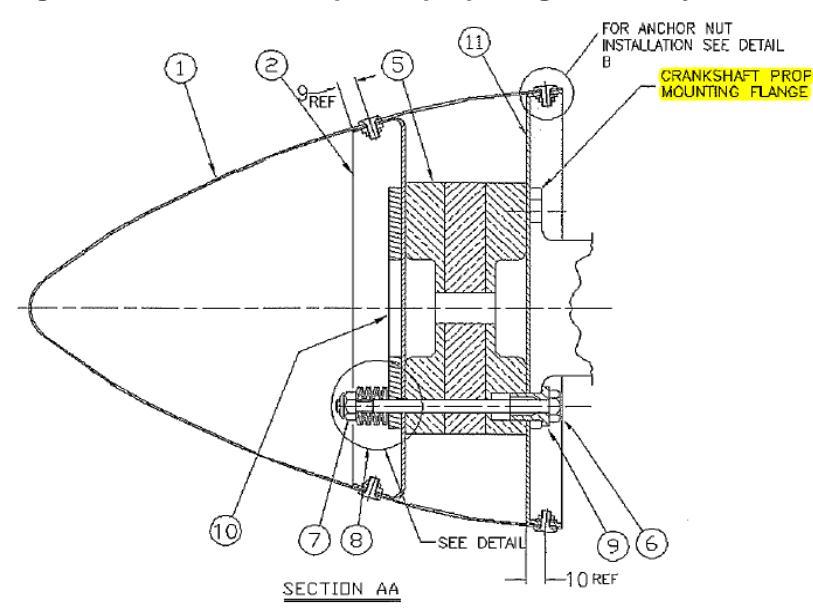
Figure 2: Recovered propeller/spinner assembly

The as-recovered propeller–spinner–prop flange assembly is shown in Figure 2 with the propellermounting flange uppermost in the figure and highlighted in the drawing cross-section below (Figure 3). The laminated wooden propeller (Item 5) fastens to this flange via six bolts (Item 6).

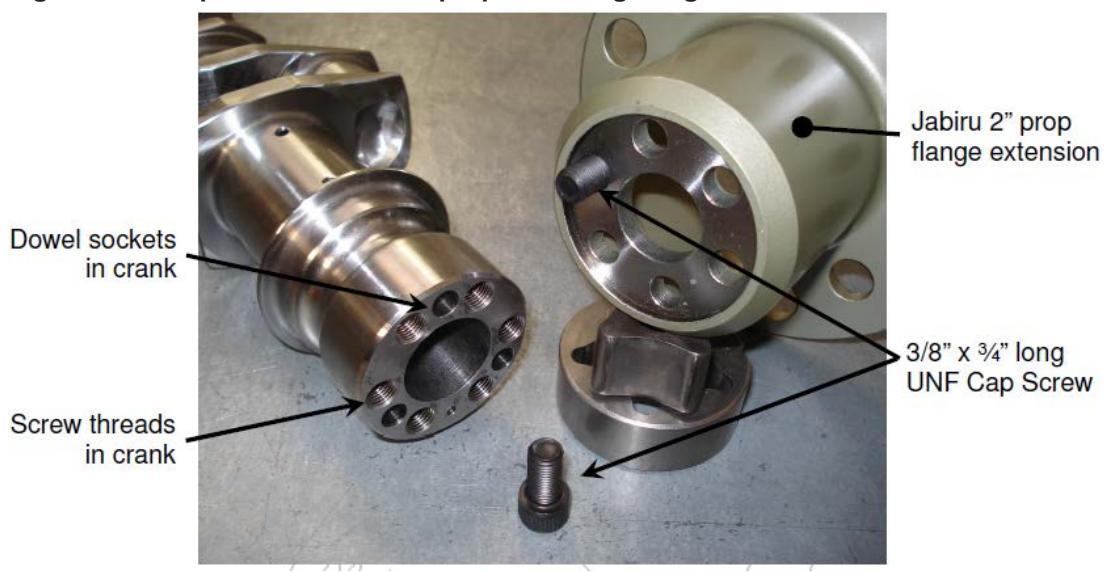
Figure 4: Exemplar attachment of prop-mounting flange onto the crankshaft

The propeller-mounting flange attaches to the engine crankshaft at the forward end via six 3/8" x 3/4" long, UNF socket-head cap screws (Figure 4). As can be seen in Figure 1, five of these screws on TJP had failed and one was missing.

Of note in Figure 4 is the absence of paint on the faying surfaces of the crankshaft and flange, and the presence of dowel sockets in the crankshaft (originally added for use by after-market propeller manufacturers²).

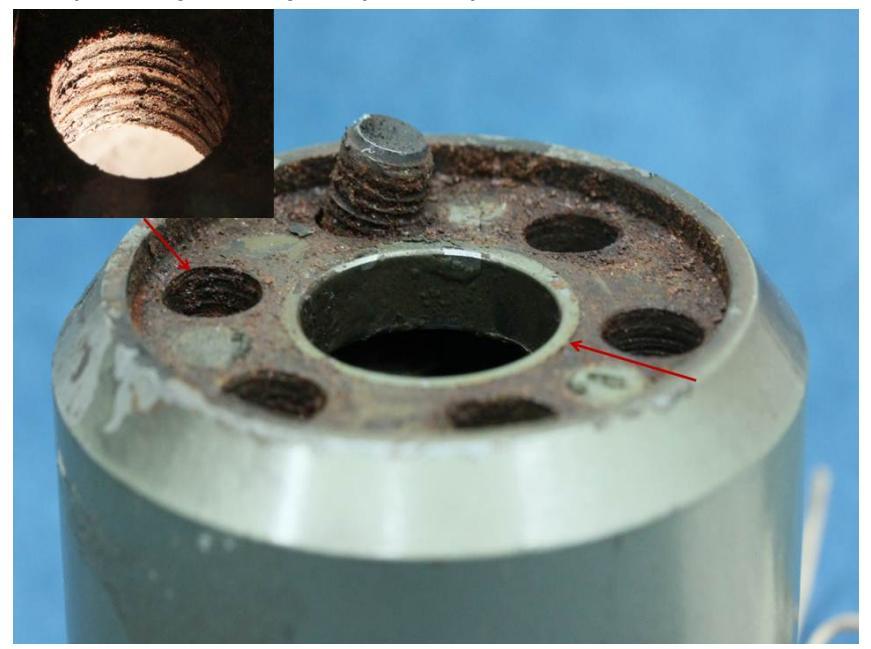
Examination of the rear faying surface of the propeller flange showed the single remaining screw to be bent with four plastically-deformed threads (Figure 5). Plastic deformation of the remaining five screw bores and driven-side corners by the screws' threads was also visible (see inset). Notable was the presence of paint and its reduced thickness in the contact areas, forming shoulders with contact-free zones (arrowed).

Figure 5: Crankshaft–prop-mounting flange faying surface; note the deformed bores (see inset) and impressed paint (arrowed)

The second key issue was the discovery of paint on the prop-flange–crank joint surfaces (Figure 5) and the cap screw washer–inner flange surface (Figure 6). This was in contradiction of some drawing, process specification and manual requirements¹⁹. The presence of paint or other soft materials on clamping surfaces can result in joint relaxation²⁰ and an elevated probability of the screws failing by fatigue cracking²¹. Visually and microscopically-detected ridges in the paint on both surfaces confirmed that relaxation had occurred within the joint from TJP.

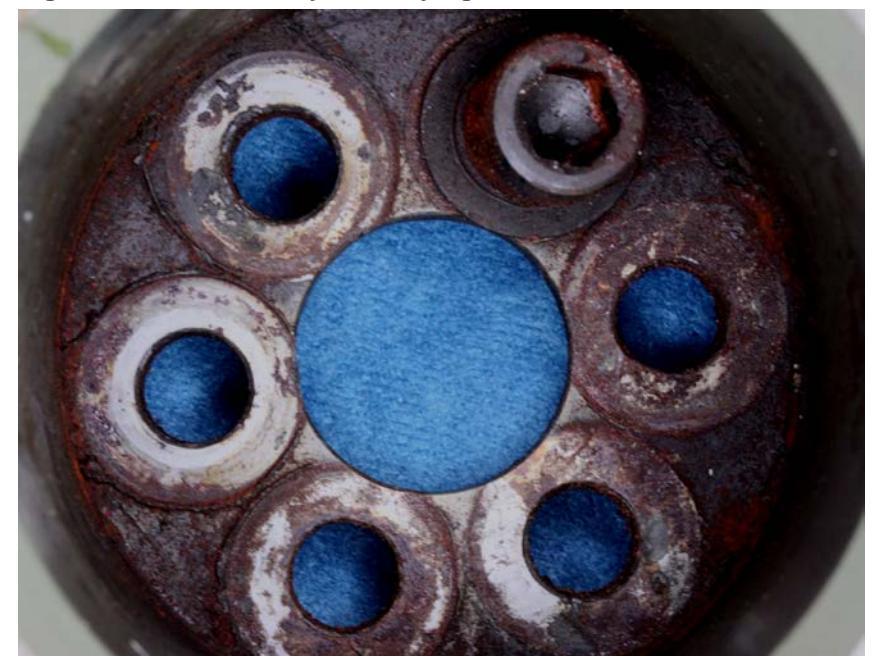
The interior faying surface between the prop flange and the cap screws' Belleville⁴ washers also had the paint reduced to predominantly bare metal in these areas (Figure 6). Paint ridges were adjacent to these six, annular areas. The undisturbed paint thickness was measured at 0.06 mm; on the reverse side (Figure 6) it was 0.05 mm in thickness. As a reference, its thickness on the crankshaft, as applied by the manufacturer, was 0.02 mm.

Figure 6: Predominantly-bare faying surfaces below washers, with adjacent paint ridges

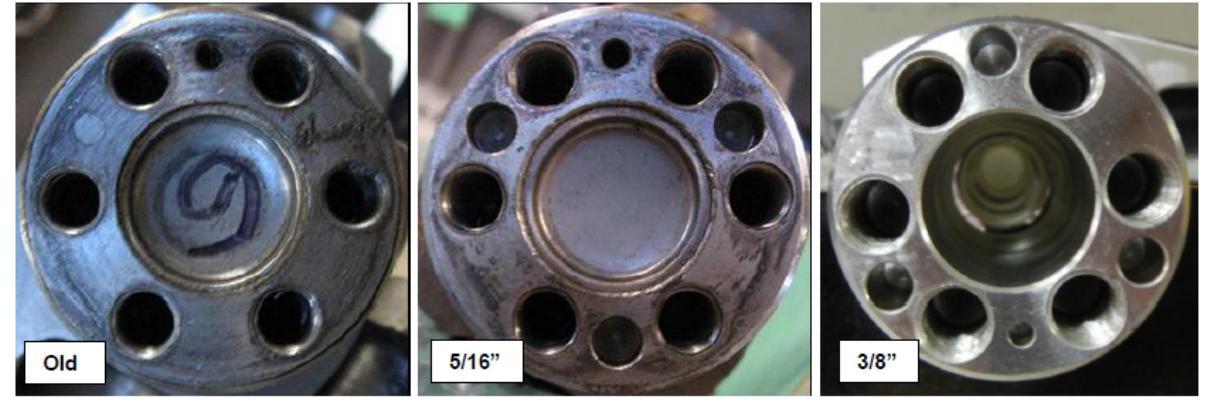
Figure 63 - Crankshaft End Detail (Dowel Holes)

- Several different length dowels have been used: older flywheels without the "starfish" use 24mm long dowels. Engines using the "starfish" initially used 20mm long dowels while later versions reverted to 24mm. Refer to Section 13 for serial number ranges. In all cases the dowels are 6mm in diameter.

- Any crankshaft which has been subjected to a forced stoppage for example from a severe prop strike or piston failure - must be discarded. Section 3.4 refers.
- 5.9.1.3 Optional Updates: Crank / Propeller Flange
- It is strongly recommended that during a full overhaul or bulk strip the engine configuration be updated to include 8mm dowels between the crankshaft and the propeller flange for those engines not built with this feature originally. This may require the replacement or modification of the propeller flange and crankshaft. Refer to Table 40 for S/No. at which this was introduced to production engines.
