Controlled flight into terrain involving Aérospatiale AS350B2 VH-HRQ

240 km west of Davis Base, Antarctica | 1 December 2013

ATSB Transport Safety Report

Aviation Occurrence Investigation AO-2013-216 Final – 25 May 2015 Released in accordance with section 25 of the Transport Safety Investigation Act 2003

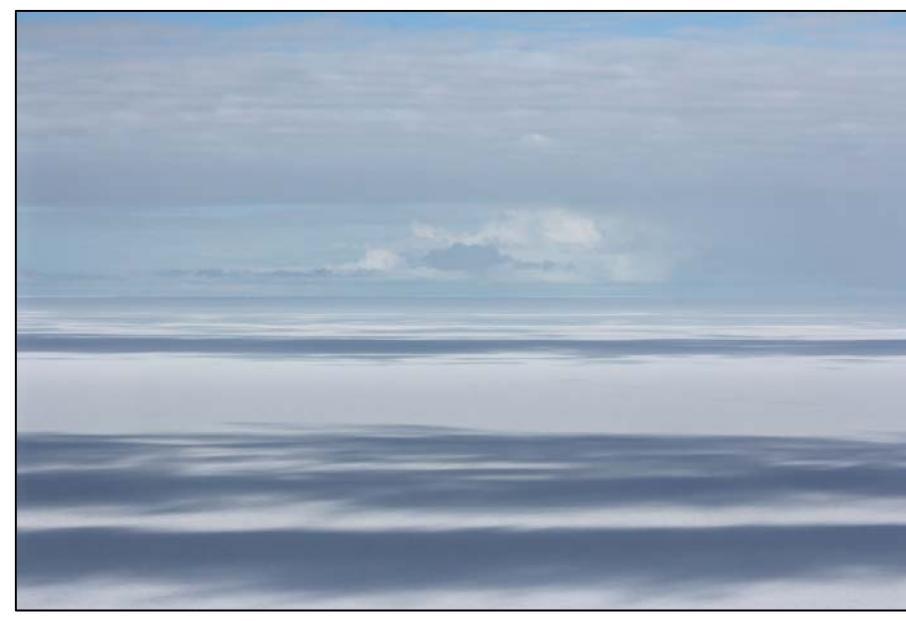
Figure 3: En route to the fuel cache

The helicopters departed for Davis via the fuel cache on the Amery ice shelf at about 1912. Weather across the ice shelf was reported to be sunny; however, approaching the fuel cache, high cloud was observed along the intended flight path. Figure 3 shows a clear horizon to the left of the image, and a reduced horizon to the right.

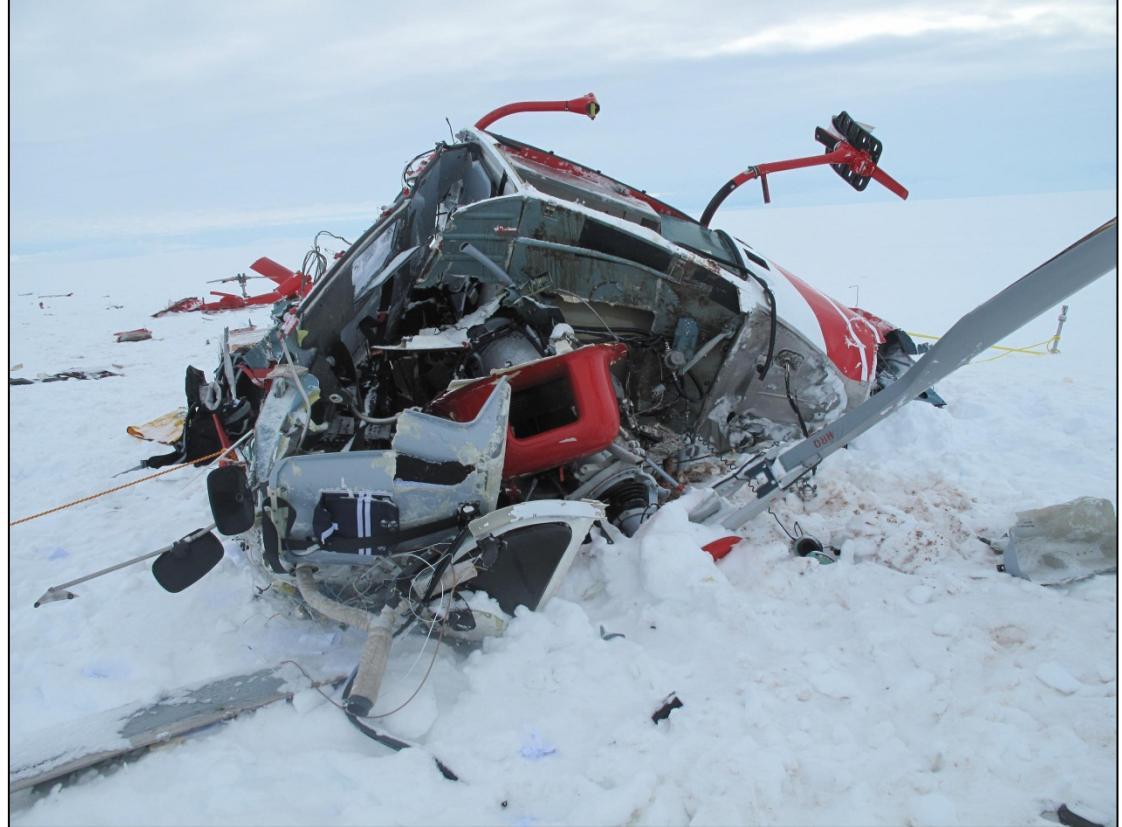
Figure 5: Accident site

The impact was in a southerly direction, about 9 km south-east of the fuel cache. The pilot, scientist and FTO in HRQ were seriously injured and the helicopter destroyed (Figure 5).

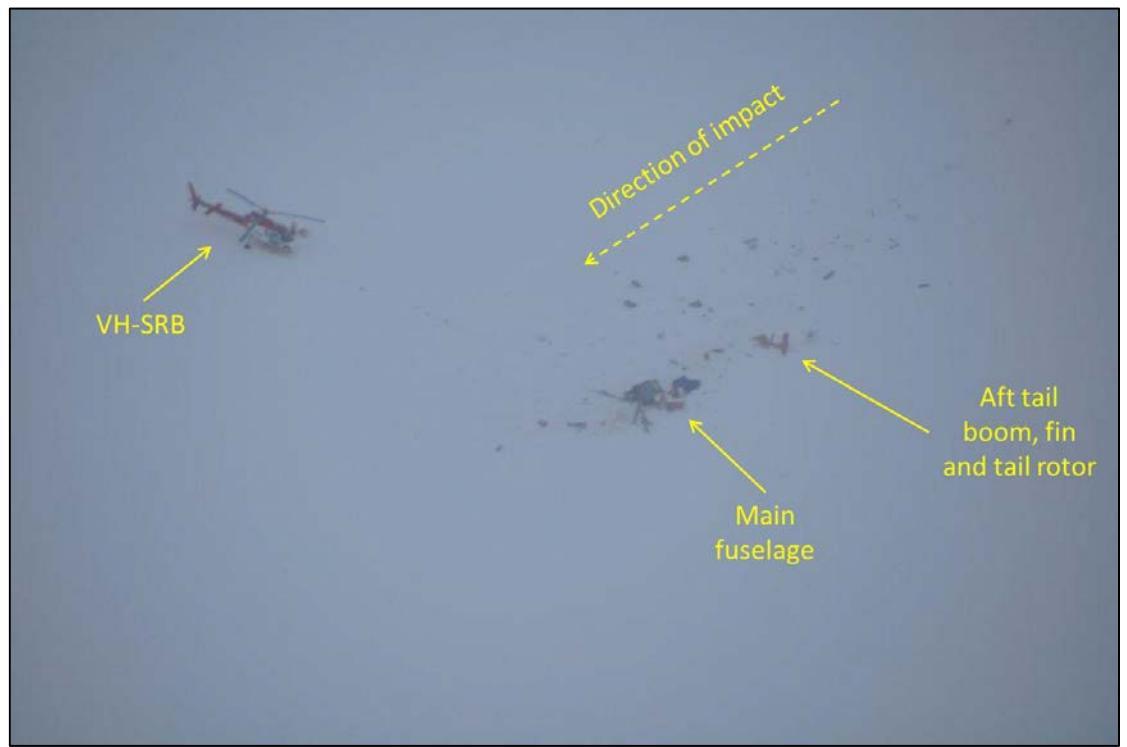
Figure 6: Aerial view of the accident site

The pilot of SRB observed HRQ impact the ice shelf through his left window during the turn and continued the turn at altitude before landing about 15 m from HRQ at about 2044 (Figure 6). Once on the ground, the pilot of SRB attempted to contact Davis by high frequency radio on several frequencies, however reception was poor. The pilot subsequently contacted Davis by satellite telephone to advise of the situation and request an aeroplane be dispatched to evacuate the injured. The pilot and FTO provided first aid to the occupants of HRQ and organised shelter from the weather.
