Collision on the ground involving a Piper PA-28, VH-TXH and a Cessna 172, VH-EUU

Moorabbin Airport, Victoria, 11 April 2015

ATSB Transport Safety Report Aviation Occurrence Investigation AO-2015-036 Final – 10 June 2015 Released in accordance with section 25 of the Transport Safety Investigation Act 2003

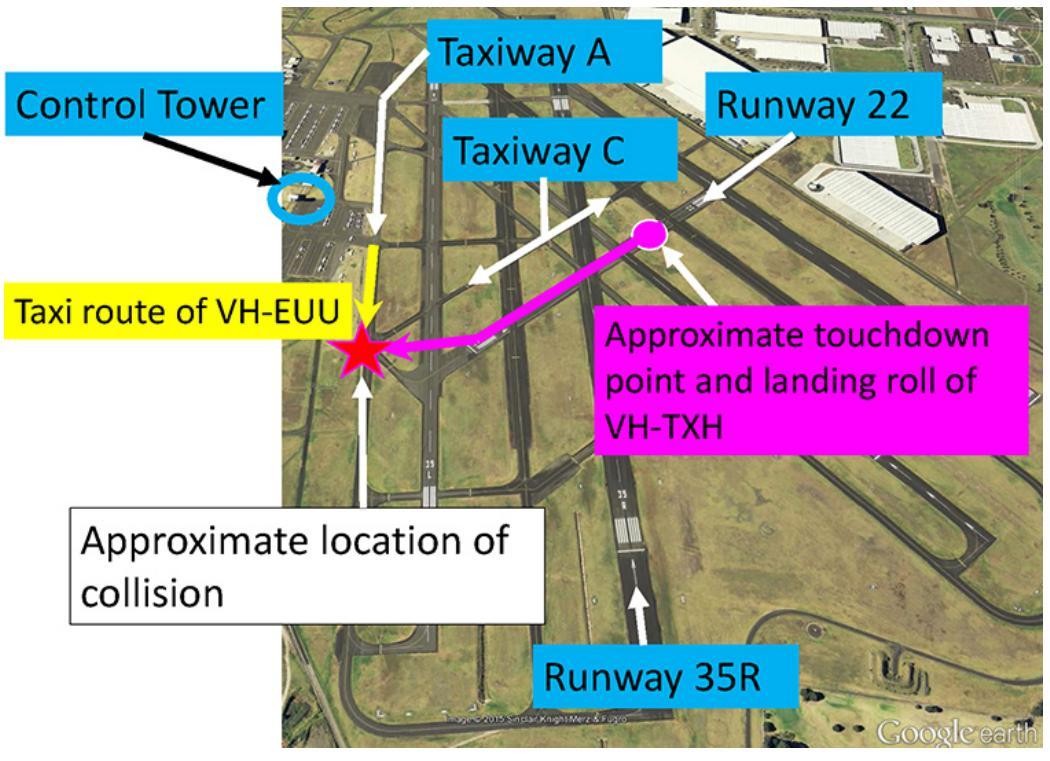
Figure 1: Moorabbin Airport, aircraft tracks and collision point

At 11:37:58, the pilot advised ADC1 that he had a 'spluttering engine' and requested a return to land. ADC1 had observed TXH in the initial climb and noted that it did not appear to be climbing out normally and was then quite low, at an estimated 300 ft AGL. ADC1 initially responded that TXH was number one for runway 35R and then offered runways 22 or 31 if required. The pilot responded that he would use runway 22 (Figure 1).

At 11:39:06, ADC1 cleared TXH to land on runway 22. The pilot of TXH conducted a tight right turn towards runway 22 and as he was concerned about clearing the buildings on the approach to runway 22, he did not select any flap. After passing over the buildings, the pilot reduced the power to idle. He reported that the aircraft touched down about one third of the way along runway 22. ADC1 observed that TXH appeared to land about half way along the runway and did not decelerate normally after touching down. The SMC observed that TXH appeared very low on final approach to runway 22 and crossed the threshold travelling very fast. The ADC1 stated to the SMC and ADC2 controllers 'he's landed long' and 'gee he's quick'.

The pilot of TXH assessed that he was not going to be able to stop the aircraft prior to the end of the sealed runway, but that there was a suitable grassed overshoot area beyond it, and maintained the aircraft on the runway centreline. ADC2 was standing up, and sighted EUU on taxiway A. ADC2 alerted the SMC to the Cessna (EUU) on taxiway A. ADC1 observed that EUU was then still north of the extended centreline of runway 22 on taxiway A.

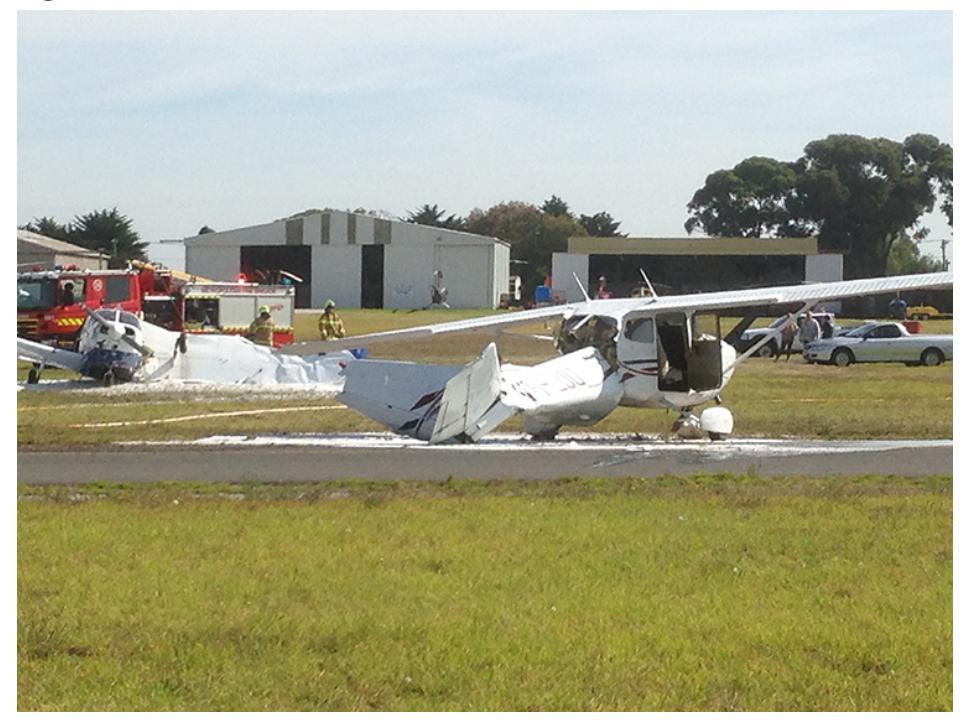
Figure 2: Accident site

The pilot of EUU assessed that if he stopped there, TXH would collide squarely with EUU, so he released the brakes and progressed forwards. The left wing of TXH then struck the tail of EUU and spun EEU around through about 180°. TXH continued veering to the right for about 20 m further before coming to rest on a grassed area (Figure 2).

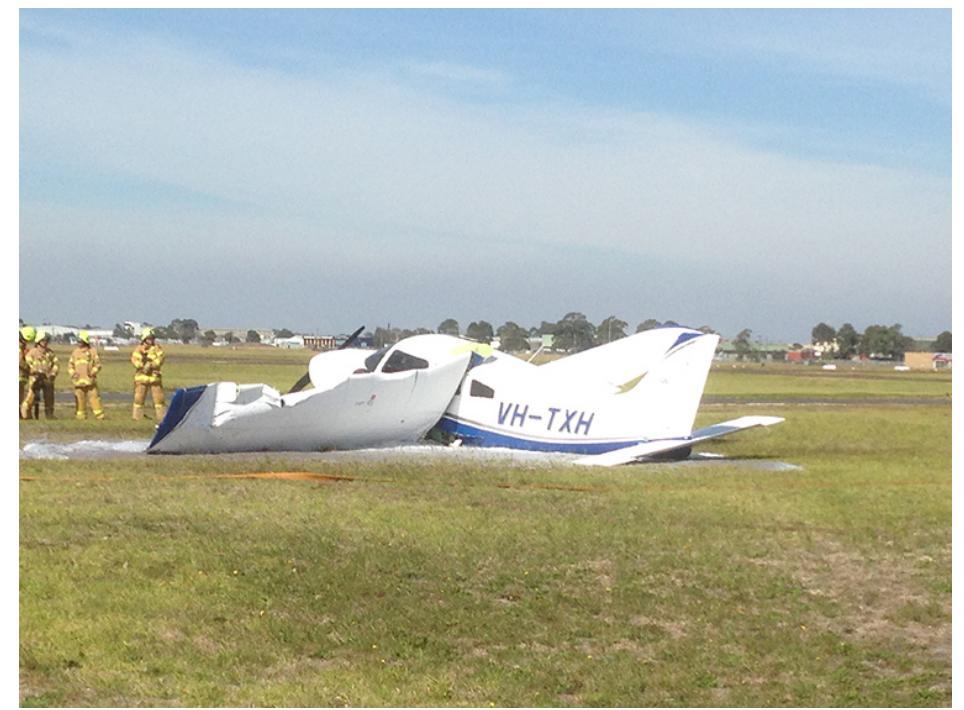
Figure 3: Damage to VH-TXH

The pilot of TXH observed fuel spilling from the ruptured fuel tank and immediately exited the aircraft and reported that he was not injured. The pilot of EUU reported that he momentarily lost consciousness at the time of the collision, but came to within seconds. He then observed fuel leaking, and although feeling disoriented, he conducted a normal aircraft shut down, including switching off the aircraft electrics and fuel. He and the passengers disembarked and were treated for minor injuries. Both aircraft sustained substantial damage (Figures 3 and 4).
