Weather-related operational event involving Boeing 717, VH-NXO

Perth Airport, Western Australia | 1 June 2012

ATSB Transport Safety Report

Aviation Occurrence Investigation AO-2012-073 Final – 12 October 2015 Cover photo: Steve Bottom

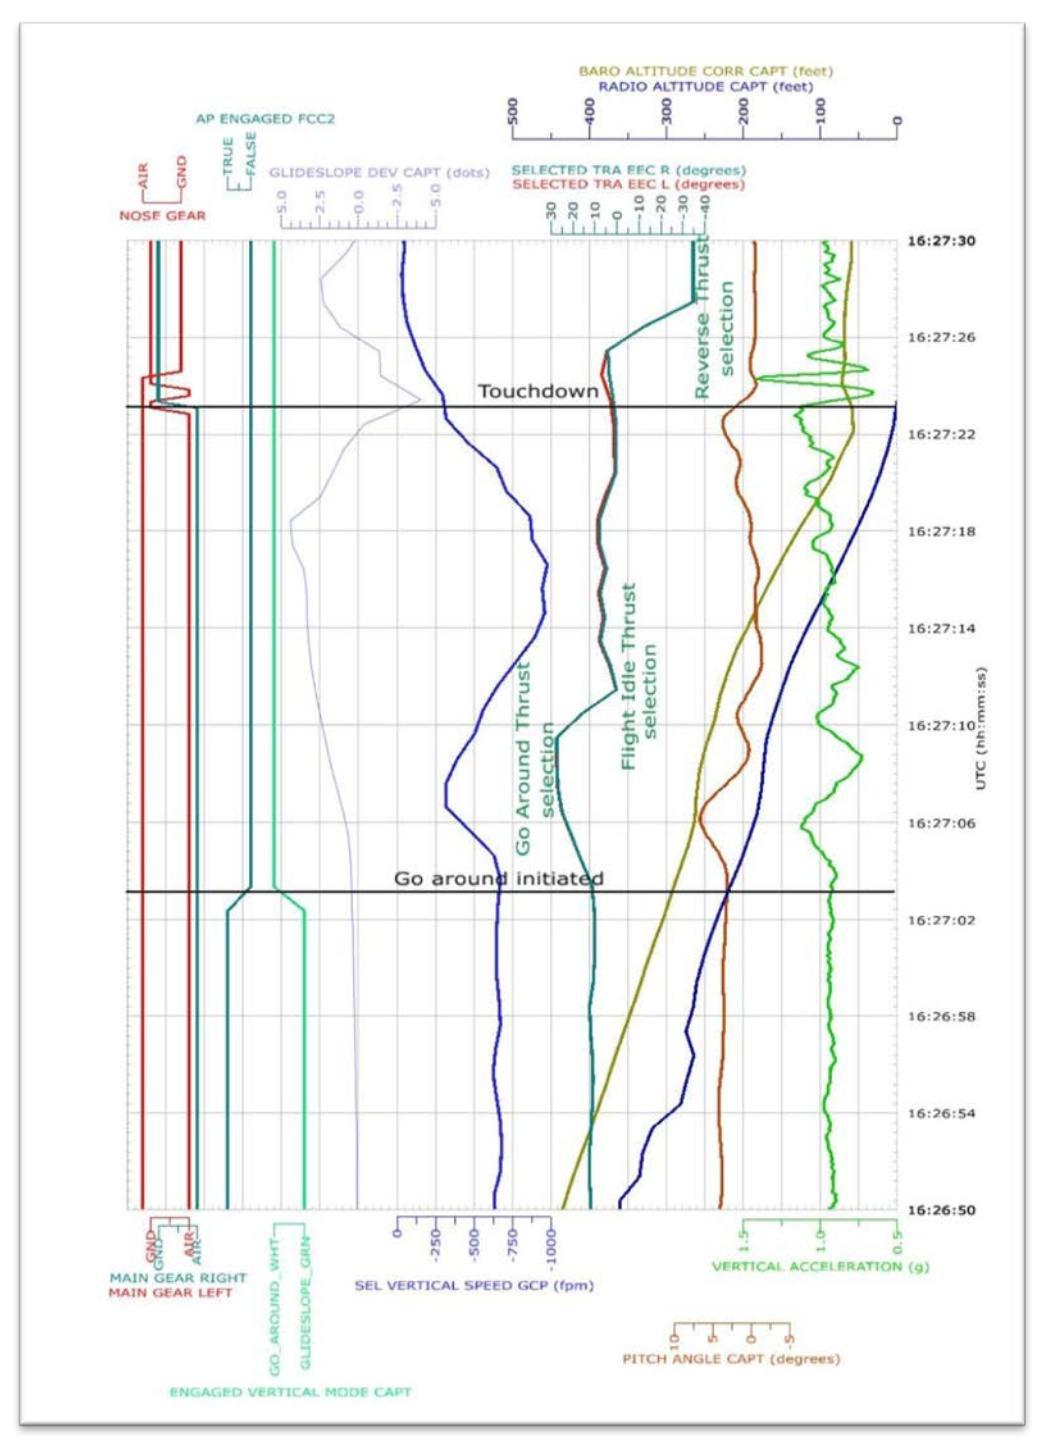
when the aircraft flew clear of cloud and both crew members obtained visual reference with the runway. The captain called 'landing', disconnected the autopilot and the autothrottle, and manually landed the aircraft without exceeding any flight or landing tolerances (Figure 1).

Figure1: Plot of selected aircraft parameters during the approach and landing

The captain later reported being concerned about the unforecast weather deterioration with limited fuel remaining, and not knowing if the weather would deteriorate further after going around and repositioning for a second attempted approach and landing. He reported that this concern influenced his decision to land after initiating the missed approach, during which the aircraft exceeded the operator's stabilised approach criteria for a landing.
