# Partial power loss and forced landing, involving a Cessna 172, VH-FPZ

Carlton Hill Station ALA, Western Australia on 10 September 2015

ATSB Transport Safety Report Aviation Occurrence Investigation AO-2015-113 Final – 22 December 2015 Released in accordance with section 25 of the Transport Safety Investigation Act 2003

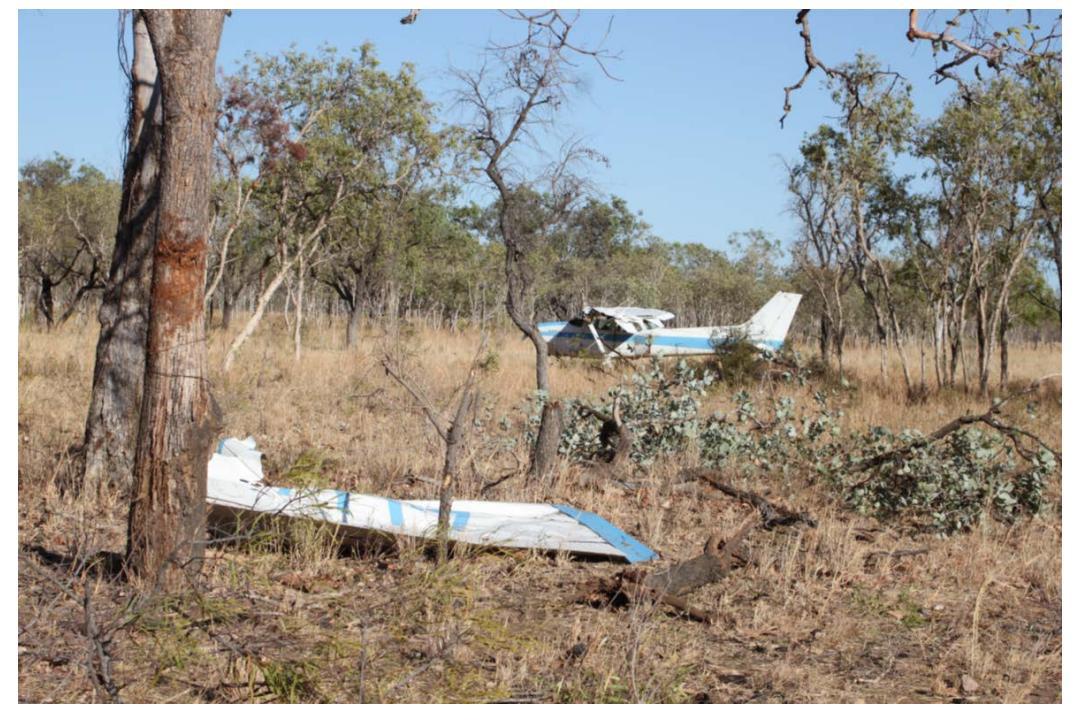
The aircraft travelled a further 20 m, before coming to rest (Figure 2). The pilot, who was not injured, was able to exit via the passenger door. The aircraft was substantially damaged (Figure 3).

Figure 2: VH-FPZ after the forced landing with part of the left wing in the foreground

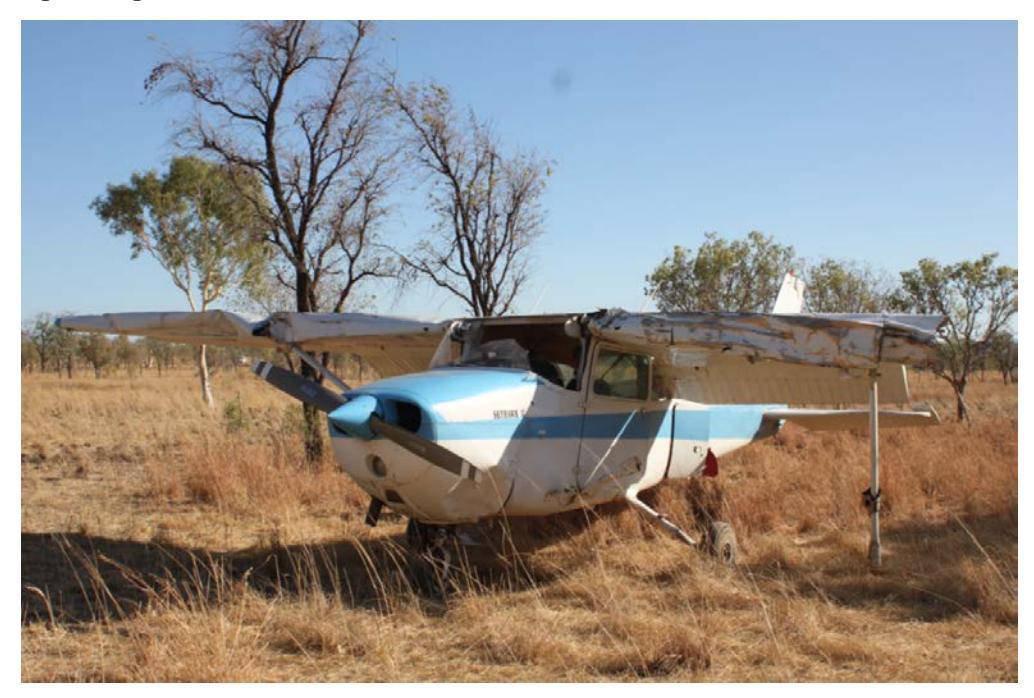
With limited time and options available, the pilot selected a space between trees at the end of the runway to land. They then turned off the fuel, pulled the mixture control to idle cut off, and selected full flap. In the seconds remaining, the pilot steered the aircraft between trees to keep the cabin intact. The wings struck the trees, resulting in the outboard section of the left wing breaking off.

Figure 3: VH-FPZ damage. Note the substantial damage to the left wing and tree impact on right wing
