Wheels up landing, involving a Nanchang CJ-6, VH-ALO

Barwon Heads Airport, Victoria on 6 February, 2016

ATSB Transport Safety Report Aviation Occurrence Investigation AO-2016-009 Final – 27 May 2016 Released in accordance with section 25 of the Transport Safety Investigation Act 2003

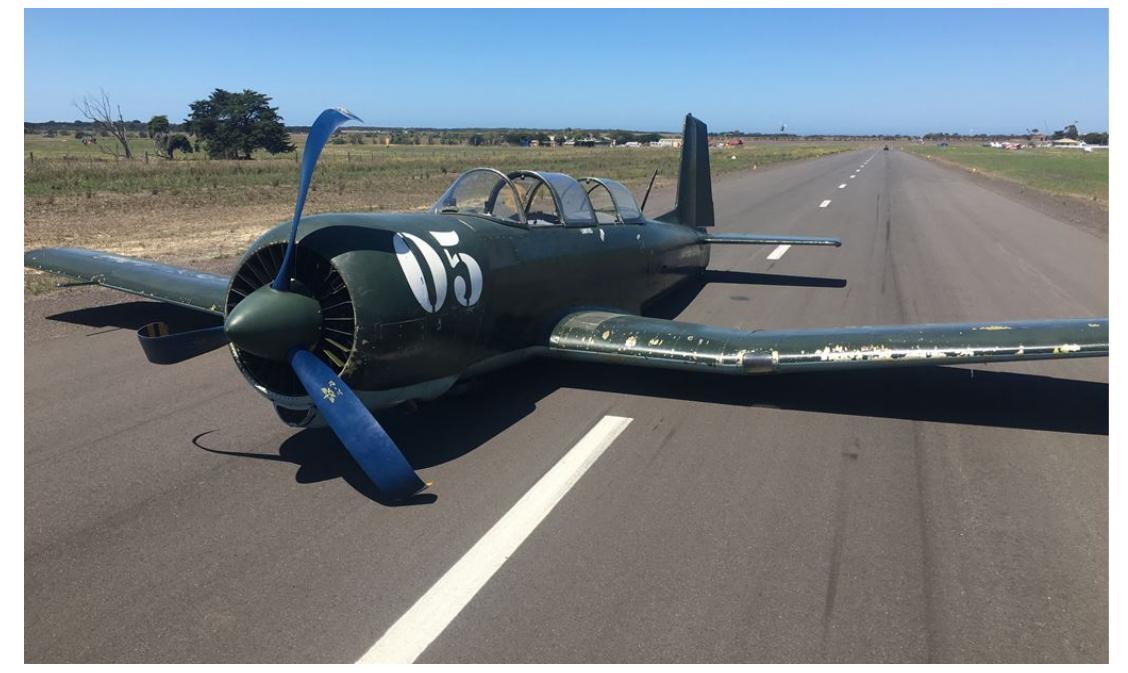
At the chosen 'break-point'² on upwind, Number 2 positioned ahead of ALO in the circuit. The two Nanchang aircraft remained in this single-file sequence behind a Pipistrel aircraft, which had joined the circuit on the downwind leg for runway 36. The Pipistrel aircraft landed, then rolled through to the end of the runway in order to exit; Number 2 followed suit. As ALO touched down, third in a close landing sequence, the pilot realised that they had not completed the pre-landing checks, and the landing gear had not been extended. The aircraft slid along the sealed runway, coming to a stop just off the centreline (Figure 1). The pilot and passenger were not injured, and were able to safely egress. The aircraft sustained damage to the propeller, engine and the underside of the fuselage.

Figure 1: Nanchang VH-ALO, on runway 36 after a wheels up landing

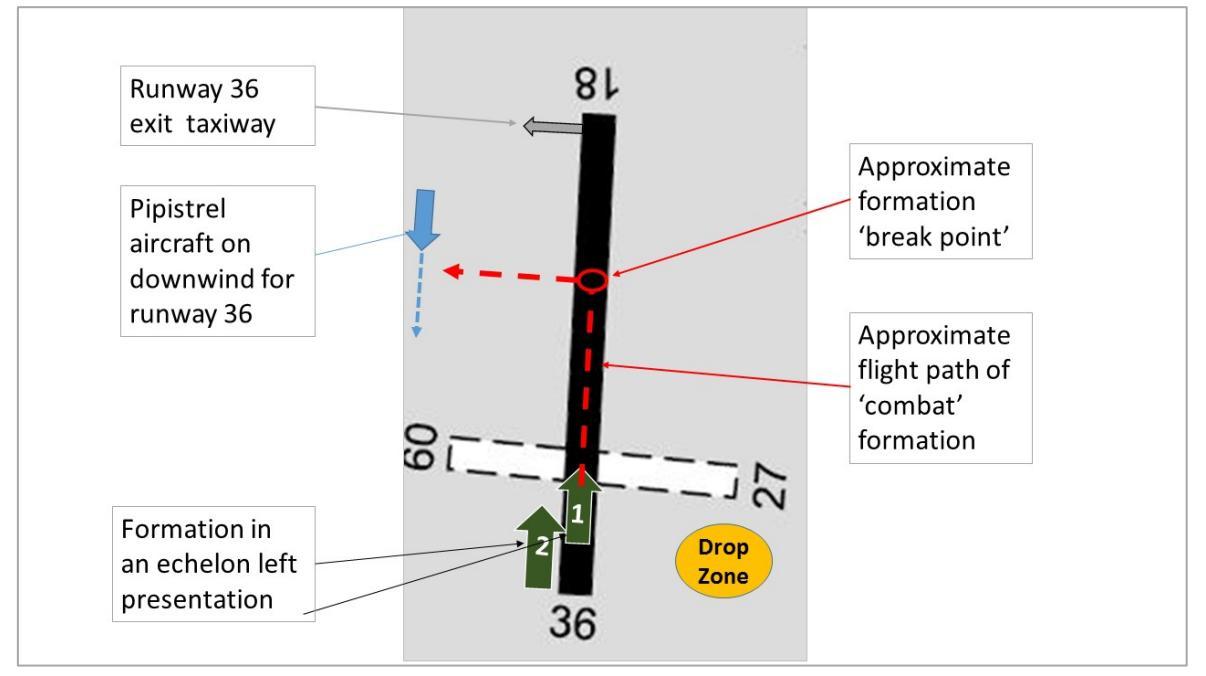
To avoid any issues for the novice parachute jumpers, and to prevent Number 2 from flying too close to the drop zone in the preferred echelon right,³ 'dead side'⁴ of the circuit join, the pilot in ALO made the decision that the formation would remain in the echelon left configuration and join over the top of runway 36. At the break point, Number 2 would move ahead, and both aircraft would conduct an early turn onto crosswind. This would keep both Nanchang aircraft well clear of the remaining parachute jumpers approaching the drop zone (Figure 2).

However, while the formation was still on upwind, the pilot of a smaller Pipistrel aircraft broadcast their intention to join the downwind leg for runway 36 (Figure 2), further delaying the Nanchang's turn onto crosswind. To maintain a reasonable separation from the Pipistrel, the two Nanchang pilots conducted a much wider crosswind leg, and resultant circuit, than normal.
