Collision with terrain Cessna 172 VH-PFT

Maingon Bay (9 km south of Port Arthur), Tasmania | 29 December 2014

Aviation Occurrence Investigation AO-2014-192 Final – 21 July 2016 Cover photo: Aircraft operator

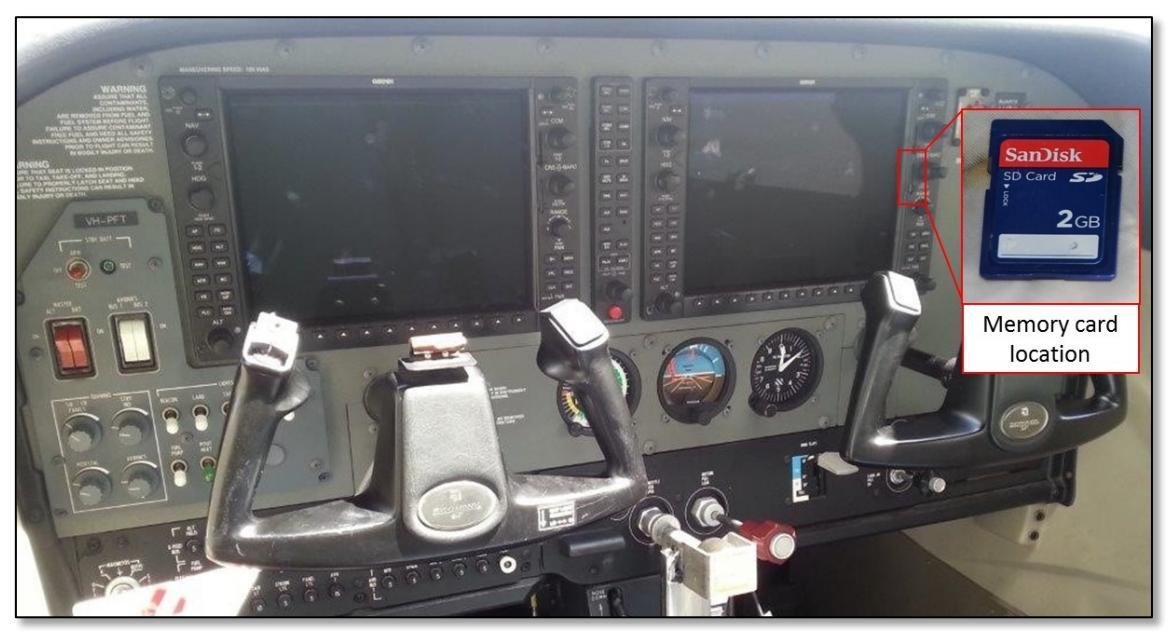
Figure 3: Garmin G1000 avionics system showing normal location of the memory card, as well as the recovered memory card

The recovered data card appeared to be in a good condition. The card was cleaned, dried, and sent to the Tasmanian Police forensic unit for data recovery. The forensic unit was unable to recover any data from the card. The card was then then transferred to the ATSB, where a more detailed forensic examination was conducted. This examination identified that the memory chip on the card was cracked through its centre, rendering the memory card unserviceable and any data contained in the chip unrecoverable.

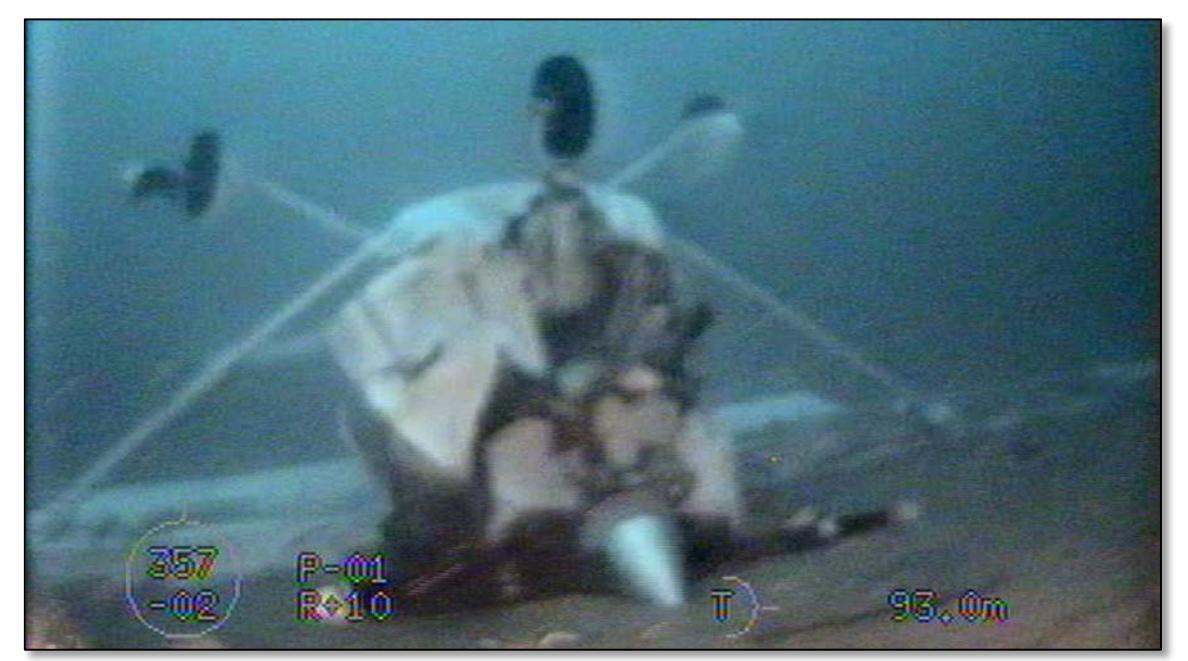
Figure 4: Image taken from the ROV video recording during the survey of the aircraft on the first recovery operation. The aircraft was lying inverted on the seabed

- identified that the aircraft was at a depth of about 90 m
- identified that the aircraft had remained relatively intact and had come to rest upside down
- provided an accurate record of the damage to the aircraft
- identified and recovered the photographer's camera
- established that the photographer's seat was at around the fully aft selectable position, indicating that it was unlikely that the passenger could have interfered with the flight controls in flight
- established that the pilot's seat appeared to be in a normal position.

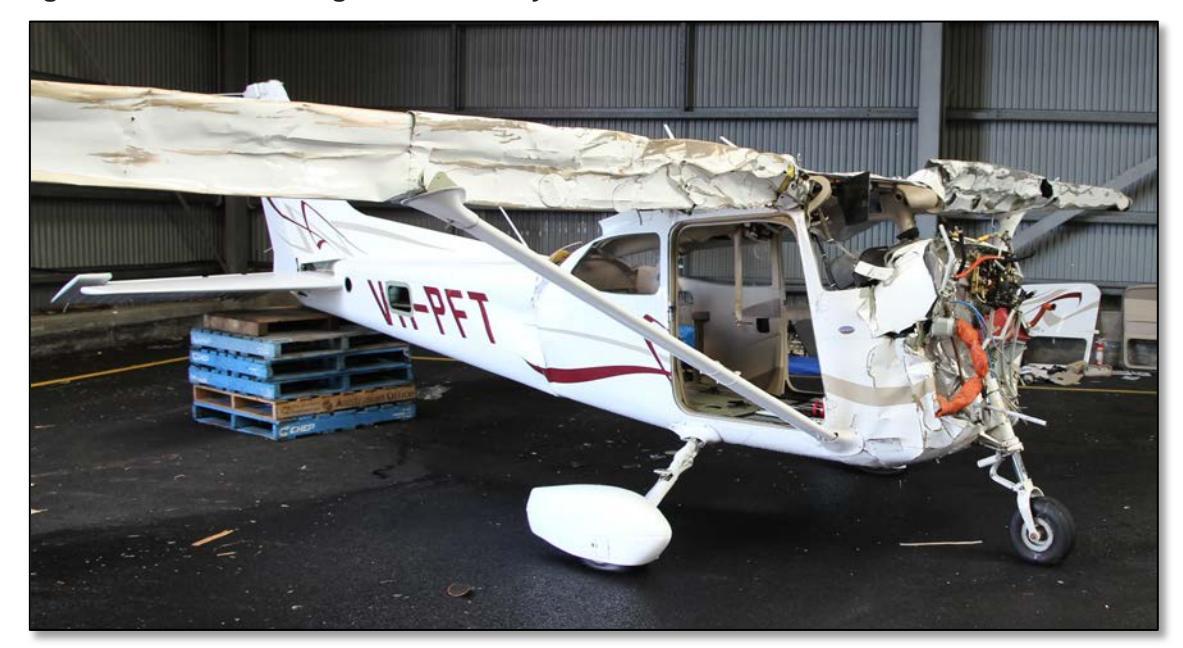
Figure 6: Aircraft wreckage after recovery

- the flap actuator position indicated that the flaps were between the 10° and 20° selectable positions
- the engine mount frames were broken, but the engine was still attached to the fuselage by control cables and fluid carrying lines

- both aircraft doors could not be opened by normal means. The doors were found to be in a latched shut position and were also jammed due to accident damage

The significant damage to the underside of the fuselage engine area and the type of damage to the aircraft's leading edges indicate a very steep impact angle. The flap being between selectable positions indicates possible inadvertent movement of the flap selector when the aircraft impacted the water.

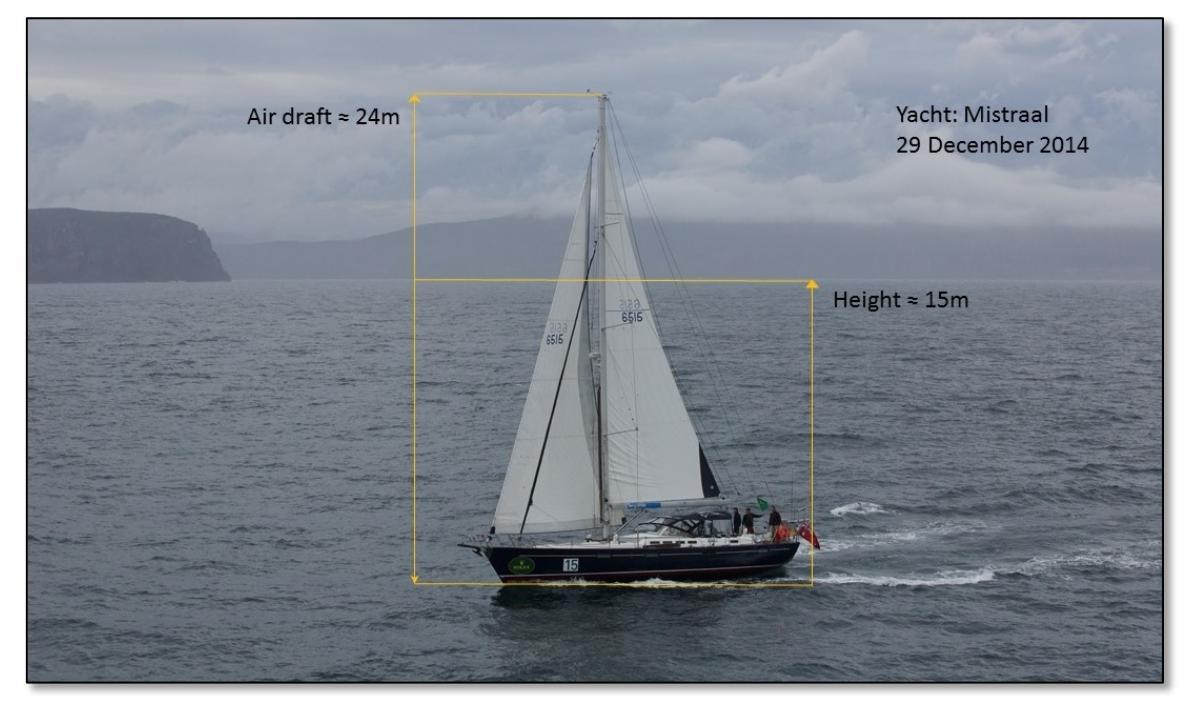
Figure 8: An image of the yacht *Mistraal*, taken by the photographer immediately prior to the accident, with the air photography height calculation overlaid

The photographer's camera was recovered from the seabed and contained a number of images of yachts taken during the accident flight. These images included an image of *Mistraal* taken immediately before the accident. *Mistraal*'s air draft was reported to be 24 m. Therefore, the lens height at the time of the photograph was about 50 ft (Figure 8). This is also the approximate height of the aircraft.

Images recovered from the photographer's camera identified that, immediately prior to entering the climbing steep turn, the aircraft was operating at an exceptionally low height of about 50 ft above the water's surface. This height was significantly lower than the authorised height of 150 ft above obstacles. Even if the aircraft had been operating at the authorised height, given the resultant stall/spin condition it is unlikely that the pilot would have been able to recover control of the aircraft before impacting the water's surface. It is for this reason that the exceptionally low level of flight is not considered to have contributed to the accident.
