Loss of control and collision with terrain involving Cessna 182S, VH-PCO

Tooradin Airfield (ALA), Victoria, 20 March 2016

ATSB Transport Safety Report Aviation Occurrence Investigation AO-2016-023 Final – 27 July 2016 Released in accordance with section 25 of the Transport Safety Investigation Act 2003

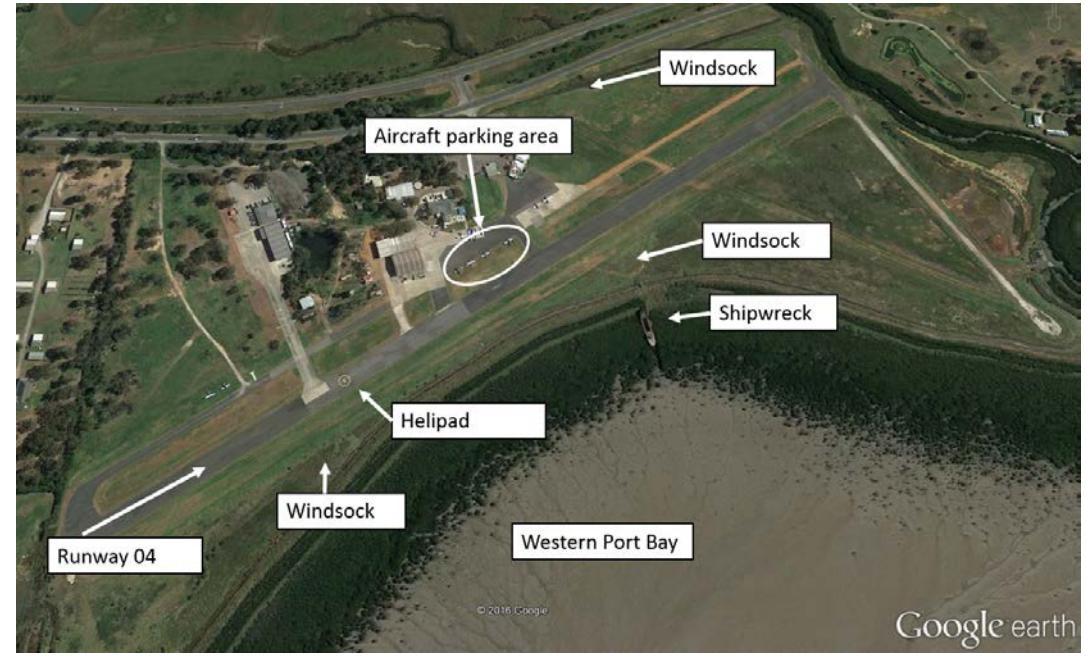
Figure 1: Tooradin Airfield

The instructor also reported that the main windsock for the airfield was to the north of the field, and there were two windsocks on the southern side of the strip – one located near the helipad and the other, which was torn but still indicating accurately, adjacent to the shipwreck (Figure 1).

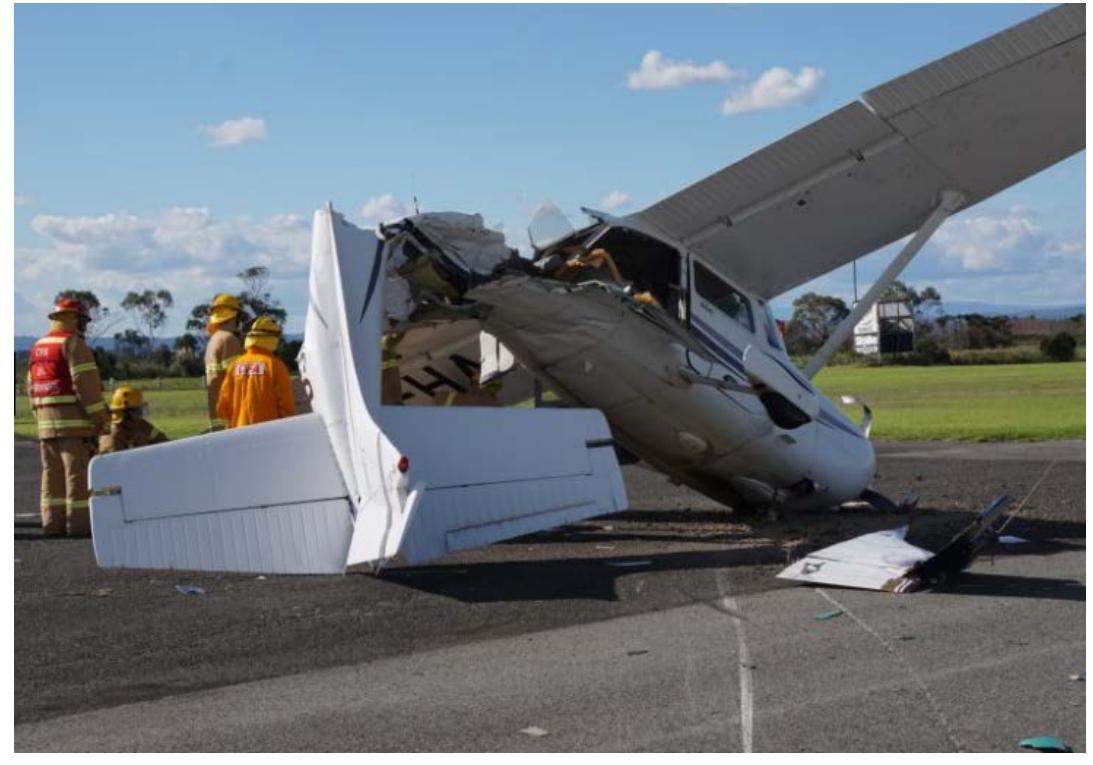
Figure 2: Accident site showing damage to VH-PCO

The pilot therefore reduced the power to idle and the aircraft landed heavily to the north of the runway. The aircraft then struck three other aircraft that were parked on a grassed area between the runway and a sealed taxiway.

The aircraft sustained substantial damage and the pilot and passengers were uninjured (Figure 2).
