Hard landing involving Maule MT-7, VH-DRS

near Noosa, Queensland, 16 May 2016

ATSB Transport Safety Report Aviation Occurrence Investigation AO-2016-049 Final – 25 August 2016 Released in accordance with section 25 of the Transport Safety Investigation Act 2003

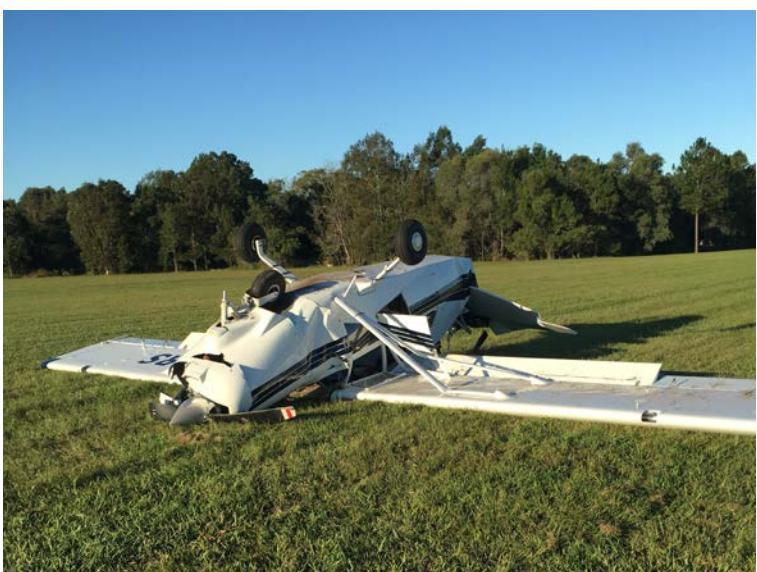
The pilot flared the aircraft for landing, the aircraft landed heavily and bounced into the air. As the aircraft landed again, the nose wheel touched down first (before the main landing gear) with sufficient force that the nose wheel strut fractured. The nose landing gear and propeller then dug into the ground and the aircraft rotated over its nose and slid a short distance inverted before coming to rest.

The pilot and one passenger were uninjured, the other passenger sustained minor injuries, and the aircraft sustained substantial damage (Figure 1).

Figure 1: Accident site showing damage to VH-DRS
