Australian Government Australian Transport Safety Bureau

Aviation Short Investigations Bulletin

Issue 54

Aviation Short Investigations AB-2016-138 Final – 22 November 2016 Released in accordance with section 25 of the Transport Safety Investigation Act 2003

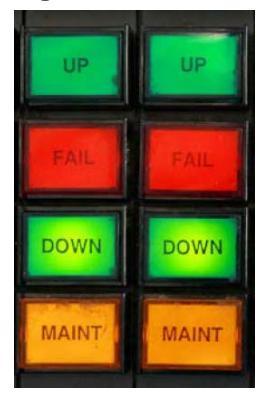
Figure 2: Tower control console cable pushbuttons

There are four pushbutton selection/indicator lights on the tower control consoles (Figure 2). They comprise two green UP and DOWN pushbuttons, an amber maintenance pushbutton and a red fail pushbutton. The maintenance pushbutton is used to pass AAS control between the tower and runway site control location.

When AAS control is passed to the runway site control, the amber maintenance pushbutton will illuminate to indicate the runway site have control of the AAS. The red fail pushbutton will also flash, and be accompanied by an audible clicking. This is a warning to the tower controllers that they do not have control of the AAS. The warning is cancelled by manually depressing the fail pushbutton. In maintenance control, the tower console UP and DOWN pushbuttons are indicator lights only, which will respond to cable position changes made at the runway location.

There are no differences in the maintenance and fail pushbutton light indications if the cable changes position after control is passed to maintenance. However, the DOWN pushbutton green light would extinguish after about one second and the UP pushbutton green light would illuminate after about 10–15 seconds.

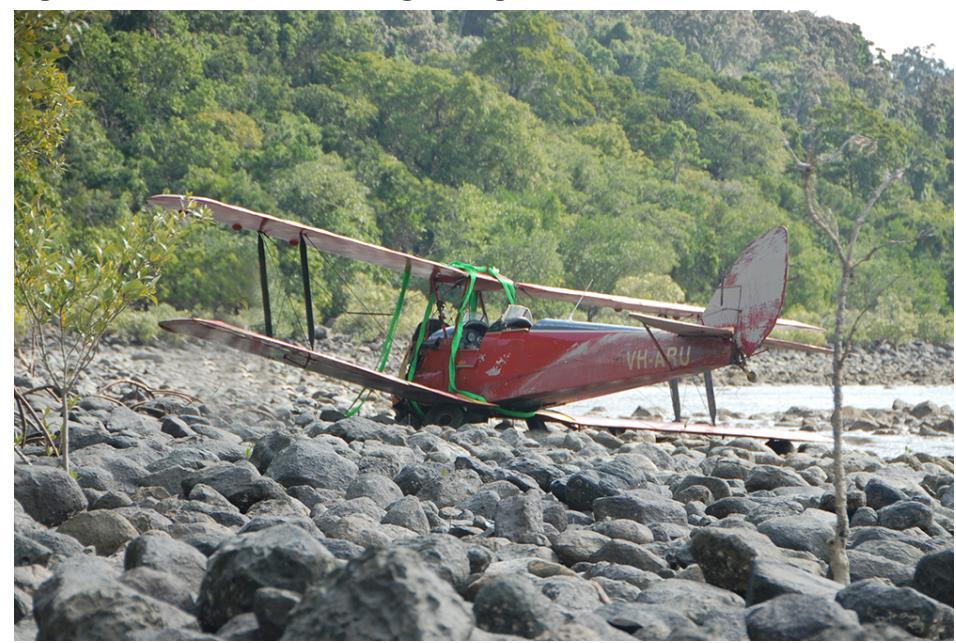
Figure 2: Accident site showing damage to VH-ARU

The pilot was uninjured and the passenger sustained minor injuries. The aircraft sustained substantial damage (Figure 2).

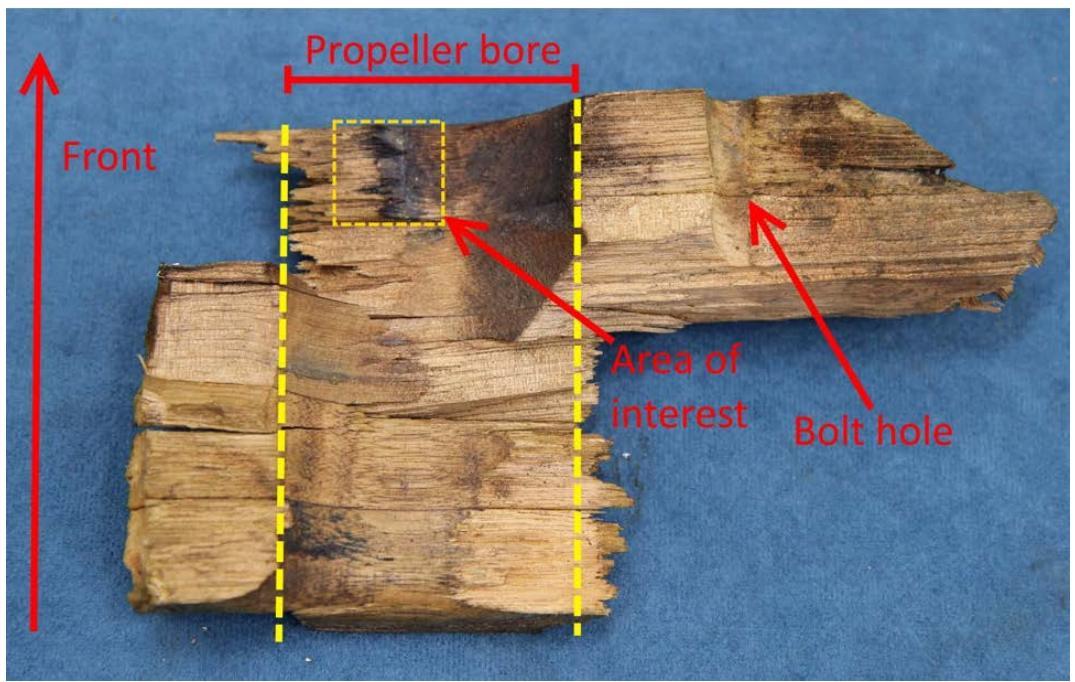
Figure 3: Propeller remnants

The ATSB examined two fragments of the propeller that were identified as parts of the hub section. An area of interest, depicted in Figure 3, showed evidence of bending consistent with the blade breaking away from the hub while under load. No bird remains were found on the fragments. The factors contributing to the propeller failure could not be determined from the timber fragments.
