Loss of control involving remotely piloted aircraft Pulse Aerospace Vapor 55

4 km NE of Ballina/Byron Gateway Airport, New South Wales, 27 September 2016

ATSB Transport Safety Report Aviation Occurrence Investigation AO-2016-128 Final – 17 January 2017 Released in accordance with section 25 of the Transport Safety Investigation Act 2003

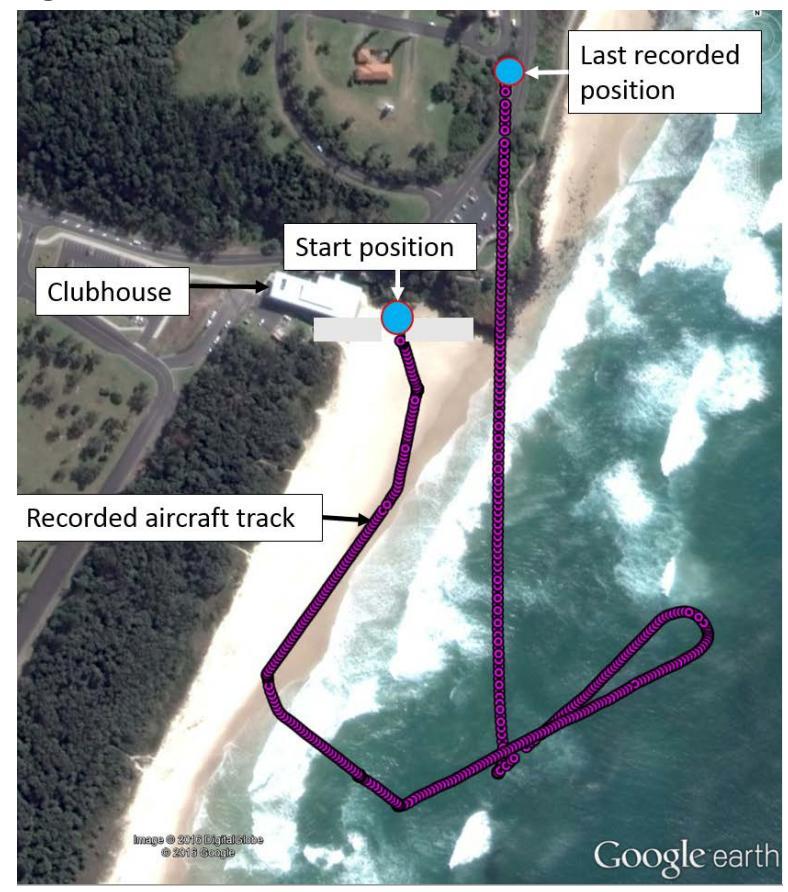
Figure 2: Recorded RPA track

According to telemetry data² recorded on the remotely piloted aircraft system's ground control station (GCS), at about 0910 Eastern Standard Time (EST), the RPA lifted off from its start position in front of the surf clubhouse (Figure 2). About 30 seconds later, when the RPA was at an altitude of about 36 ft, it entered 'manual' flight mode. The RPA then tracked according to manual inputs from the pilot for about 7 minutes, at which time (when at 124 ft altitude) the data-link signal was lost. Thirty seconds later, the RPA entered the 'home' flight mode, and commenced tracking to the programmed home position at an altitude of 154 ft. The last position of the RPA recorded by the GCS was about 165 m NNE of the start position, and about 4 km SE of Ballina/Byron Gateway Airport.

In the home flight mode, the RPA did not respond to the flight control inputs made by the pilot and the pilot subsequently lost sight of the RPA. The RPA was not found despite an extensive search.

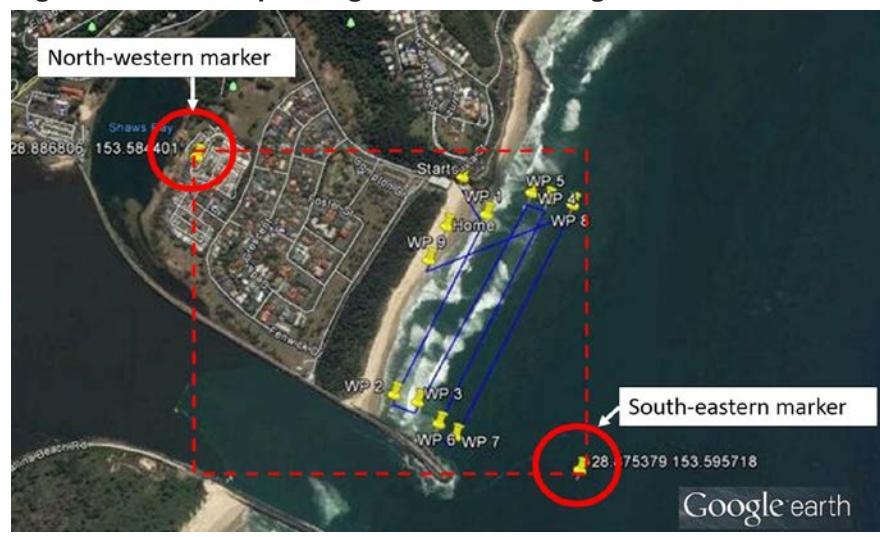
Figure 3: Planned operating area defined using NW and SE markers

Prior to the flight, the pilot's preparation for the planned mission involved using Google earth on a computer (not the GCS), and selecting a north-western and a south-eastern reference point. These markers defined an outer rectangle, within which the flight was to take place (Figure 3).

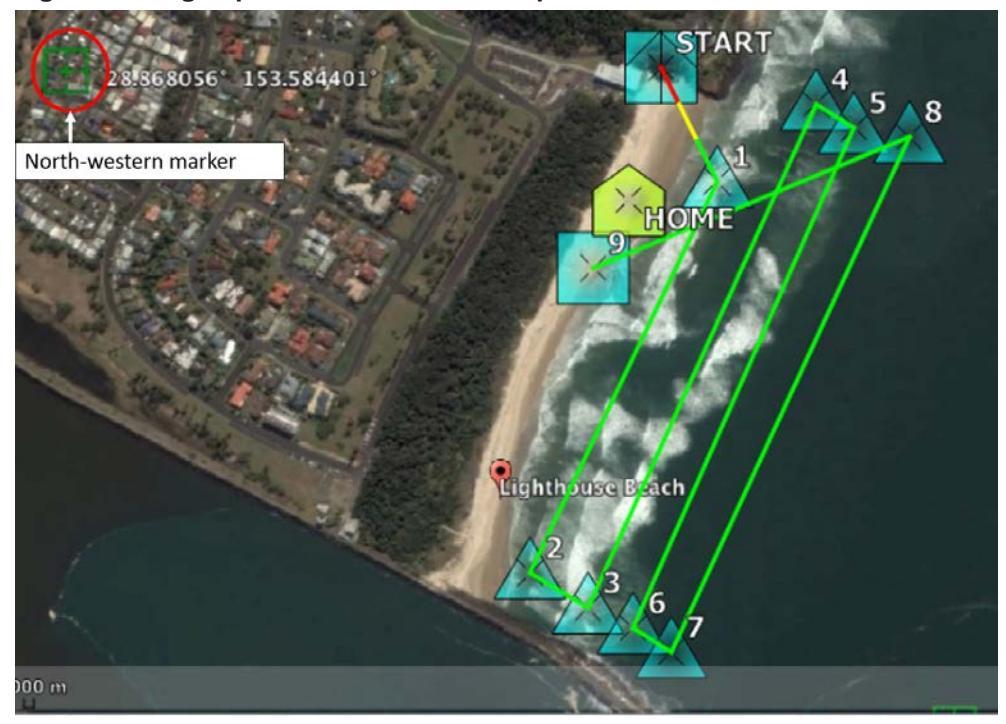
Figure 4: Image uploaded onto GCS with planned mission overlaid

The pilot then transferred an image of the google earth map for the area onto the GCS using a USB stick, and uploaded it to create the 'Lighthouse Beach' mission. To georeference³ the image, the pilot then overlaid the markers in the image with a point icon on the controller, and entered the latitude and longitude of two positions into the dialogue box on the GCS. The north-western GCS marker is visible in the top left corner of Figure 4, but the latitude and longitude values visible are image text only.

Once the image had been georeferenced, the pilot then used the graphical interface to place the start and home icons and any intervening waypoints for the planned mission (Figure 4).

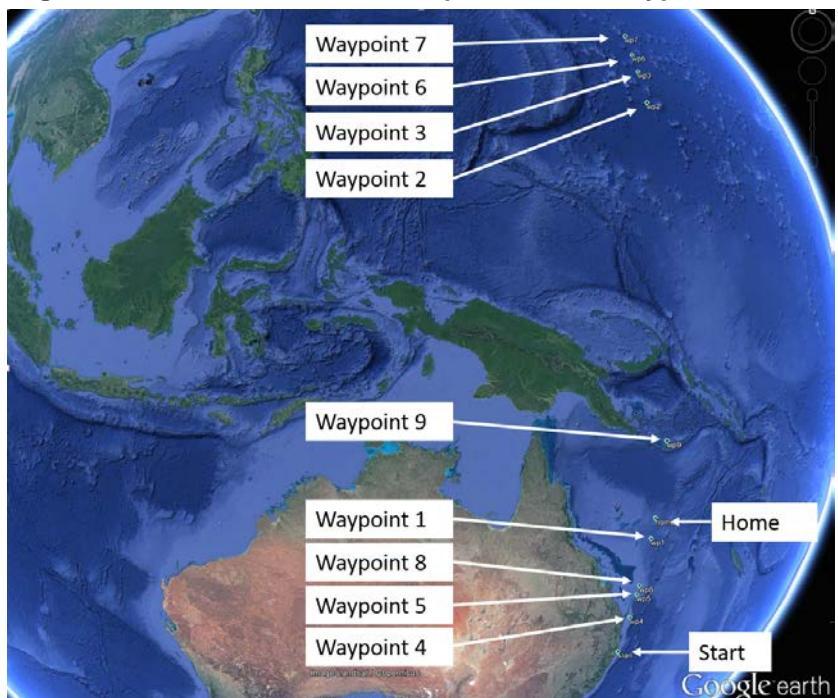
Figure 5: Actual location of home position and waypoints from the GCS

The remote pilot reported that both they and an observer checked each waypoint before the flight, verifying latitude, longitude, altitude and height. However, the GCS data shows that during the planning phase, while the north-western marker was correctly assigned, the south-eastern marker was incorrectly assigned to a georeference point with a latitude in the northern hemisphere. This resulted in all of the waypoints and home location being incorrect, as they were created by dragging icons on the georeferenced image. Waypoints 2, 3, 6 and 7 had latitudes in the northern hemisphere, and the home position was assigned to 17.222395° S and 153.591582° E. That location was in the Coral Sea Islands about 1,200 km north of the start position (Figure 5).

Although the pilot reported having completed the pre-flight preparations and associated checks, the data stored on the GCS showed that the incorrect (northern) hemisphere was assigned to the south-eastern georeference marker at the time the map image was created. This led to the home position being assigned a location in the Coral Sea Islands, so when the RPA lost signal and tracked for home, it headed north and was not recovered. The same outcome would have occurred if the pilot had selected the RPA to fly home, even with a continuous data-link signal. While all of the intermediate waypoints were also incorrect, as the GCS remained in manual mode, the RPA did not attempt to track to any of those waypoints.

- The south-eastern point used to georeference the image on the ground control station map was selected to a northern hemisphere latitude, which resulted in incorrect waypoints and home position for the mission.
- The RPA data-link signal to the ground control station was lost, so it commenced tracking to the programmed home position, which was in the Coral Sea Islands at a latitude 17.22° S, about 1,200 km north of the start position.

- Audit of training curriculum to ensure that pilots understand how to verify GPS coordinates, interpret their values and signs. The training course will continue to train pilots on the tools available to them within, and outside of the GCS software.
- Share this incident with operator trainers so that new operators can learn from the events of this incident.
- Continued education and outreach discussions with RPAS operators pertaining to decreased mishap rates through training and currency policies.

- The pre-launch checklists have been modified to include additional and enhanced procedures to verify data input and flight plans.
- Investigate the fitting of either GPS or cellular tracking devices to remotely piloted aircraft.
- Update the risk assessment form to include location of external broadcast stations such as television outside broadcast units.
- Brief all company pilots on the event for safety and education purposes.
- Continue liaison with the manufacturer.
