Australian Government Australian Transport Safety Bureau

Forced landing involving Cessna 188, VH-BCT

near Hay Airport, New South Wales, 9 August 2016

ATSB Transport Safety Report Aviation Occurrence Investigation AO-2016-099 Final – 9 February 2017 Released in accordance with section 25 of the Transport Safety Investigation Act 2003

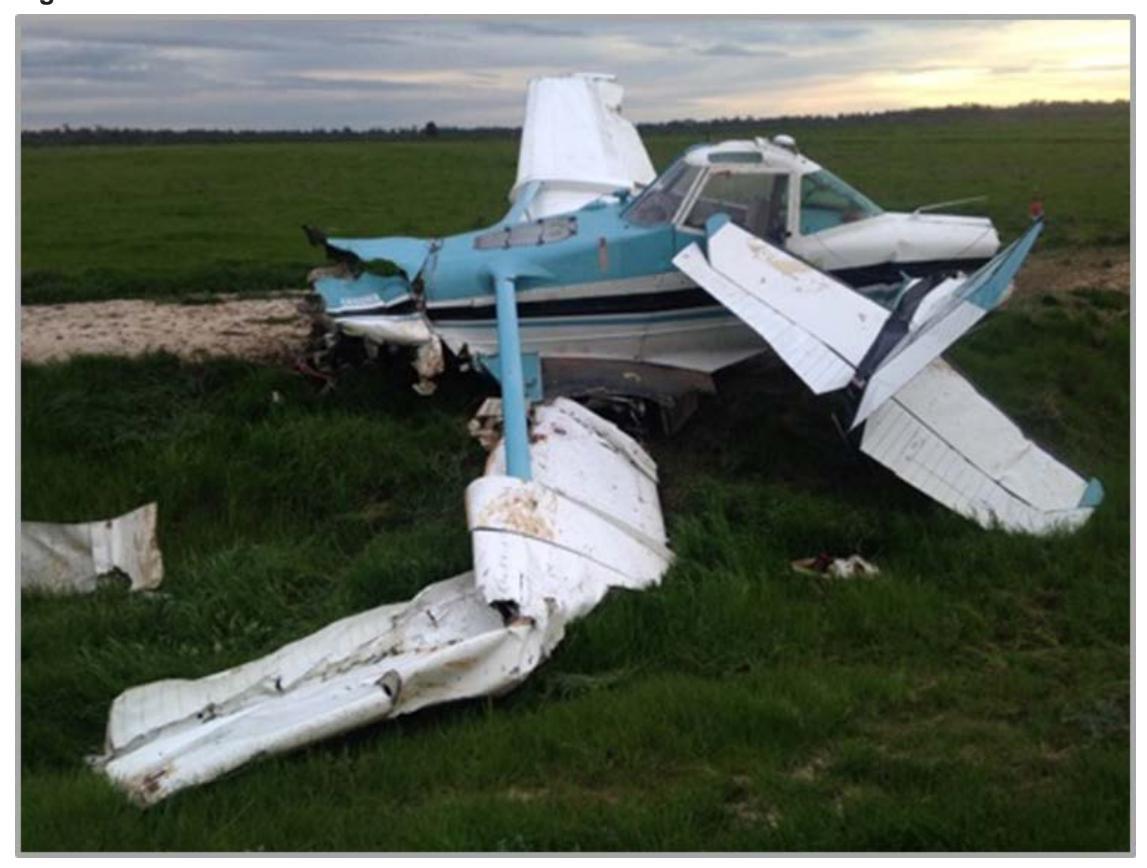
nose of the aircraft and when it became evident that the aircraft was not going to make the strip, the pilot elected to land straight ahead. As the aircraft flew over a channel, the tail wheel clipped that channel, and the aircraft collided with the ground on the flat area between two channels. The landing gear and propeller detached as the aircraft continued forward and came to rest on the top of the opposite channel. As there was a lot of fuel leaking from the fuel tanks, the pilot quickly turned off the engine magnetos and the electrical master switch and exited the aircraft through the cockpit door. The pilot was uninjured and the aircraft was substantially damaged (Figure 2).

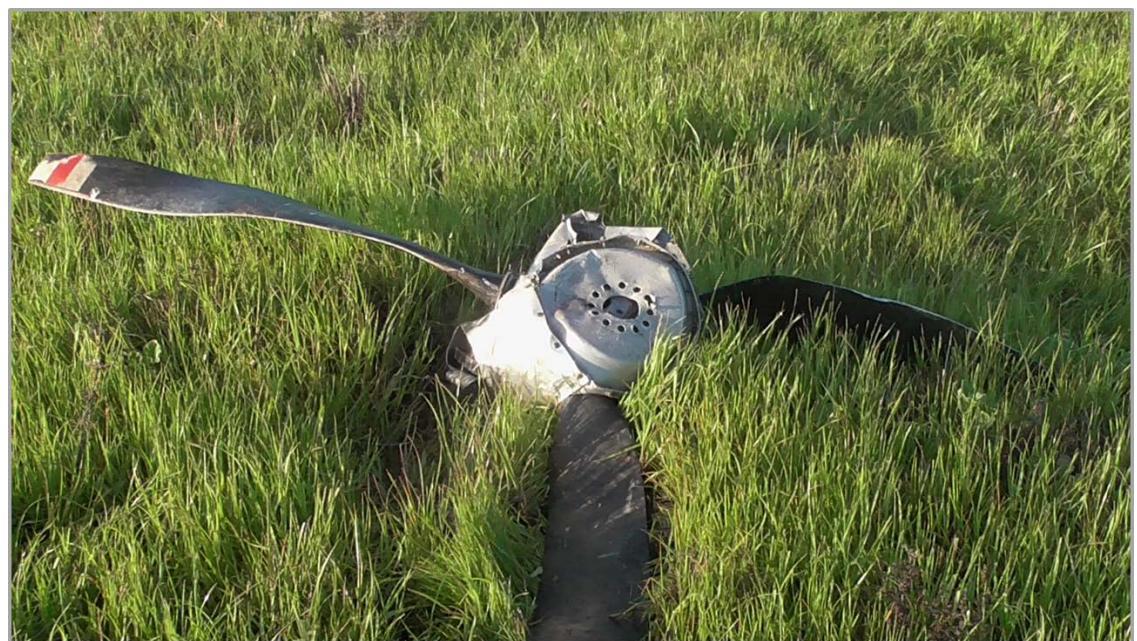
Figure 3: BCT damaged propeller²

A licensed aircraft maintenance engineer inspected the engine and no reason was identified for an engine power loss. The engine magnetos and engine carburettor were tested separately and found to be operating normally. As such, the operator believed the engine was still producing full power at the time of the accident. The engine and propeller were extensively damaged by the accident sequence (Figure 3).

² The damage to a propeller alone cannot accurately quantify the power produced by an engine. There are many inconsistencies in the way propellers bend and twist under impact loads. Some variables include terrain type and surface, angle and speed of the aircraft at impact (<u>Manual of aircraft accident and incident investigation Part III — Investigation ICAO Doc 9756-AN/965</u>, is available from the US Naval Safety Centre website).
