# Traffic management occurrence involving Airbus A320, VH-VQS and Beech Aircraft Corporation BE 76, VH-EWL

#### Ballina/Byron Gateway Airport, New South Wales | 14 January 2016

ATSB Transport Safety Report Aviation Occurrence Investigation AO-2016-003 Final – 19 May 2017 Cover: Google map, Beechcraft aircraft from Wikimedia, Jetstar Airbus from 123RF

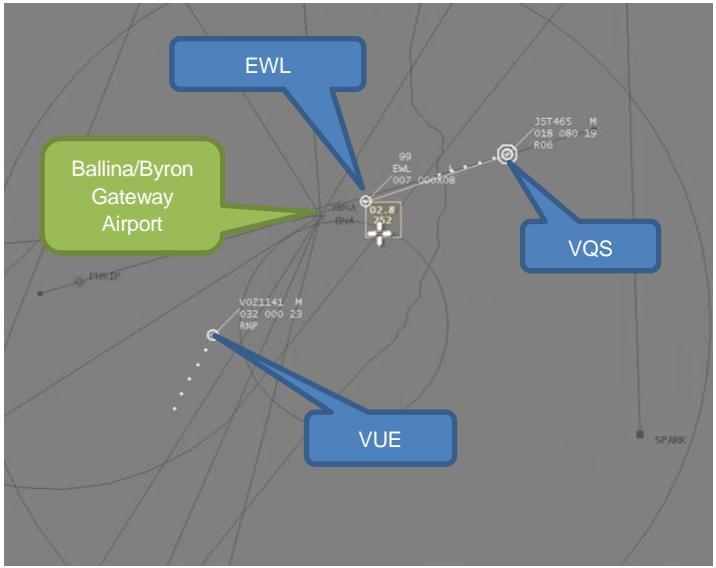
The crew of VQS stated that on assessing that the aircraft was clear of EWL and accelerating away (Figure 1), they manually re-established a normal climb out pitch attitude and thrust setting. At approximately 1,700 ft VQS conducted a right turn to intercept the outbound track, which was contrary to the left turn stipulated in the Jetstar Airways departure procedures. The remaining flight to Melbourne was normal.

Figure 1: A screenshot of the radar display depicting the positions of VQS (JST 465) and EWL in the vicinity of Ballina. VUE (VOZ 1141) is also seen approaching from the southwest

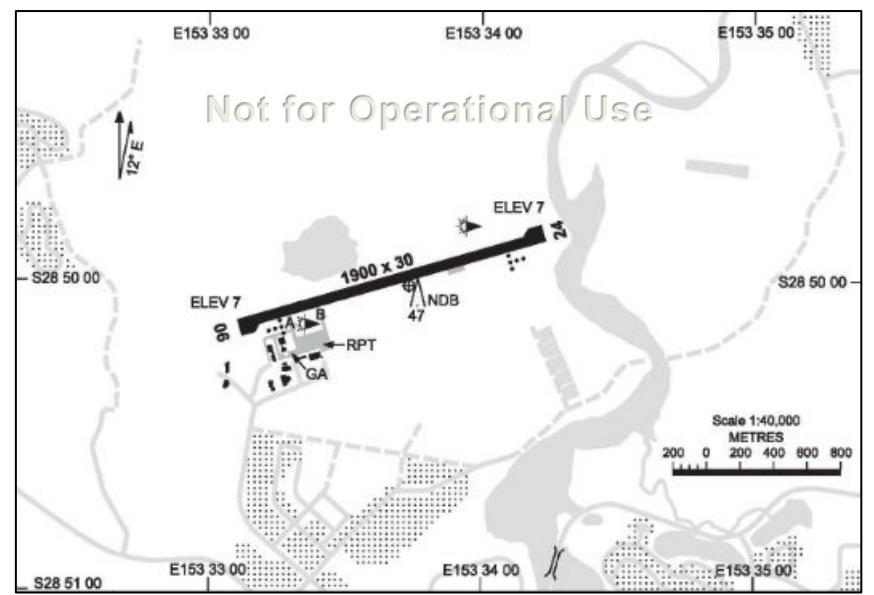
Ballina/Byron Gateway Airport (Ballina airport) was a certified aerodrome with a single, sealed 1,900 m long and 30 m wide runway. The runway was orientated in a 062°/242° magnetic (north-east/south-west) direction with an elevation of 7 ft above sea level. The airport did not have taxiways parallel to the runway for use when positioning aircraft for departure or after arrival. Therefore, aircraft were often required to backtrack on the runway prior to take-off and after landing. The airport had GPS-based instrument approaches and a non-directional beacon ground-based navigation aid. Runway 06 was designated as a right-hand traffic pattern and circling to the north of runway 06/24 was not permitted for aircraft conducting instrument approaches. These requirements were due to the higher terrain to the north of the runway (Figure 2).

# Figure 2: Navigational chart depicting the Ballina airport runway and position of the regular public transport (RPT) apron areas. Note there are no taxiways running parallel to the runway

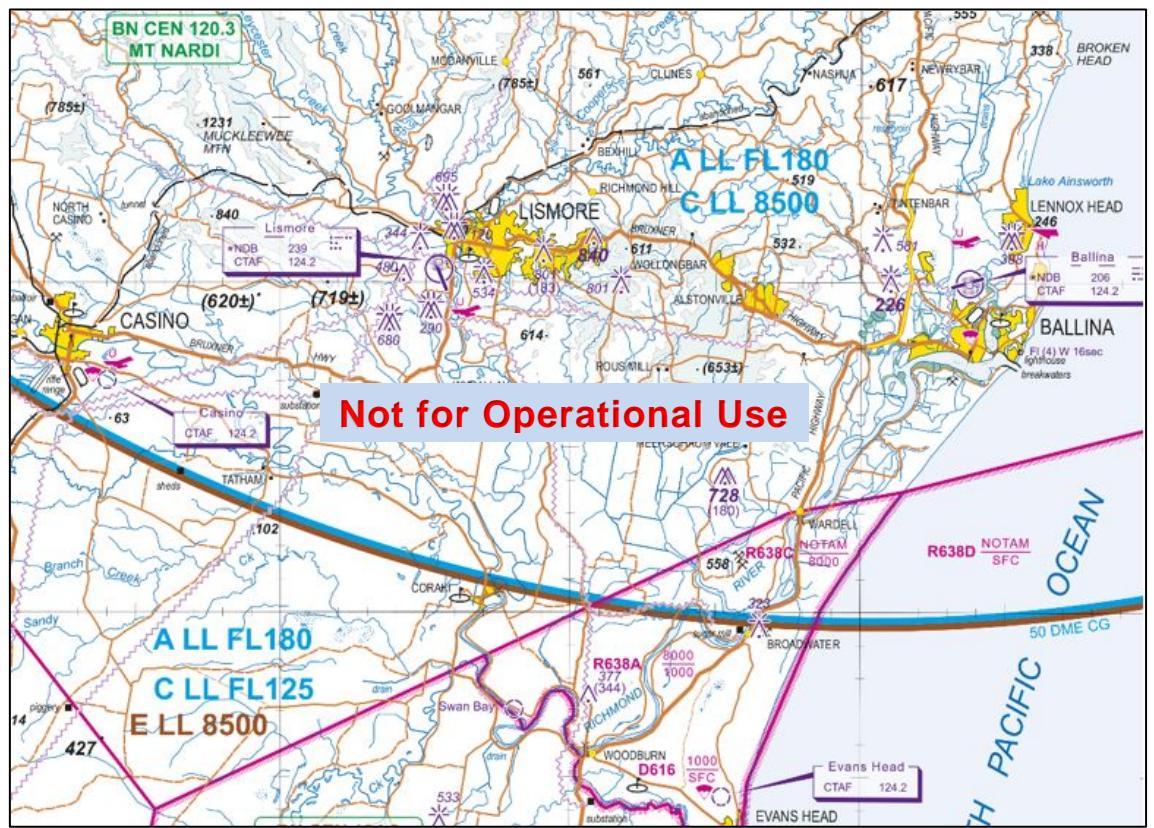
being able to use 'see and avoid procedures', which were stipulated in various regulations and guidance material for non-controlled aerodromes. See and avoid also relies on voice communication using the Common Traffic Advisory Frequency (CTAF). Due to their close proximity, the Ballina airport CTAF was shared with Casino and Lismore airports. As such, a pilot using this frequency would be affected by all radio transmissions from traffic at any one of these airports (Figure 3).

Figure 3: An extract of the Visual Terminal Chart of the Ballina area. The Casino and Lismore airports are depicted and share the CTAF of 124.2 MHz with Ballina airport. Also depicted in magenta are the restricted areas to the south Ballina, and the lower limit of the class C controlled airspace overhead those airports of 8,500 ft (in blue)
