Loss of control and collision with water involving Piper Aircraft Corp PA-28-235, VH-PXD

33 km SSE of Avalon Airport, Victoria | 29 January 2016

ATSB Transport Safety Report Aviation Occurrence Investigation AO-2016-006 Final – 28 June 2017 Cover photo: Copyright Nick Dunn

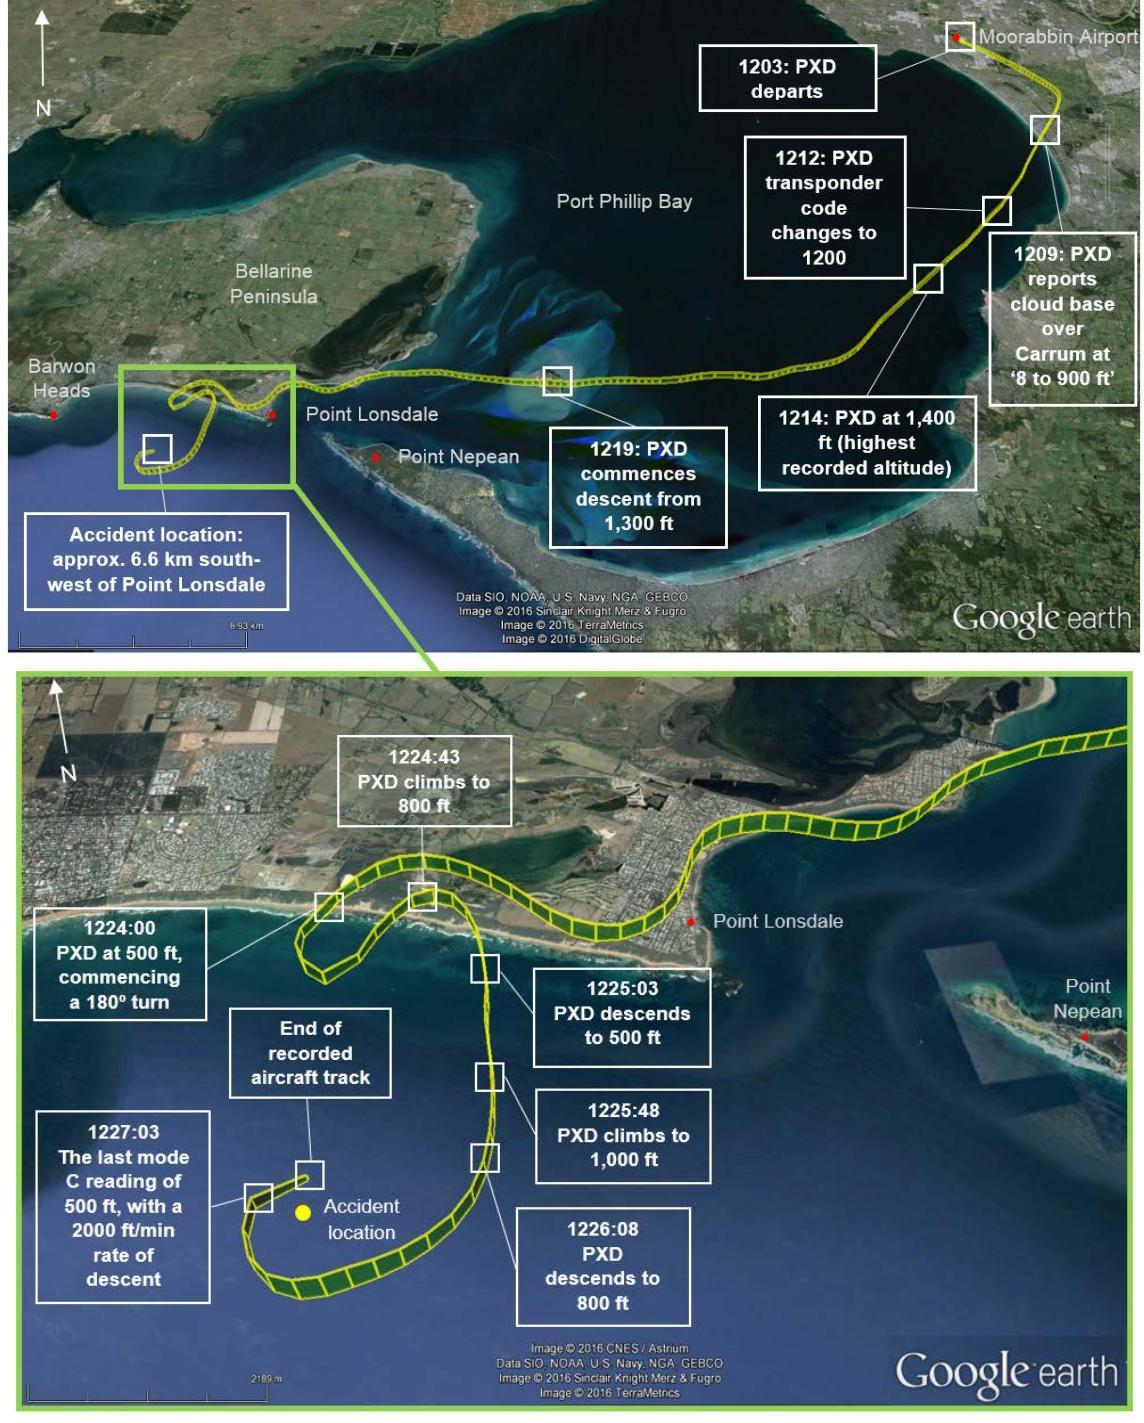
Figure 1: PXD's track from Moorabbin Airport until the collision with water near Point Lonsdale with the area between Point Lonsdale and the impact with the water at inset. Noteworthy pilot actions and other observations are annotated.

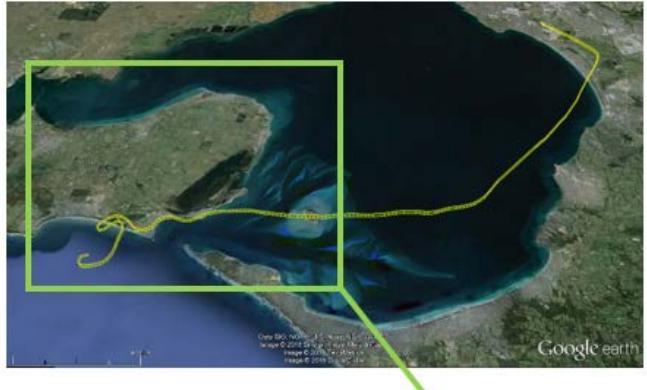
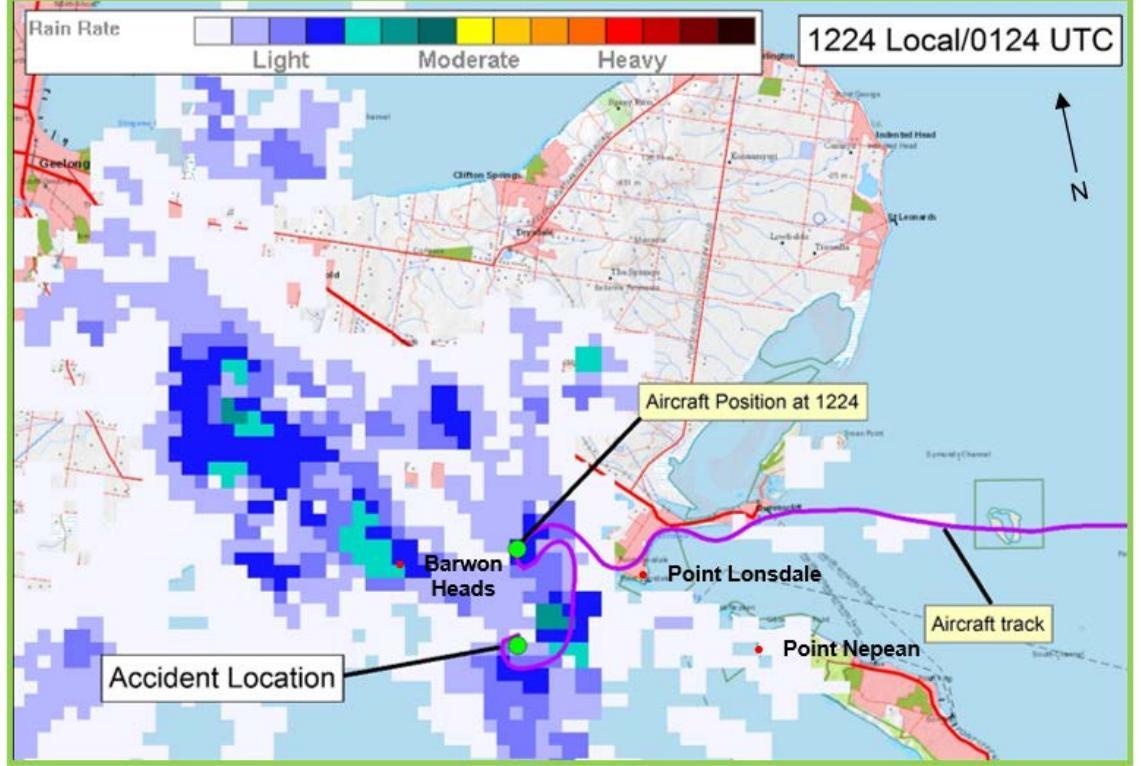
Figure 4: Weather radar recording (orientated with reference to a Google earth map at inset) and associated 'Rain rate' at 1224, showing the aircraft's track

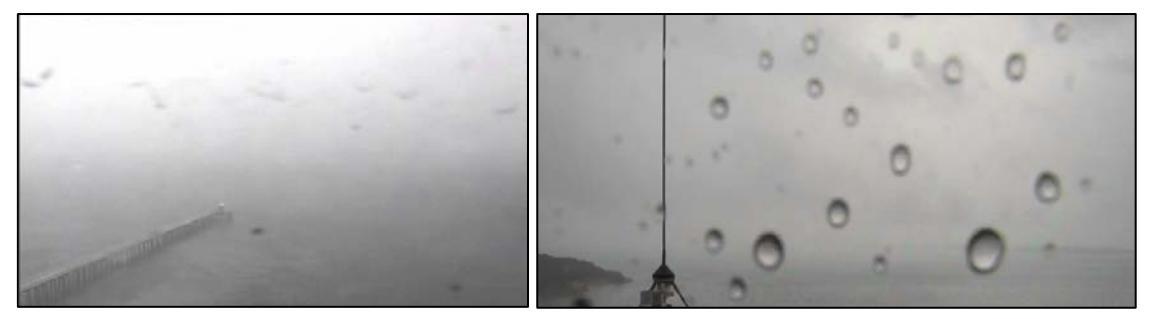
Closed-circuit television images from Port of Melbourne cameras facing east across the water from Point Lonsdale, and north from Point Nepean both showed drizzle, light rain and reduced visibility including little natural horizon as PXD tracked south along the eastern shore of Port Phillip Bay (Figure 5).

Figure 5: Still images taken at 1215 from two different closed-circuit television cameras owned by the Port of Melbourne. One camera (left image) was positioned on the Point Lonsdale lighthouse facing east. The other camera (right image) was positioned at Point Nepean, facing north. The image quality is affected by contaminants on the camera lens, but the extent of the low visibility conditions in the area is evident

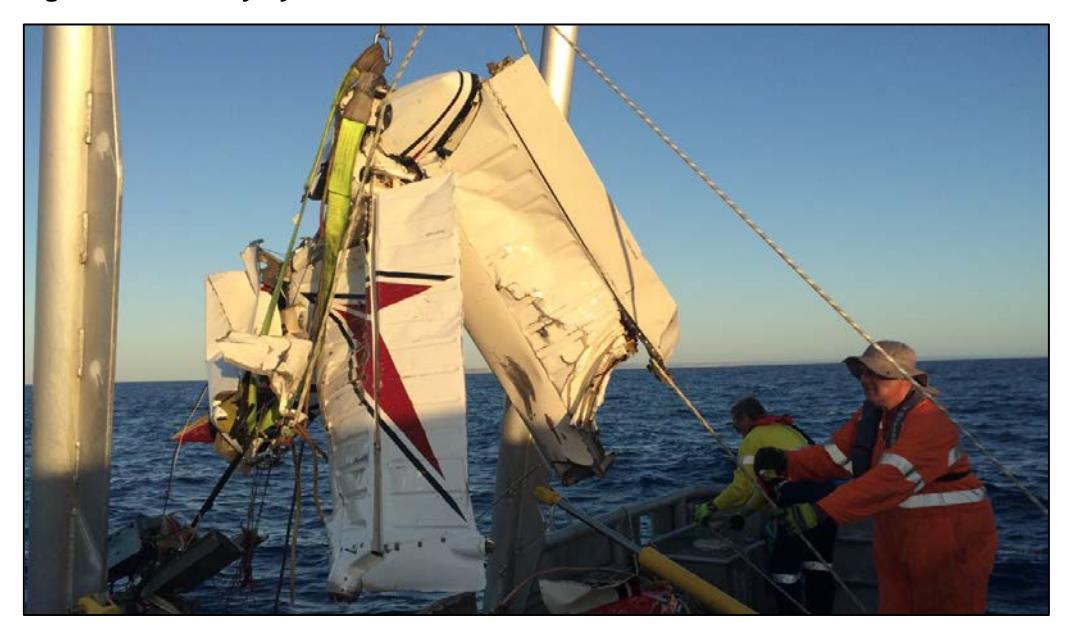
Figure 6: Recovery by Victoria Police of the aircraft's fin and left horizontal stabiliser

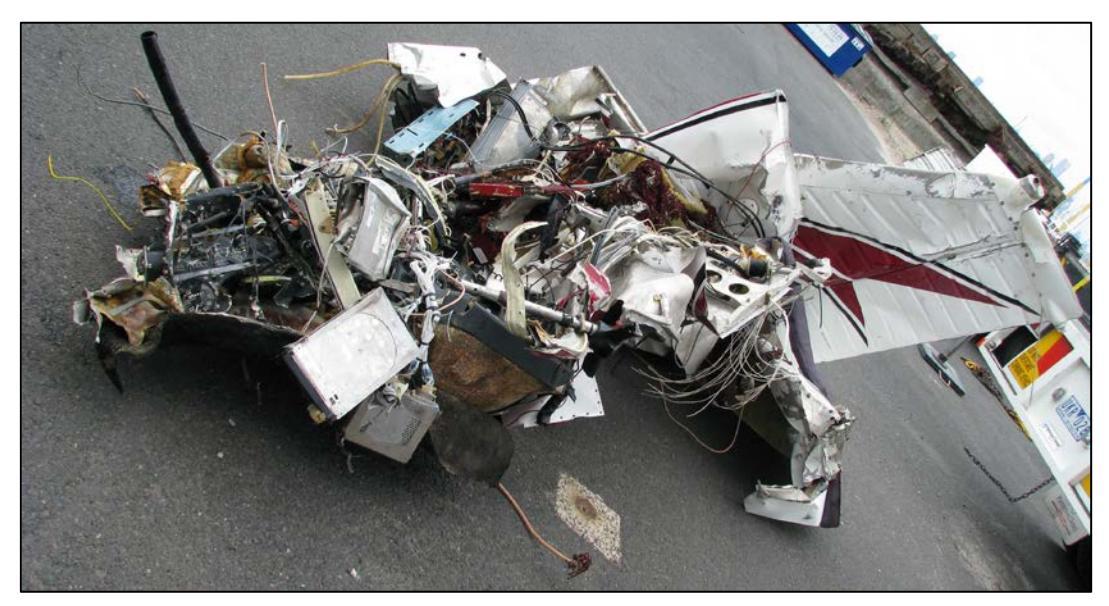
All identified fracture surfaces throughout the recovered wreckage were consistent with overload failure as a result of the impact with water. There was no evidence of pre-existing damage to the airframe, or failure of the primary control systems that may have contributed to the accident. However, the aircraft wreckage exhibited severe disruption.

Some components, such as the engine carburettor, right horizontal stabiliser assembly and left and right wing structures were not recovered.

Figure 7: Some of the recovered aircraft wreckage. Note the extent of the disruption of the airframe

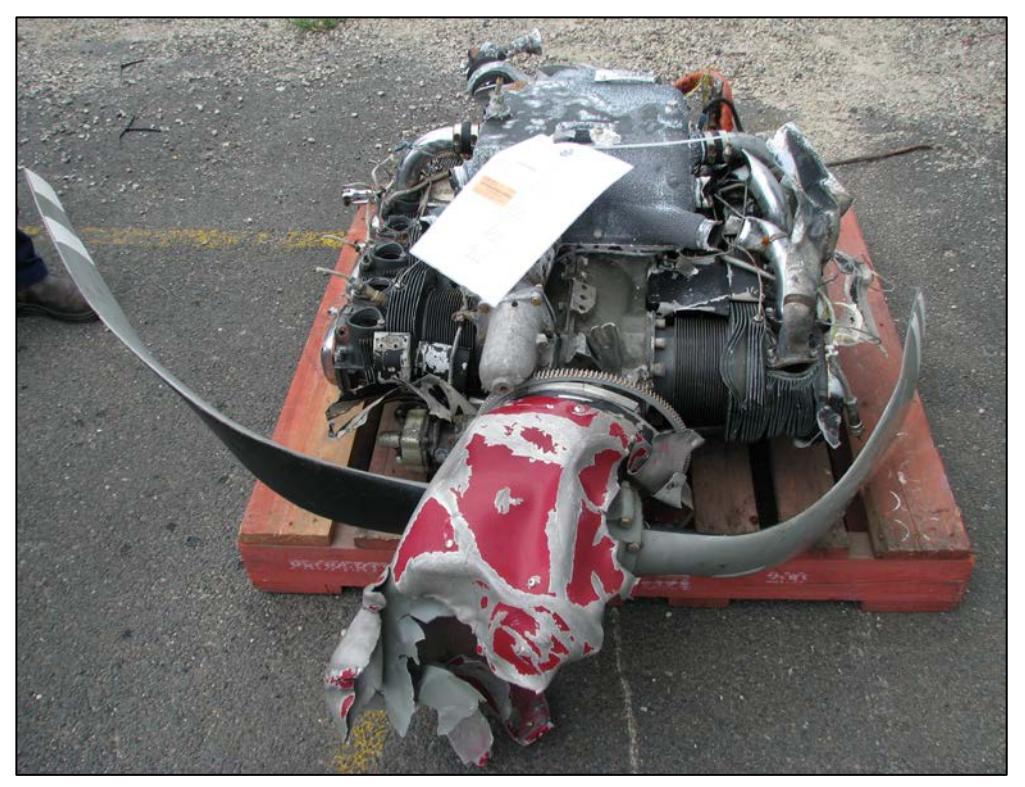
A detailed inspection of the engine and propeller was conducted in a CASA-approved maintenance facility. Nothing was identified during that inspection that may have contributed to the accident, or would have prevented the engine and propeller from normal operation.

Figure 8: Recovered aircraft engine, propeller and propeller spinner, looking at the lower surface of the engine
