Derailment of train 3MP5

Rawlinna, Western Australia | 21 April 2016

ATSB Transport Safety Report

Rail Occurrence Investigation RO-2016-005 Final – 18 July 2017

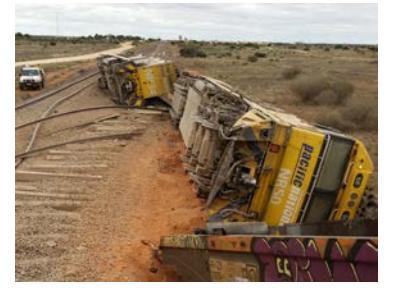
Derailed locomotives

There were minor injuries sustained by the crew. About 200 m of track infrastructure was damaged, and the main line between Adelaide and Perth was blocked until 1351 on 25 April 2016.

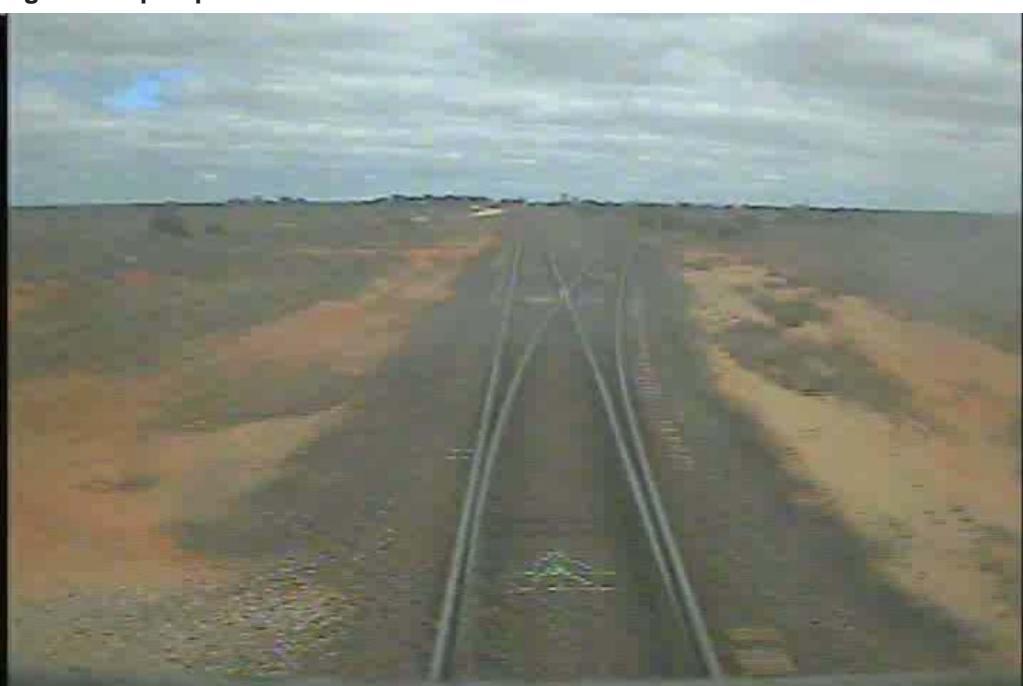
Figure 2: Open points at Rawlinna – as seen from 3MP5.

Train 3MP5 was unable to stop and, at 1114:56, it travelled over the points (Figure 2) at 90 km/h and derailed. The train continued to travel derailed for a further 160 m, coming to rest between the main and loop lines. Both locomotives and the crew van tipped onto their sides. The following six wagons, totalling 389 tonnes and 450 m in length, all derailed. Most of the wagons jack-knifed into an area about 140 m in length (Figure 3).

Graphic derived from the General Electric LocoCAM showing the Rawlinna eastern points in an open condition. That is, the points are not closed for either the main line (straight through) or the loop line (diverging to the right). Source: Pacific National

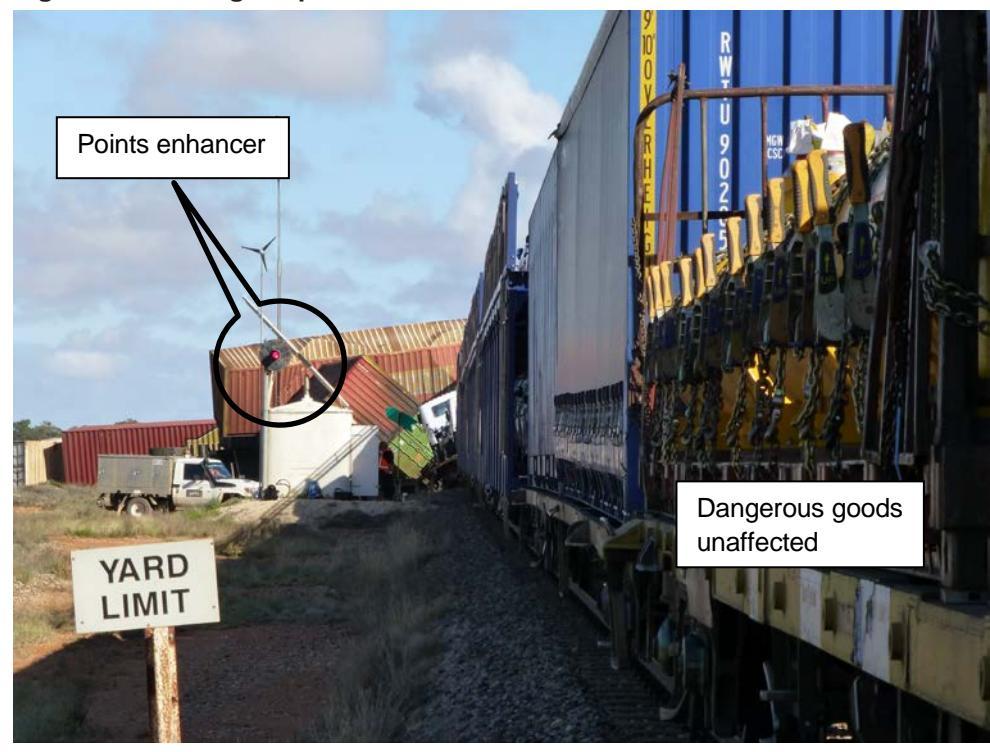
Figure 3: Wreckage at points

About 200 m of track was damaged, including the points. The ARTC built a track deviation to the south around the wreckage in order to allow rail traffic pass while recovery works were undertaken. The deviation was completed and the track, main line only, was reopened to allow rail traffic to pass at 1351 on 25 April 2016.

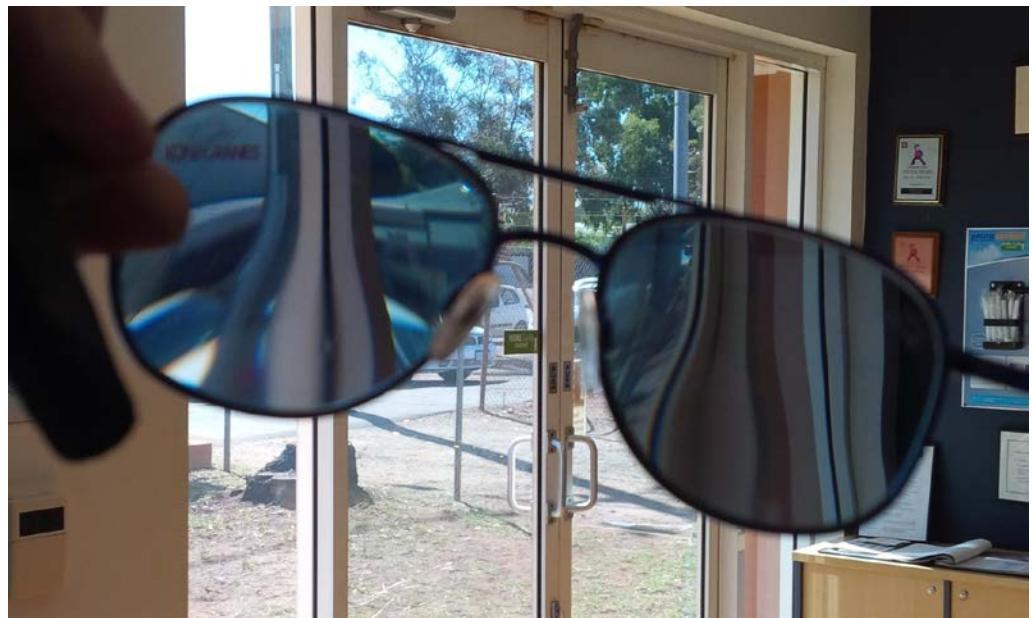
Figure 6: Prescribed tinted sunglasses

The driver stated that on this occasion, he was wearing prescribed sunglasses supplied by an ophthalmic retailer through Pacific National. The lenses were tinted grey and not polarised, Figure 6.

Given the driver's fitness for duty and no evidence of colour interference from a grey tint, it is likely that the prescription sunglasses worn by the driver did not affect the colour transmission of the red indicator. It is plausible that other factors such as distance, heat haze, and expectation may affect the interpretation of a red indicator.

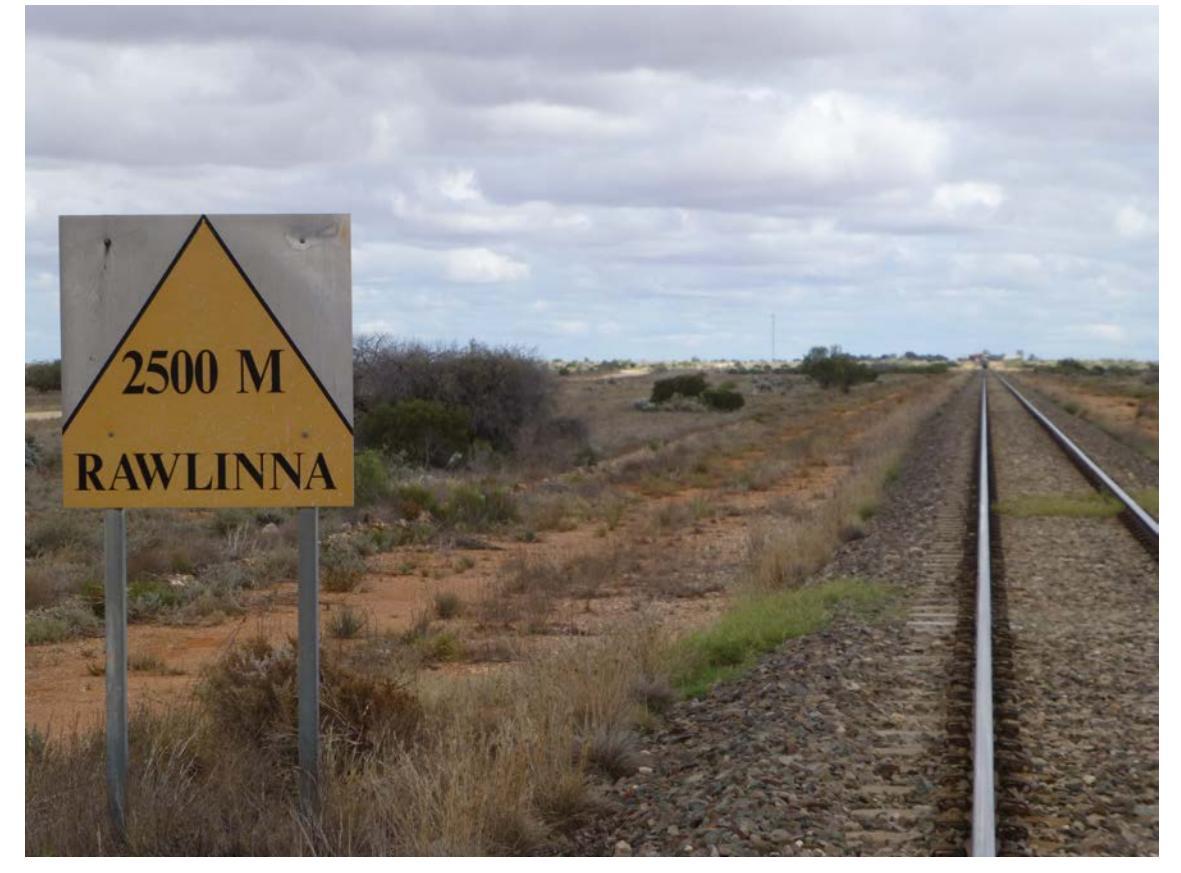
Figure 7: Sighting from Rawlinna location board

Train crew vigilance and effective indicator sighting distance are critical. The enhancer lights at Rawlinna consisted of an incandescent long distance (K3) search light. Depending on lens system, lamp, and ambient conditions, the K3 signal can attain a range of up to 2500 m in clean air. Any form of beam spread applied to a signal reduces its range. Based on the recollections of train crews (including 3MP5), the effective sighting distance of the eastern enhancer light is about 1000 m. ATSB investigators onsite measured about 1200 m sighting of the eastern enhancer light from ground level. This is dependent on time of day, weather, heat haze, direction of sun, and other environmental conditions.

Train 3MP5 was approaching the location board at 104 km/h. Using the same parameters, the calculator specifies a full service braking distance of about 2050 m on level track. This equates to about 15 seconds for the train crew to make a full service brake application after passing the Rawlinna location board, Figure 7.

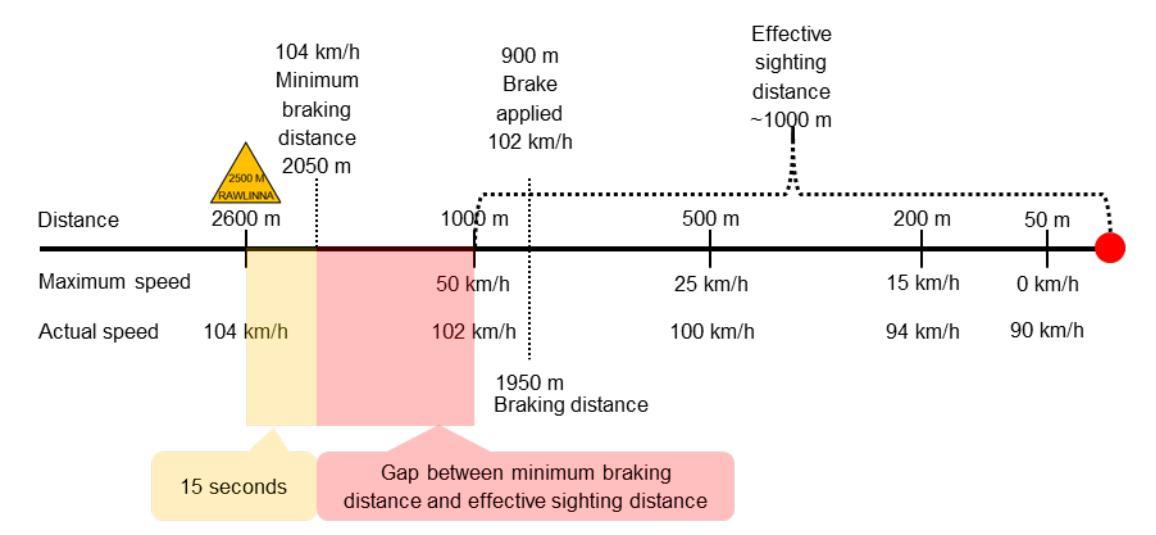
Figure 8: Sighting and braking distances

The ARTC use a train braking calculator¹⁶ when determining braking distances of trains. The calculator specifies a full service braking application stopping distance of 2220 m for an 1800 m freight train, three quarter loaded and travelling at track speed of 110 km/h.

When considering Pacific National's train handling guidelines and safety critical zones, Pacific National trains should be braking at the location board in order to reduce speed to 50 km/h at the 1000 m point. This would allow trains greater time to slow or stop as required or until the condition of the points could be positively confirmed.

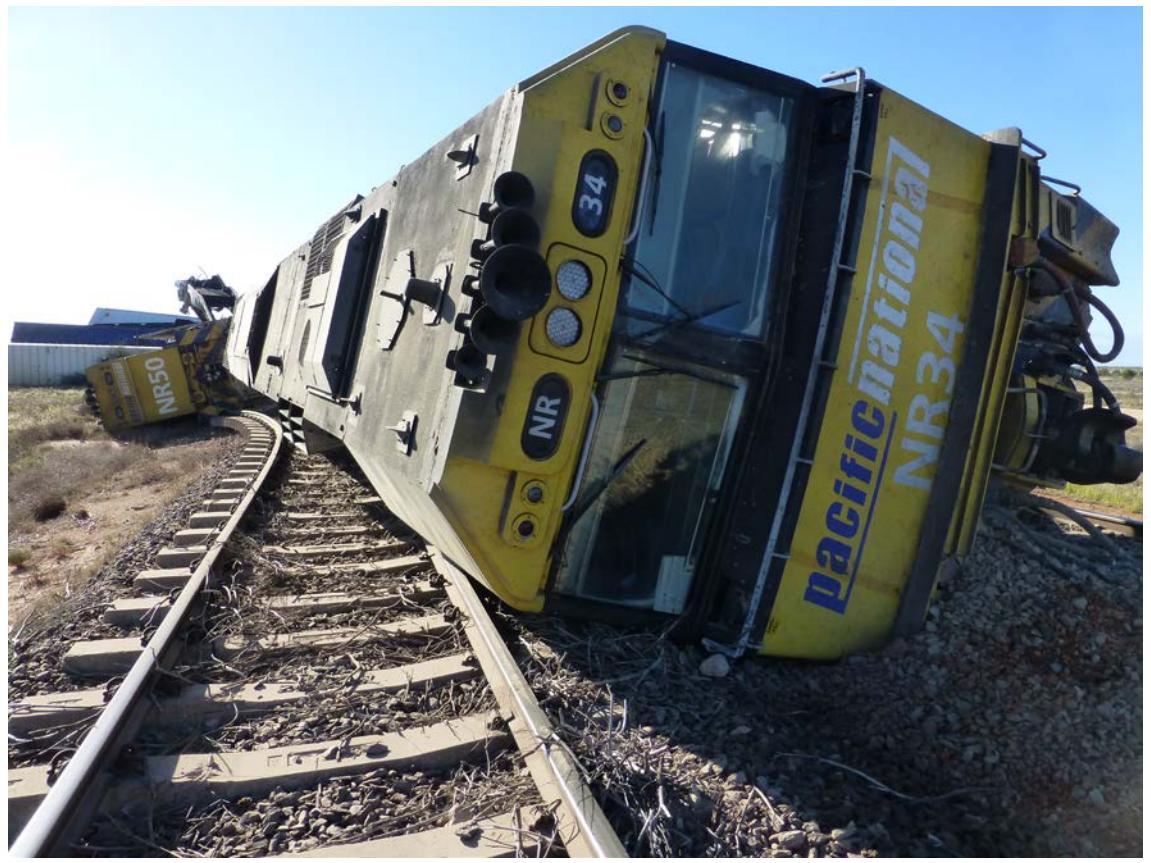
In the derailment of train 3MP5, both identified escape paths necessitated the crew climbing on internal structures to facilitate egress. The minor injuries sustained by the drivers did not overly affect their escape in climbing up through the cab and out of the side window (now on top).

Image showing resting position post derailment. Source: ATSB

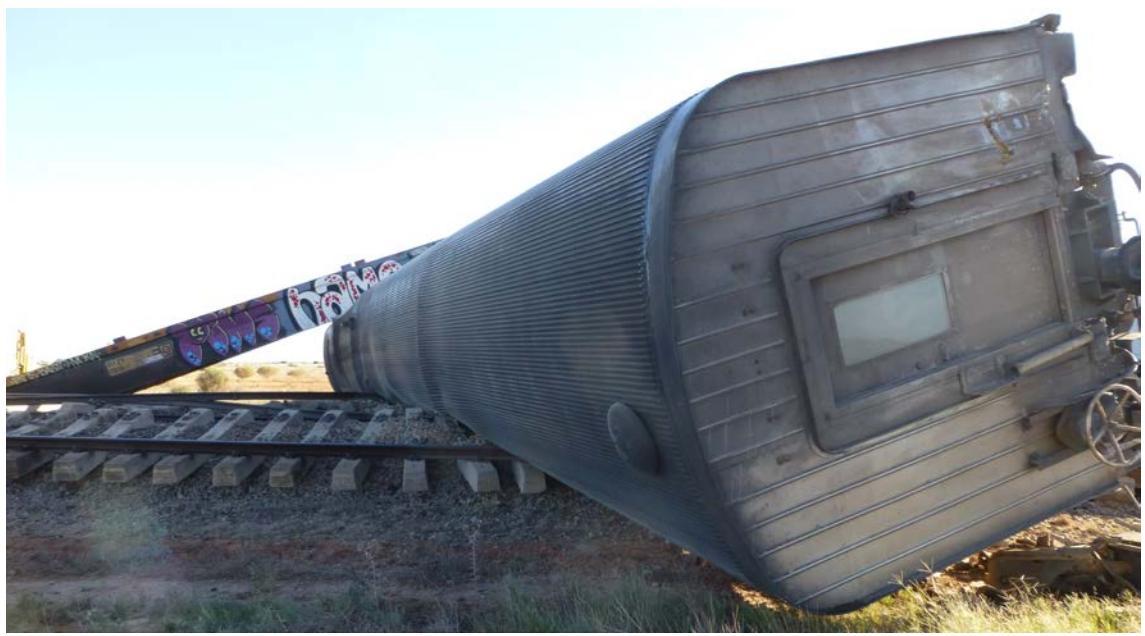
Figure 14: Crew van resting position

Following the derailment, the crew van came to rest on its left side in direction of travel. The resting driver was thrown around inside of the van (Figure 14) and received facial lacerations from a lunch box.

Image showing resting place of the crew van. Source: ATSB.

The driver in the crew van could not access the primary escape paths. Similarly, since the vehicle was on its side, the driver could not reach the emergency push-out window, so remained trapped. Both drivers (from the locomotive) tried to assist the driver in the crew van. Initially, the emergency window accessing the dining area was smashed and the emergency ladder deployed (Figure 15).

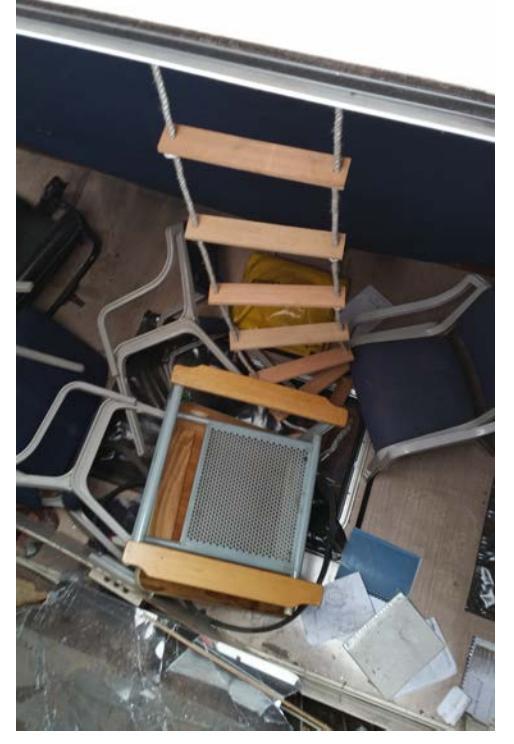
Figure 15: Crew van emergency ladder

Image showing emergency exit ladder inside the crew van. Source: Driver of 3MP5.

Unfortunately, the ladder was only designed to be deployed to the ground outside the window, providing effective egress from a wagon in an upright position. In this case, the wagon was on its side and the mounting position of the ladder made it ineffective as a method to allow escape. Consequently, the resting driver remained trapped in the crew van until an ARTC worker (who attended the incident site) could provide a standard step ladder (Figure 16).

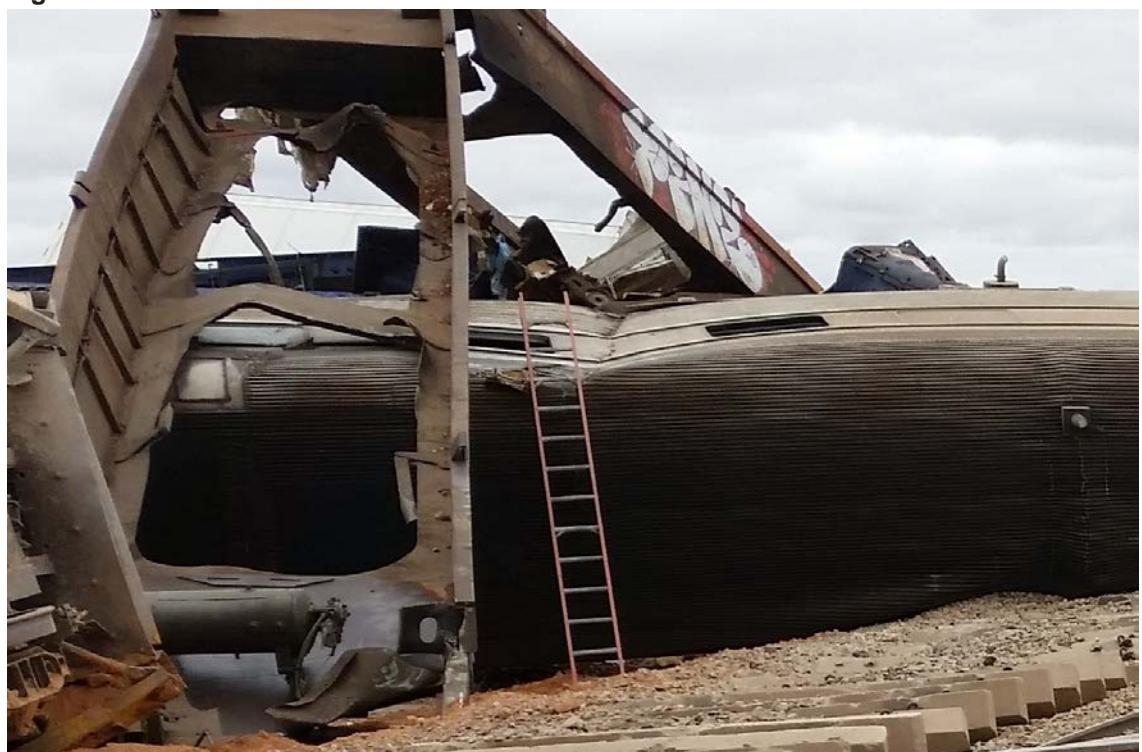
Figure 16: Crew van evacuation

Image showing step ladder used to extricate the driver from the crew van. Source: Driver of 3MP5.
