MH370 – Search and debris examination update

ATSB Transport Safety Report Aviation External Investigation AE-2014-054 2 November 2016 Released in accordance with section 25 of the Transport Safety Investigation Act 2003

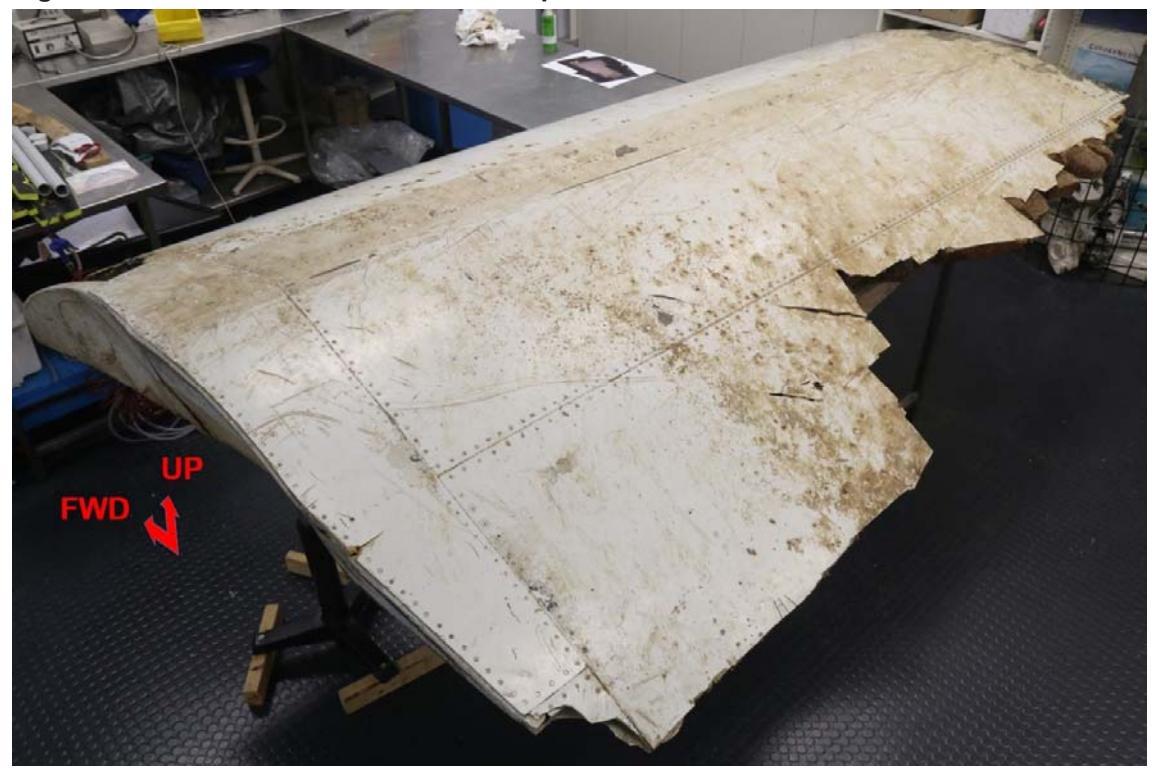
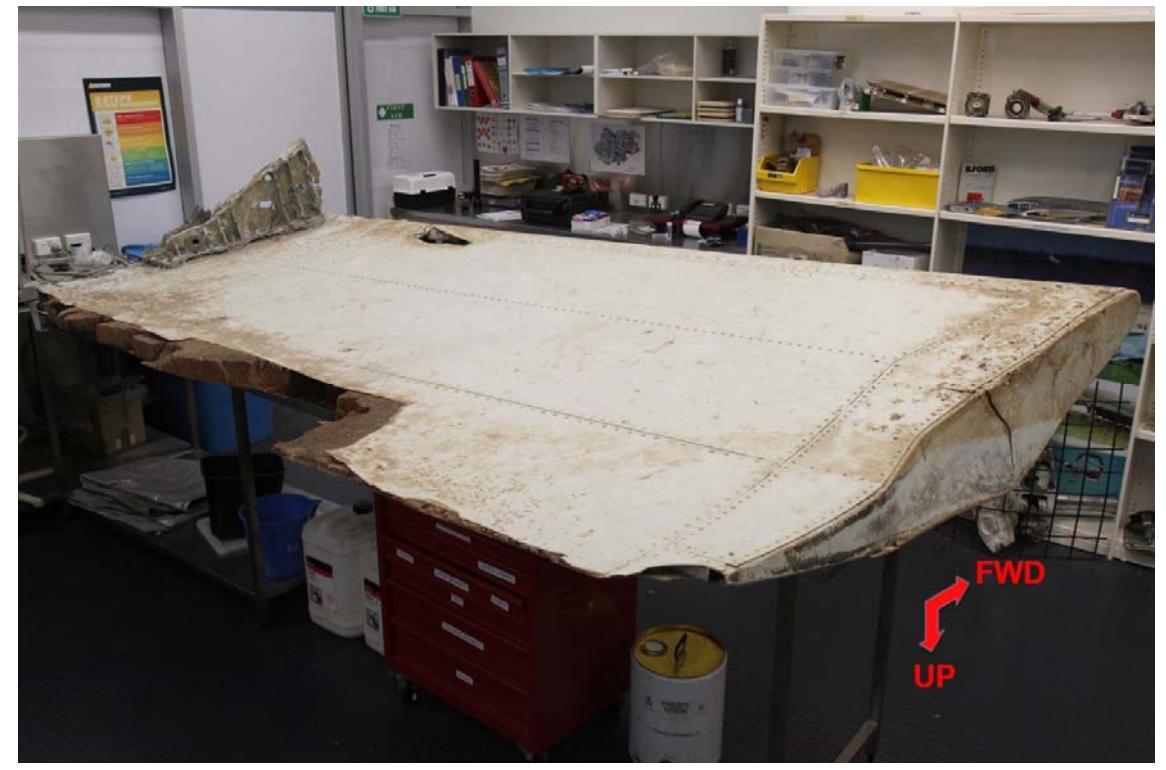
The recovered right, outboard wing flap section (Figures 12, 13 and 14) was examined for any evidence of interaction with mechanisms, supports and surrounding components that may indicate the state of flap operation at the time of fracture and separation from the wing. The purpose of the examination was to inform the end-of-flight scenarios being considered by the search team. The most significant items of evidence in relation to this are documented below.

Figure 13: Inboard section of outboard flap

Figure 14: Inboard section of outboard flap (inverted)

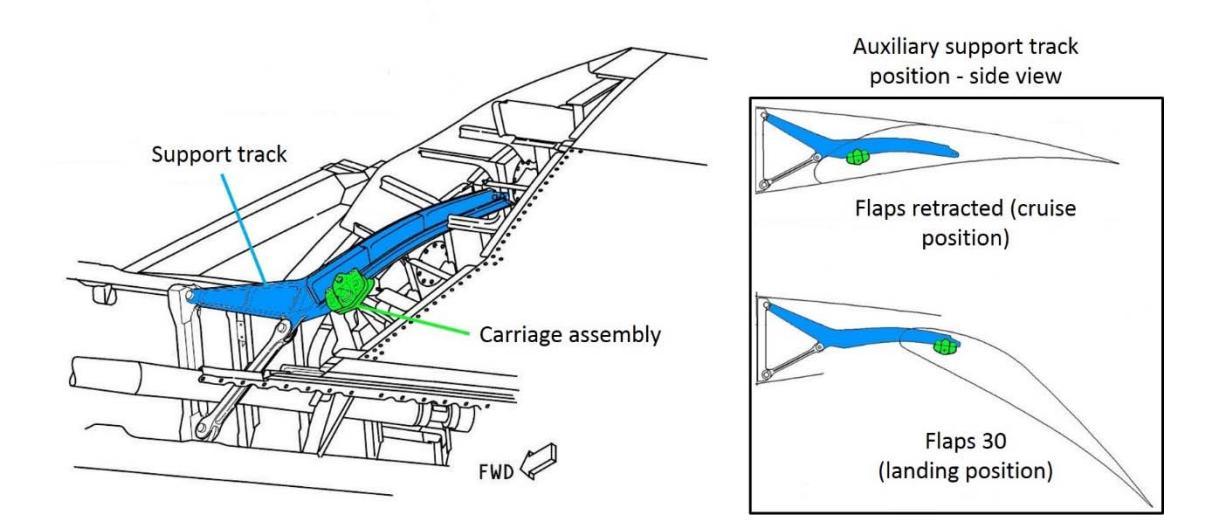
A fibreglass and aluminium seal pan is located at the inboard end of the outboard flap. It houses the inboard auxiliary support, comprising a deflection control track (support track) and carriage assembly. The support track is affixed to the rear of the wing. Using rollers in the carriage assembly, the inboard end of the flap is guided along the support track as the flap moves through its deflection range. The track is fully inserted into the flap in the 'up' position and progressively withdrawn from the flap as the flaps are deployed (Figure 15). The inboard auxiliary support track and carriage assembly were not present with the recovered debris.

Figure 15: Outboard flap, inboard auxiliary support

Damage to the internal seal pan components at the inboard end of the outboard flap was possible with the auxiliary support track fully inserted into the flap. That damage was consistent with contact between the support track and flap, with the flap in the retracted position. The possibility of the damage originating from a more complex failure sequence, commencing with the flaps extended, was considered much less likely.

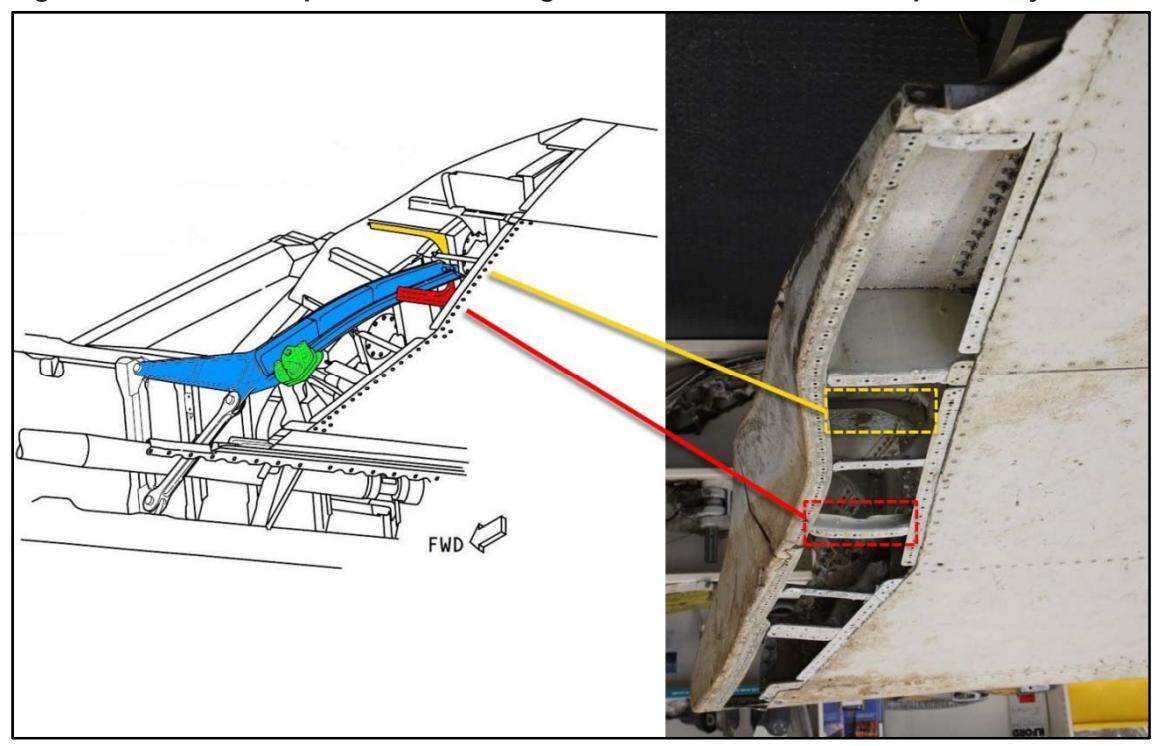
Two adjacent aluminium stiffeners within the inboard seal pan area exhibited impact damage. The damage was significant because it was indicative of impact damage and the only component in the vicinity of the stiffeners, capable of independent movement within the seal pan, was the support track. Measurements of the support track position at the various stages of flap deployment, indicated that the track would have to be fully inserted into the flap in the retracted position to be adjacent to the damaged stiffeners (Figures 16, 17 and 18).

Figure 16: Outboard flap location of damaged stiffeners within the seal pan cavity

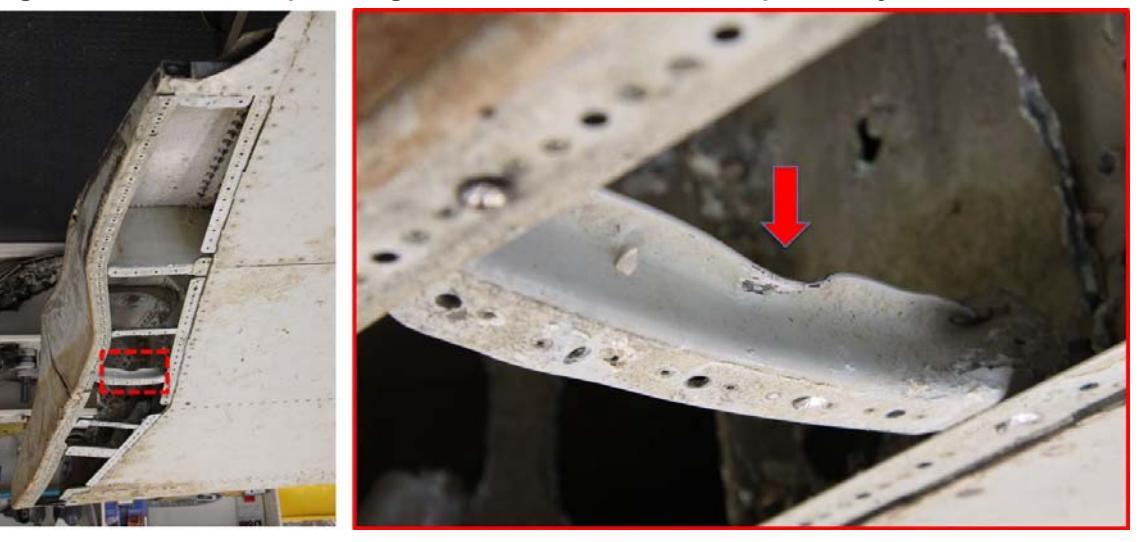
Figure 17: Outboard flap, damaged stiffeners within the seal pan cavity

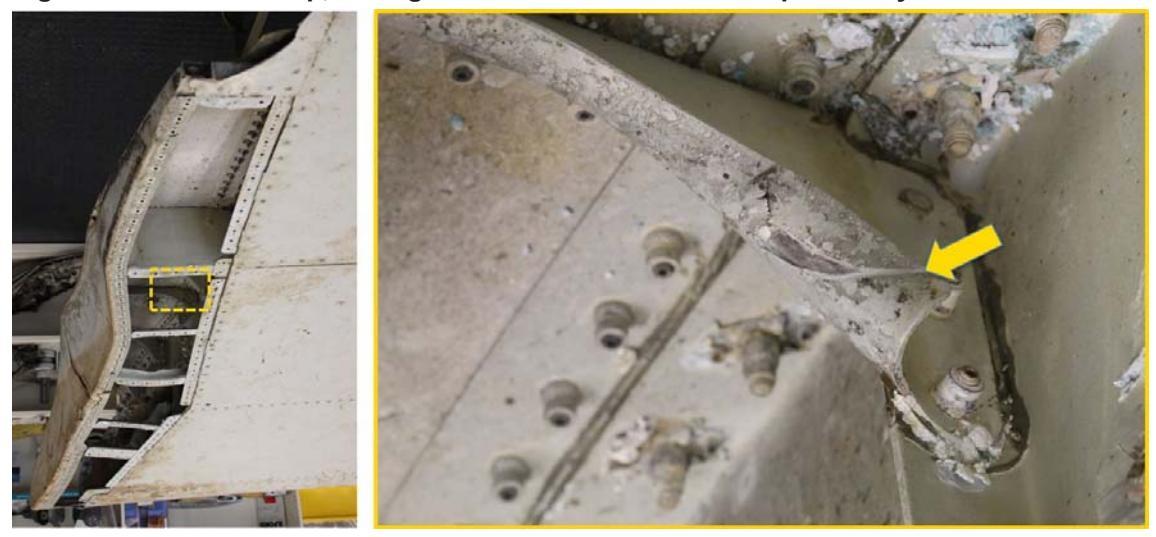
Figure 18: Outboard flap, damaged stiffeners within the seal pan cavity

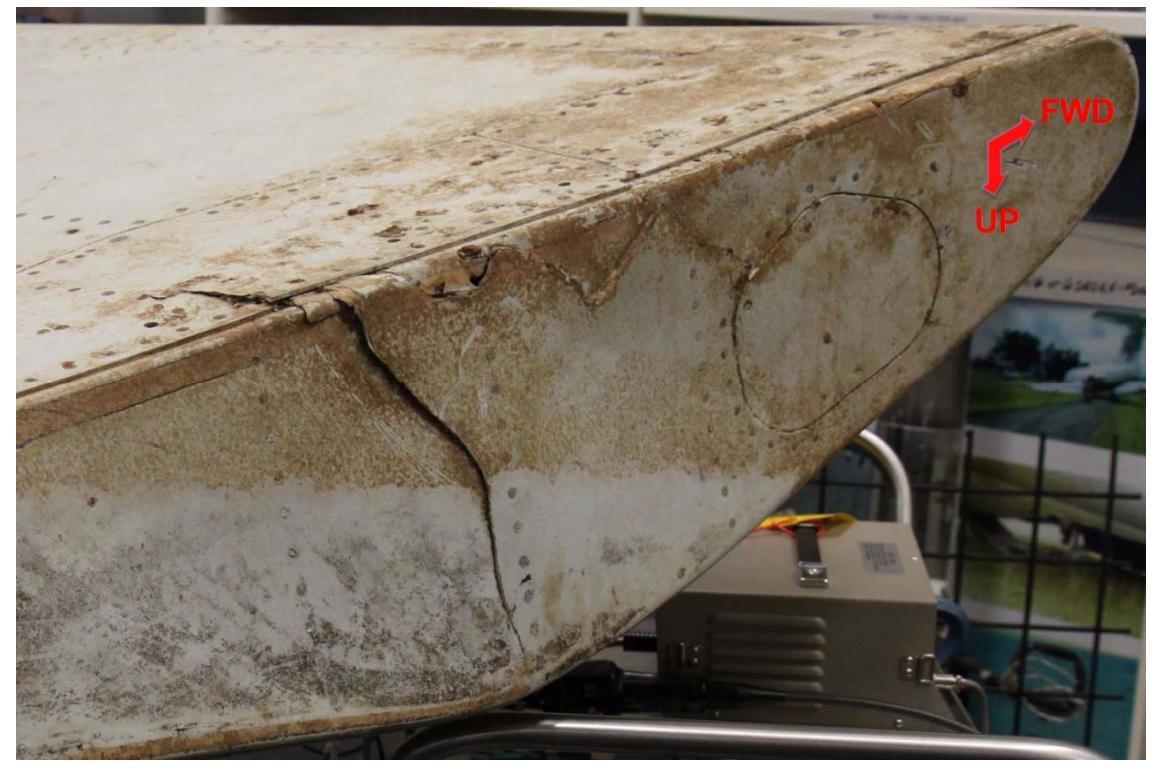
An outwards-fracture of the fibreglass seal pan initiated at a location adjacent to the damaged aluminium stiffeners (Figure 19). The damage was most likely also caused by impact from the support track. That damage provided further evidence of the support track position within the flap seal pan cavity, indicating that the flaps were retracted at the point of fracture and separation from the wing.

Figure 19: Outboard flap, fractured seal pan (forward)

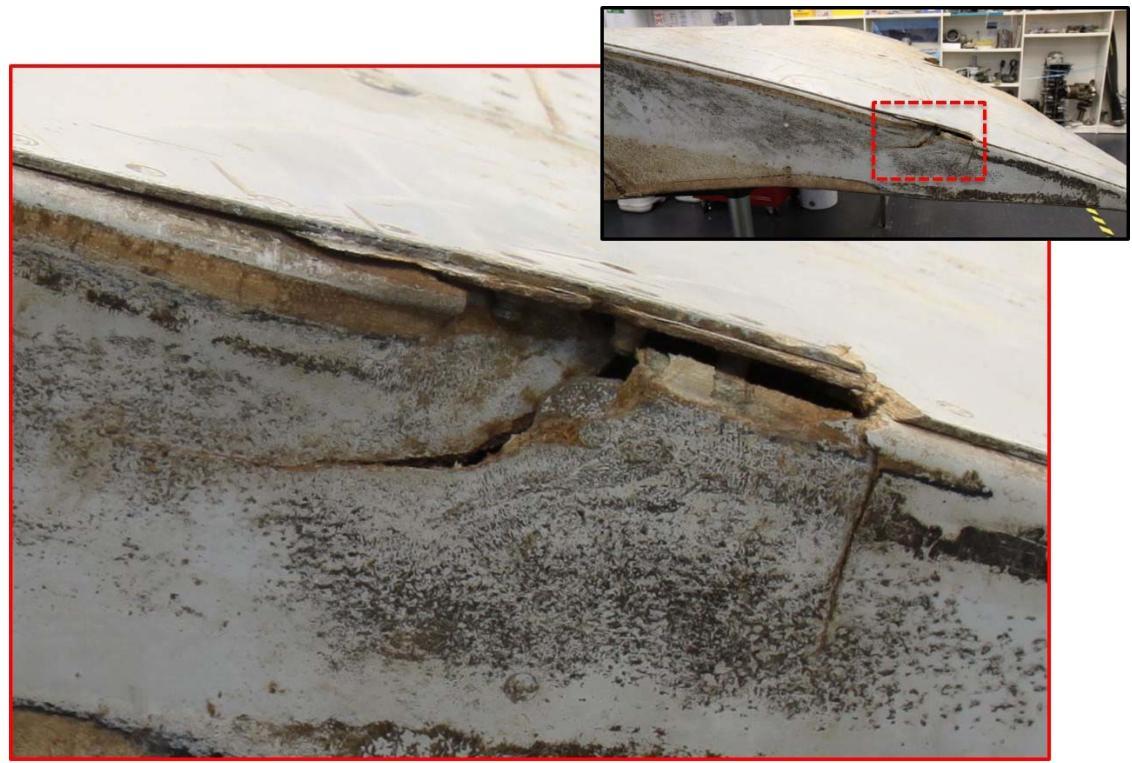
The flap seal pan was also fractured adjacent to the rear spar. The fracture resulted from external impact, puncturing the fibreglass and plastically deforming the supporting aluminium structure within the seal pan cavity (Figure 20). Comparable damage was noted at the outboard, rear spar and surrounding structure of the adjacent flaperon (Figure 21). It was noted that the two areas in question are aligned when the flaps are in the retracted position, with a significant offset existing at other stages of flap extension (Figure 22).

Figure 20: Outboard flap, fractured seal pan (aft)

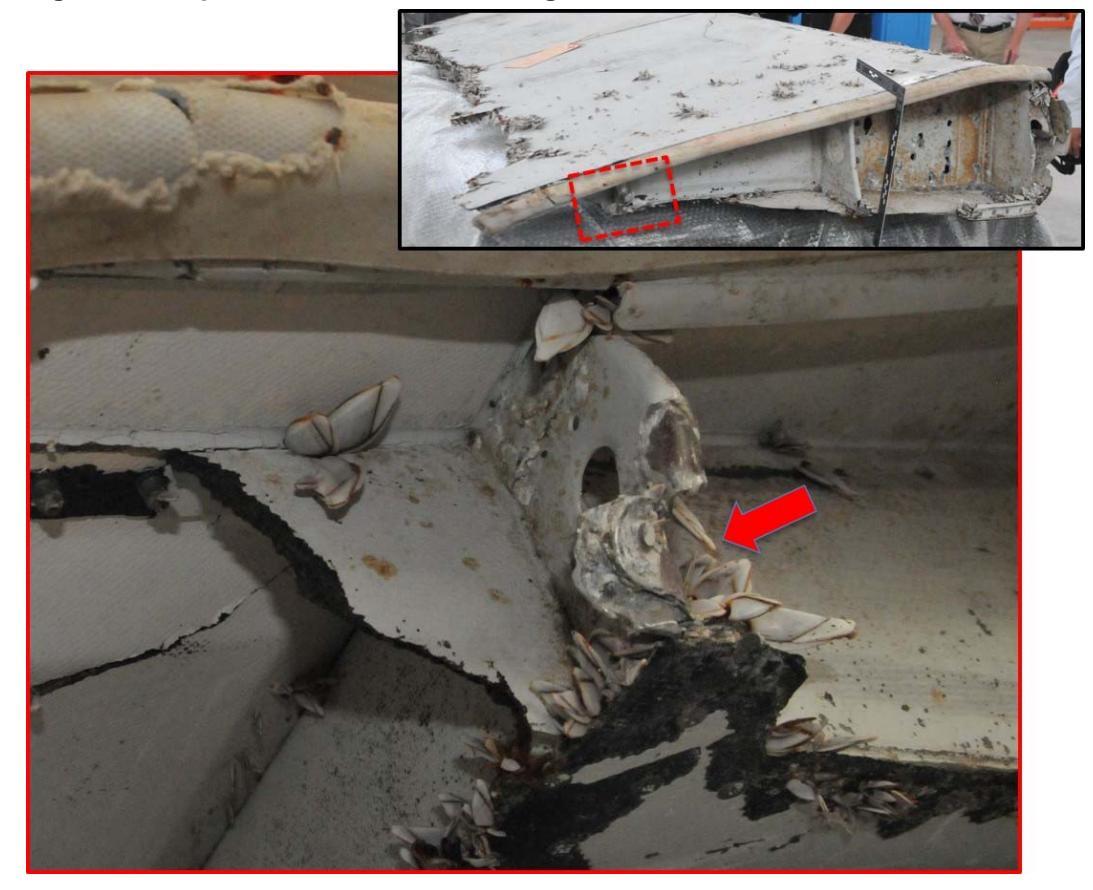
Figure 21: Flaperon, outboard side damage

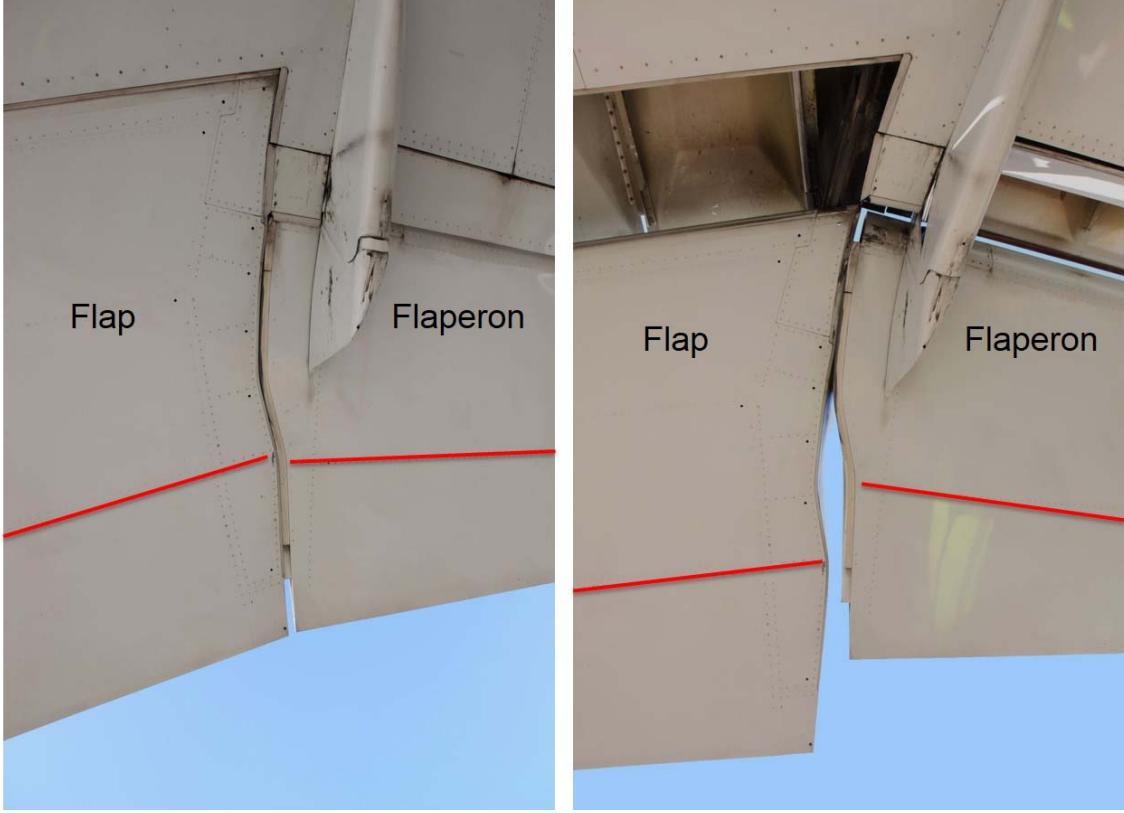
Figure 22: Flaperon and outboard flap from below, showing relative alignment of rear spar rivet line (highlighted) in the flaps retracted (left) and extended position (right)

With the flap in the retracted position, alignment of the flap and flaperon rear spar lines, along with the close proximity of the two parts, indicated a probable relationship between two areas of damage around the rear spars of the parts. This was consistent with contact between the two parts during the aircraft breakup sequence, indicating that the flaperon was probably aligned with the flap, at or close to the neutral (faired) position.
