Incorrect configuration involving ATR - Gie Avions De Transport Régional ATR72, VH-FVL

Brisbane Airport, Queensland, 2 April 2017

ATSB Transport Safety Report Aviation Occurrence Investigation AO-2017-039 Final – 5 September 2017 Released in accordance with section 25 of the Transport Safety Investigation Act 2003

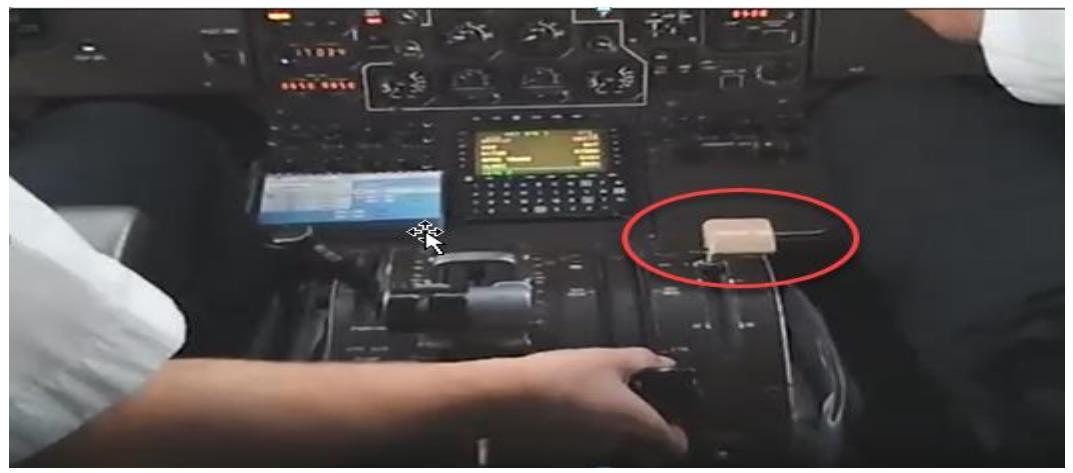
While the aircraft was turning onto the final approach leg, the captain directed the first officer to select flap 30, set the airspeed indicator bug to the approach speed (V_{APP}) ,² and start the before landing checklist. The first officer completed a radio call with ATC, moved the flap selection lever (Figure 1), set the approach speed (104 kt) and responded 'V approach set', and then started the checklist.

Figure 1: Location of flap lever on ATR72

- During the approach, the first officer moved the flap lever up from flap 15 to flap 0, instead of from flap 15 to flap 30 as intended. This resulted in an unstable approach.
- The crew did not identify the incorrect flap setting until the ground proximity warning system alerted them to an incorrect configuration, likely due to workload.

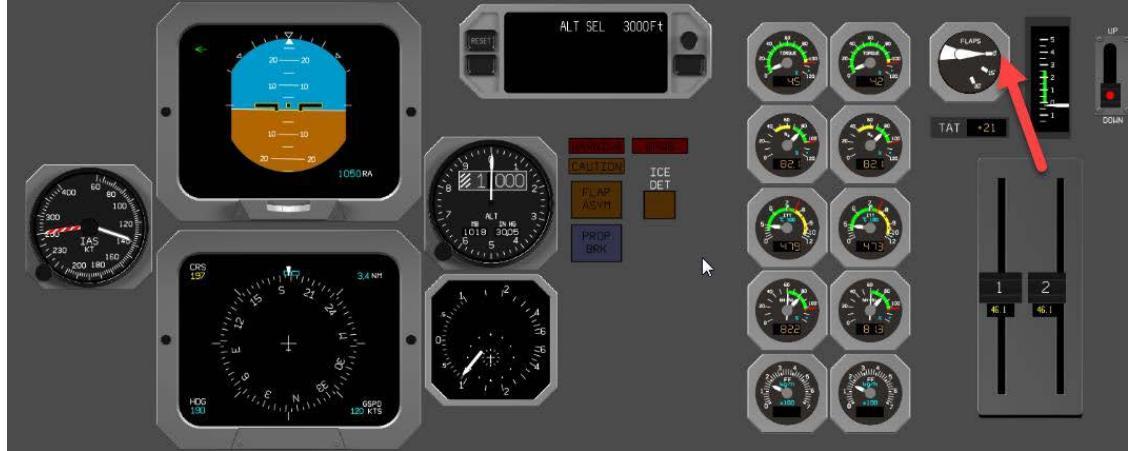
The operator extracted the flight data from the aircraft's quick access recorder. It was recorded that the aircraft commenced the turn onto the final approach at 1,720 ft above the airport and was at 1,729 ft when the flaps lever was moved from 15 to 0 degrees at a calibrated air speed (CAS) of 139 kt.

The flap lever is in the 12 o'clock position for flap 0, in the 2 o'clock position for flap 15, and in the 5 o'clock position for flap 30. The flap position is also shown on the flap indicator where the needle points at 0, 15, or 30 (Figure 2).

Figure 2: A screen capture from the operator's flight data showing the flap indicator positioned at 0 degrees while the aircraft was passing 1,000 feet on descent
