Collision with terrain involving Agusta AB206, VH-DPU

45 km NNW Gladstone Airport, Queensland, 17 March 2017

ATSB Transport Safety Report Aviation Occurrence Investigation AO-2017-033 Final – 5 September 2017 Released in accordance with section 25 of the Transport Safety Investigation Act 2003

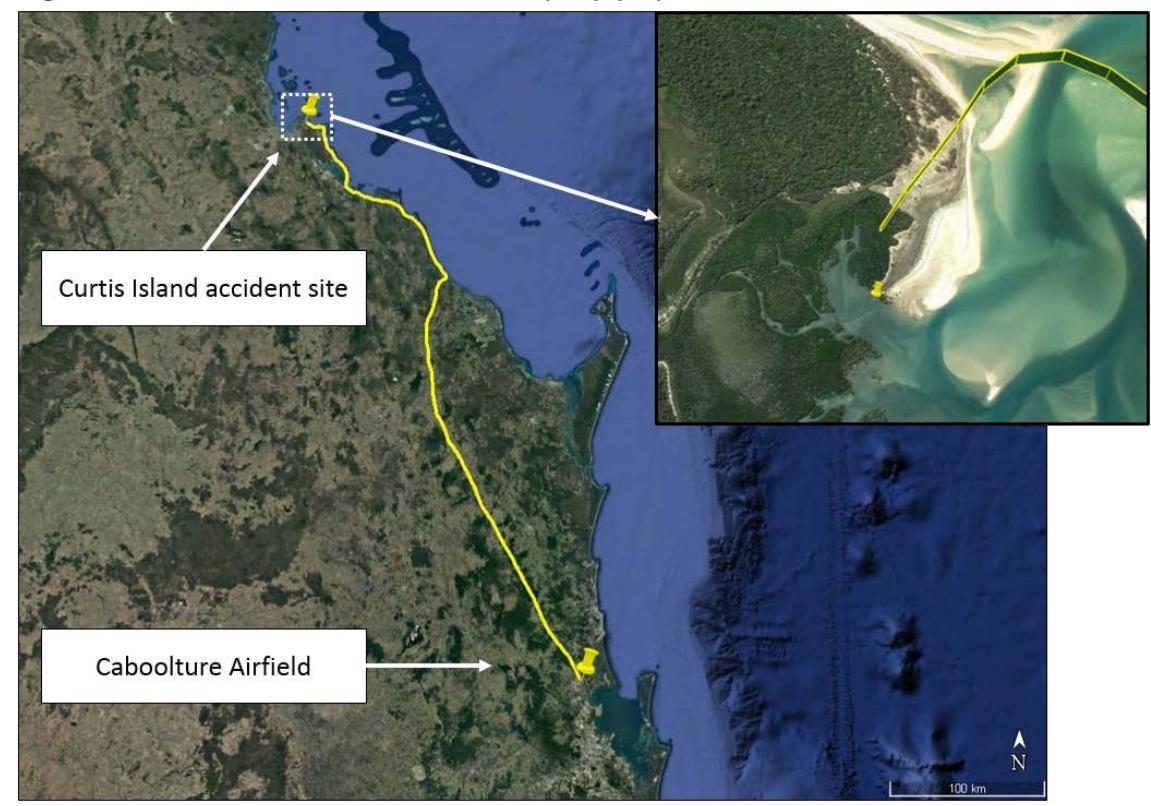
Figure 1: VH-DPU track and accident site (drop pin)

Prior to departure, the helicopter had been refuelled to full at Caboolture Airfield. The helicopter was flown for about 2.5 hours north, initially inland, then coastal to the north of Curtis Island where the pilot planned to land for a fishing trip (Figure 1). At 1142 Eastern Standard Time (EST), the pilot sent a text message from their¹ mobile phone to a friend monitoring their search and rescue time, which indicated they had arrived at their planned fishing spot.² At 1144, the helicopter was recorded on an OzRunways application, running on a mobile device, at the north-east coast of Curtis Island heading 209°.

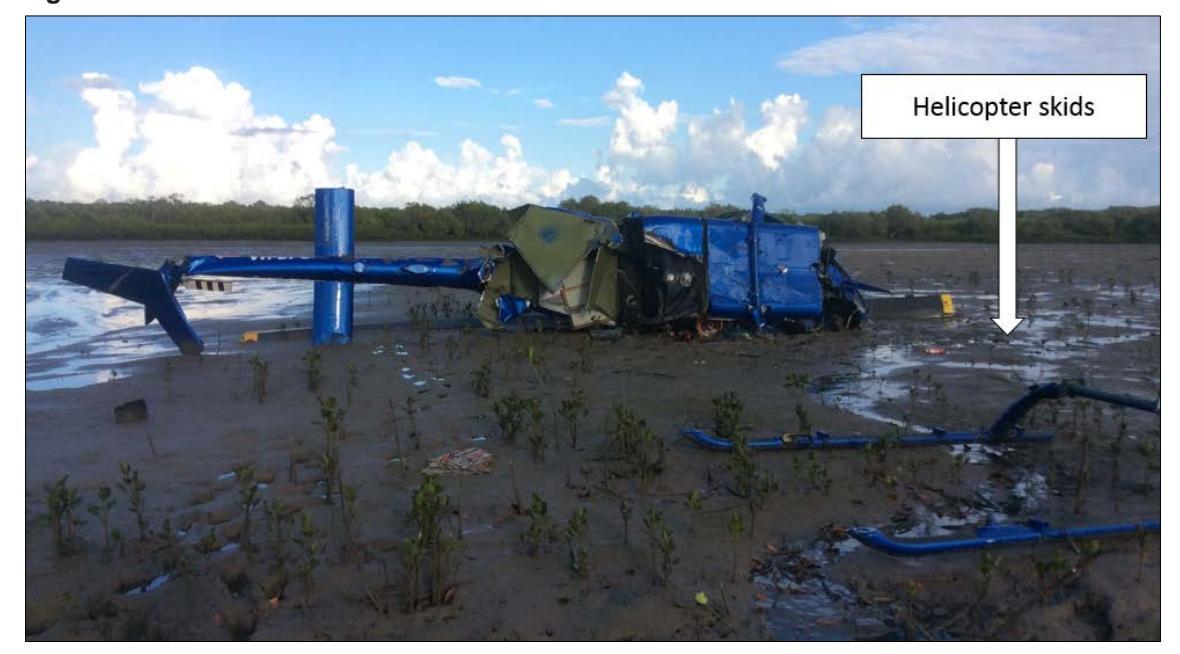
Figure 2: VH-DPU accident site at low tide

The helicopter initially impacted upright in the water before the airframe separated from the helicopter skids, turned through 180° and rolled onto its left side (Figure 2). This placed the passenger, in the left seat, under water. As soon as movement ceased, the pilot tried to pull the passenger's head above the water, but the passenger was initially trapped in their harness. The passenger subsequently struggled free from their harness without unfastening it. The pilot and passenger exited the helicopter, at which stage the pilot reported to the passenger that they felt paralysed below the waist.

The separation of the airframe from the landing skids, and final relative position of the airframe and landing skids, was consistent with low forward speed and engine torque combined with low

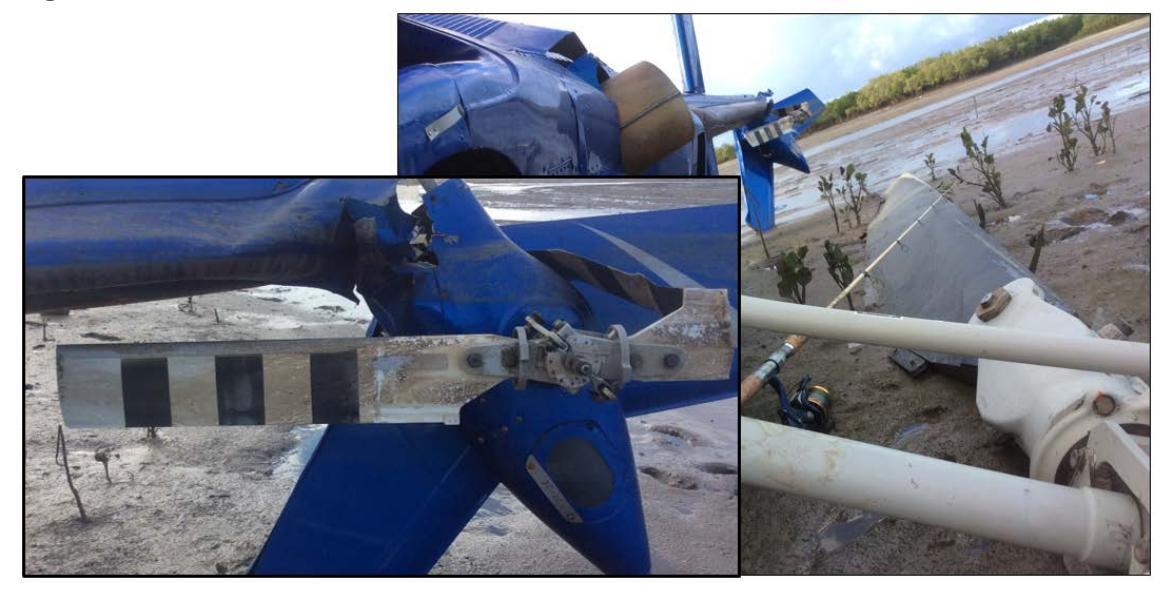
Figure 3: VH-DPU main and tail rotor blades

Testing the warning and caution lights, and checking the overhead circuit breakers, are items in the flight manual checklists for before and after engine start. The pilot reported that these checks were performed before departure from Caboolture. They made radio transmissions during the flight and communicated with the passenger using headsets, which indicates that the audio circuit breaker was in prior to the accident. The ATSB noted that the condition of the main and tail rotor blades indicated there was little rotational energy in the blades at the time of impact (Figure 3).

The condition of the rotor blades post-impact indicated there was little rotational energy in the blades at the time of impact. The helicopter could lose rotor speed due to either an engine failure or rotor stall condition. In each case, other than an engine failure close to the ground,¹⁵ the pilot should lower the collective to maintain or recover rotor speed.
