Forced landing involving Robinson Helicopter R44 VH-MQE

27 km N Silver Plains (ALA), Queensland, on 6 April 2017

ATSB Transport Safety Report Aviation Occurrence Investigation AO-2017-041 Final – 5 September 2017 Released in accordance with section 25 of the Transport Safety Investigation Act 2003

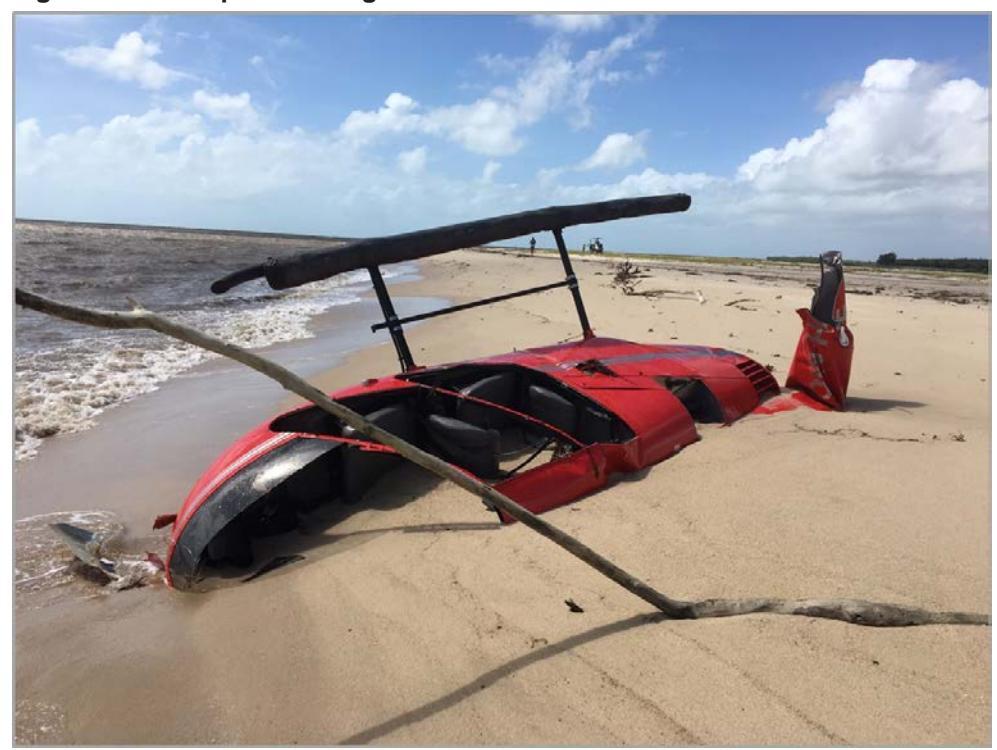
The operator reported that subsequent to the accident, the helicopter sustained substantial damage due to ocean tide (Figure 2). The operator was not able to provide any information in relation to any mechanical defects that may have contributed to the accident.

Figure 2: Subsequent damage due to the ocean tides

Due to the nature of the subsequent damage to the helicopter after the accident the integrity of the helicopter systems prior to the accident were not determined. Consequently, the reason for the loss of main rotor speed was not determined.
