# Collision with vehicle during approach involving Piper PA-31 VH-JQS

Barwon Heads/Geelong ALA, Victoria, 29 March 2017

ATSB Transport Safety Report Aviation Occurrence Investigation AO-2017-040 Final – 5 September 2017 Released in accordance with section 25 of the Transport Safety Investigation Act 2003

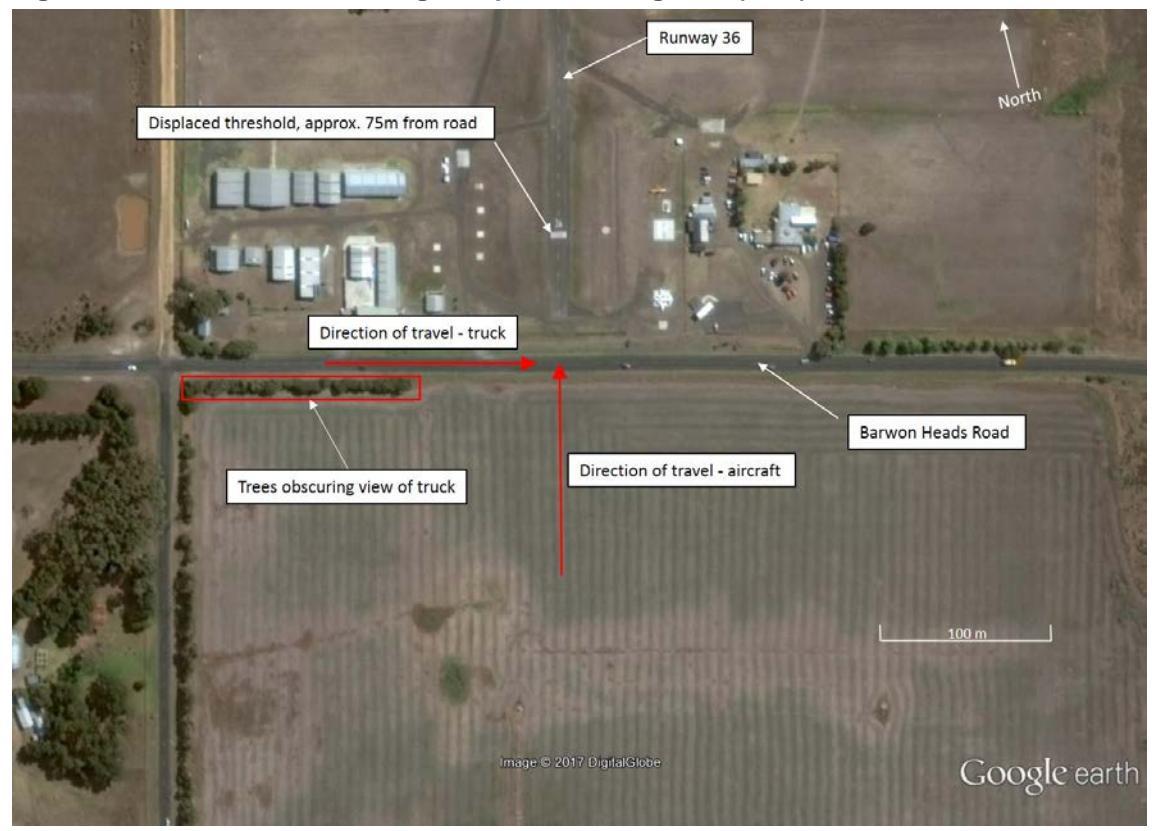
Figure 2: Barwon Heads/Geelong aeroplane landing area (ALA).

Barwon Heads Road is in close proximity to runway 36 (Figure 2). The start of runway 36 was about 25 m from the road, and the displaced threshold was 78 m from the road. Additionally, the elevation of the runway at the threshold was 0.31 m higher than that of the road. Using the 5 per cent approach recommended by CAAP 92-1, a distance of 78 m results in a height of 3.9 m (see Figure 5) over the runway elevation, providing a total road-crossing height of 4.21m. The *VicRoads vehicle height limit* in Victoria for road vehicles was 4.6 m.

The threshold of runway 36 was 78 m from Barwon Heads Road (Figure 2). Using the 5 per cent approach recommended by CAAP 92-1, a distance of 78 m results height of 3.9 m above the runway elevation. Combining this with the 0.31 m elevation difference, results in a clearance of 4.21 m which is less than the 4.6 m road vehicle height permitted in Victoria. Therefore, a normal approach aiming for the threshold of runway 36 at Barwon Heads can intersect with road vehicles on Barwon Heads Road.

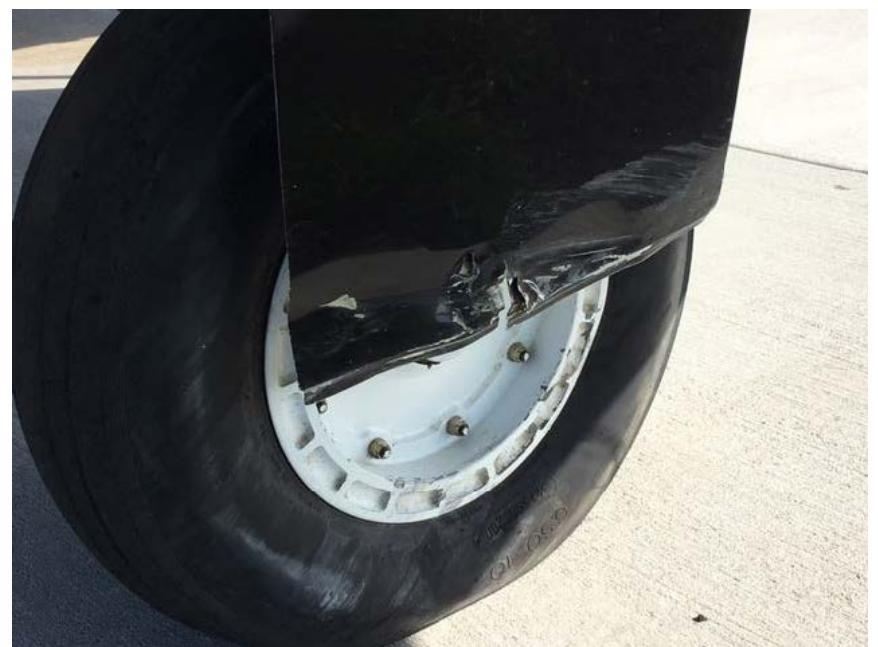
The pilot applied full power to conduct a go-around.<sup>2</sup> As full power was applied, the aircraft passed over Barwon Heads Road and the left main landing gear impacted the truck. The pilot observed the truck continue on Barwon Heads Road without stopping and the pilot continued with the go-around. The pilot elected to leave the landing gear extended in case it had sustained damage.

The pilot subsequently landed the aircraft without incident. The pilot was uninjured and the aircraft sustained minor damage (Figure 3).

Figure 3: Damage to left main landing gear of VH-JQS.

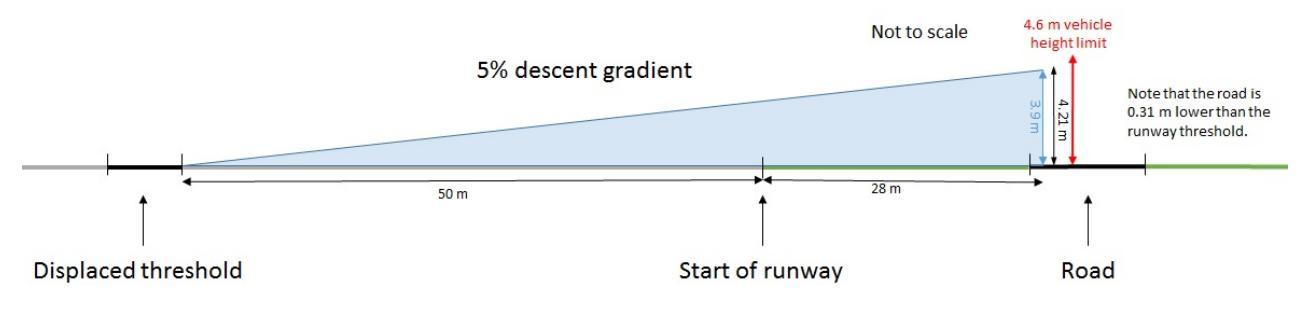
Figure 4: Diagram showing a 5 per cent (3 degree) approach profile for Barwon Heads runway 36 and the proximity of Barwon Heads Road. A 5 per cent descent gradient aiming at the threshold results in aircraft passing over Barwon Heads Road at 4.21m which is lower than the VicRoads vehicle height limit of 4.6m.

- The aircraft descended below the desired approach profile and the corrective action was not effective in sufficiently reducing the rate of descent.
- The displaced threshold on runway 36 at Barwon Heads does not provide the level of clearance recommended by the Civil Aviation Safety Authority Civil Aviation Advisory Publication 92-1.
