# Partial engine power loss and ditching involving Robinson R44, VH-WRR

49 km N of Hamilton Island Airport, Queensland, 8 November 2017

ATSB Transport Safety Report Aviation Occurrence Investigation AO-2017-110 Final – 20 March 2018 Released in accordance with section 25 of the Transport Safety Investigation Act 2003

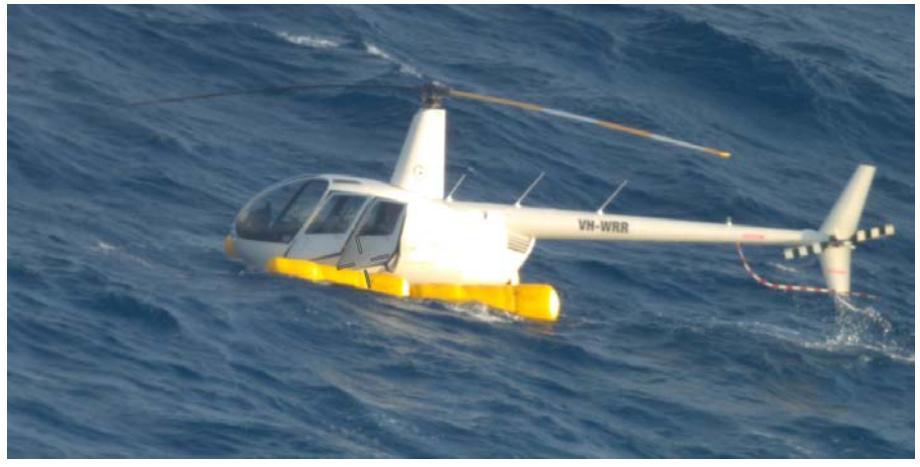
Consequently, when at 700 ft, the pilot elected to conduct an autorotation<sup>4</sup> onto the water. The pilot activated the emergency flotation system<sup>5</sup> and broadcast a MAYDAY<sup>6</sup> call on the common traffic advisory frequency. The engine RPM gauge continued to provide erratic readings and the low engine sound continued during the landing. About 30 seconds later, the helicopter landed on the water with the emergency floats deployed (Figure 1).

1 hour later. All occupants were uninjured. While there appeared to be no observable damage sustained to the helicopter, it later sank and was unable to be recovered.

# Figure 1: VH-WRR after ditching about 49 km north of Hamilton Island Airport, Queensland
